2009 Downtown Revitalization Plan UPDATE

City of Rockland, Maine

2009 DOWNTOWN REVITALIZATION PLAN UPDATE

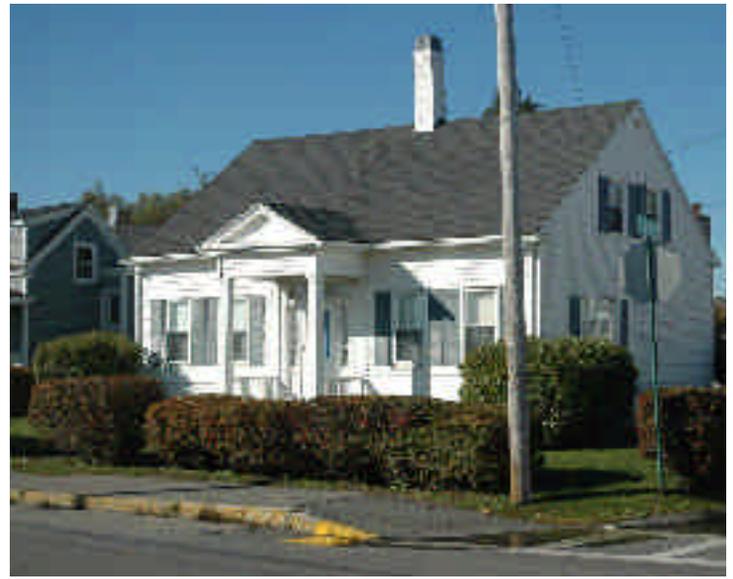
Most aspects of this residential property are in good condition with exception of the eaves and roofline facing Main Street. The eaves and shingles (and potentially the roof sheathing) require improvement. The siding is vinyl which hides a substantial amount of the building's original detailing. The long-term goal for this property should be to remove the vinyl and restore the original siding and detailing.

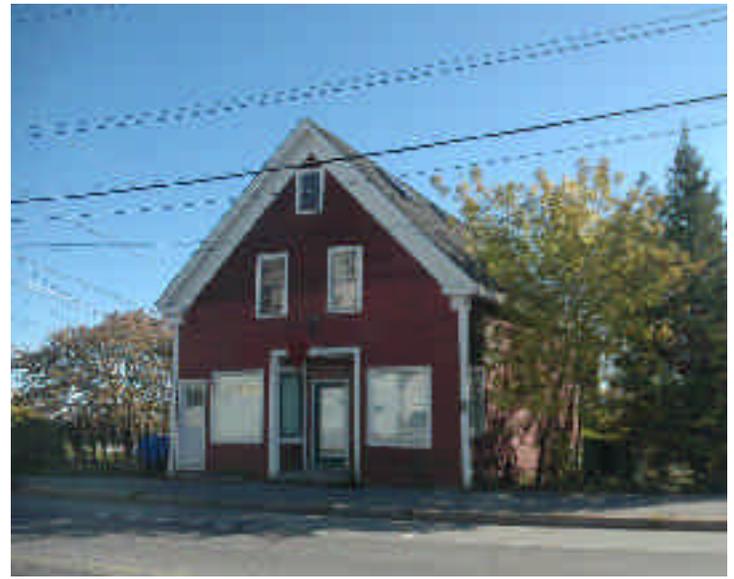
Most aspects of this property are in good condition with exception of the paint and signage. Signage is inadequately small. Painted finish on the clapboard siding is inconsistent in both application and color. Owner should complete painting work or repaint to create consistency especially on the Main Street facade.

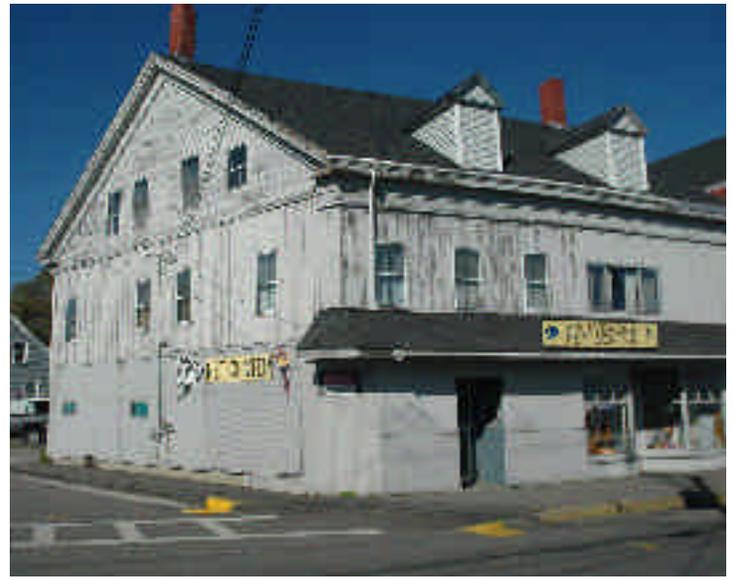
This property has deficiencies in many areas. Signage and facade materials are not in keeping with the historical character of the street. The overall condition of the building is poor. Replacement of sign, repainting, and removal of shingled bump out along Main Street are highly recommended. Siding, and roofline / eave trim replacement are also recommended.

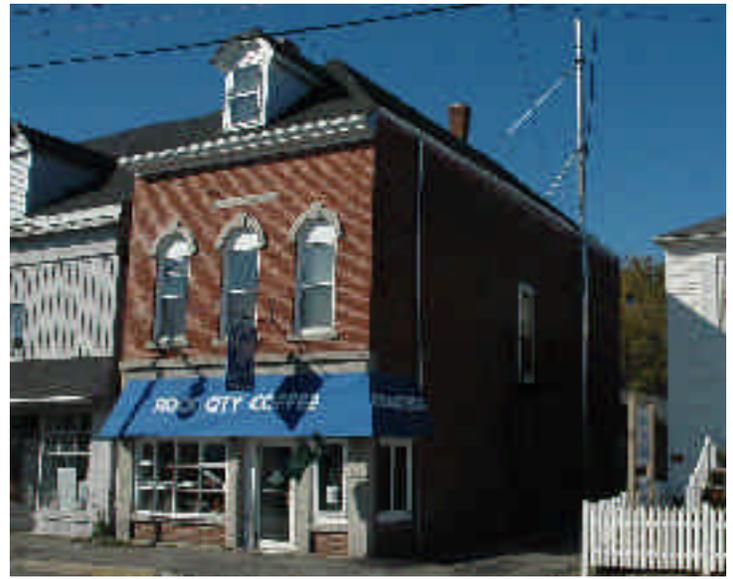
Most aspects of this property are in good condition with exception of the street level windows, signage, and eave trim. Windows on the street level facing Main Street appear to require restoration or replacement. At minimum, the windows require new paint. Signage is excessive: showing up over 4 times on awnings, windows, and on a projecting sign. Elimination of half of these signs is recommended. Eave trim appears to require maintenance or repair from street level observation.

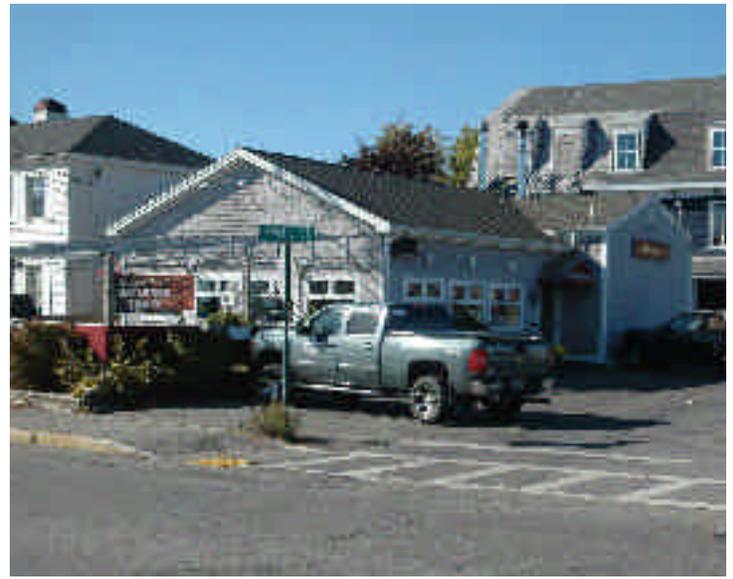
Most aspects of this property are in good condition with exception of excessive signage, and awnings. Signage was too large and some were difficult to read from Main Street due to the fact that it was obscured behind vegetation. Signs should be reduced in number and relocated to a location that provides better visibility. The awning facing Main Street is extremely large and is not in keeping with a historic district. However, its function and importance for the restaurant use is understood. In the event this property changes use, it is recommended that the awning be removed.

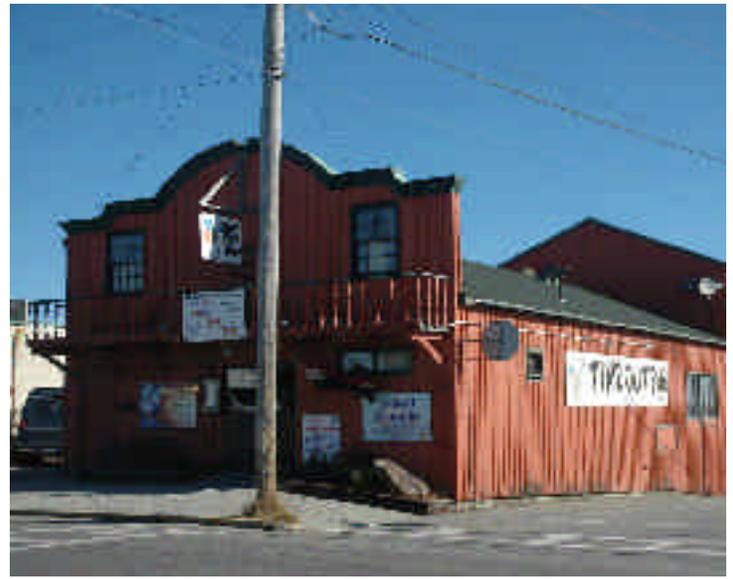
This property has several issues including inconsistent paint, excessive signage, no views from Main Street to the building interior, and poor landscaping. Signs, in the form of promotional banners are not in keeping with the historical context of Main Street and should be removed or controlled by designating areas for banners to be placed. Signs on the sides of the building are excessive and should be removed since the projecting sign over Main Street provides ample designation to the business inside. The entire building should be repainted and exterior trim replaced as needed. Landscaping should be improved to buffer against the lack of windows facing Main Street.

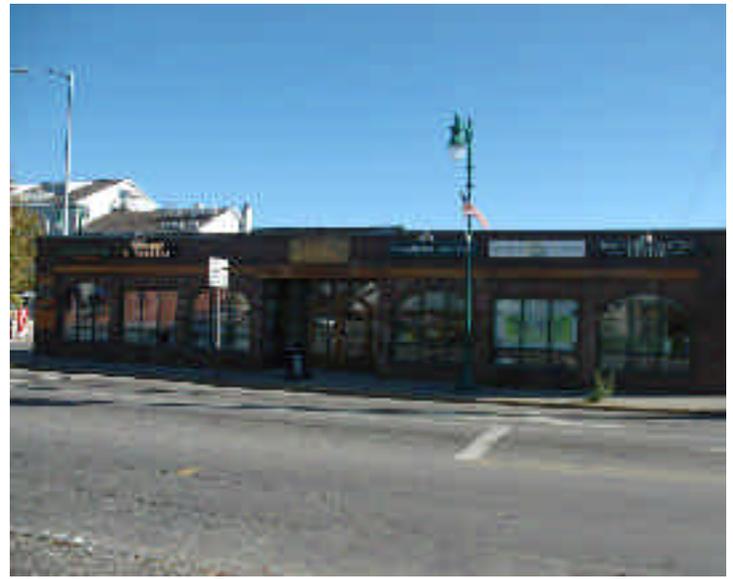
Most aspects of this property are in good condition with exception of excessive signage, inconsistent varnish throughout the exterior wood trim, and roofline metal trim. Signage was too varied, with 8 different signs applied to the facade. Some of these signs are in need of replacement. The main building entrance sign should be replaced with a projecting sign identifying the entrance from Main Street. Other tenant space signs should be organized to either be the same size or to be hung at a consistent height. Wood trim around doorways and windows requires cleaning, scraping, and new clear finish. Roof trim is rusted and should be cleaned, repaired, painted or replaced.

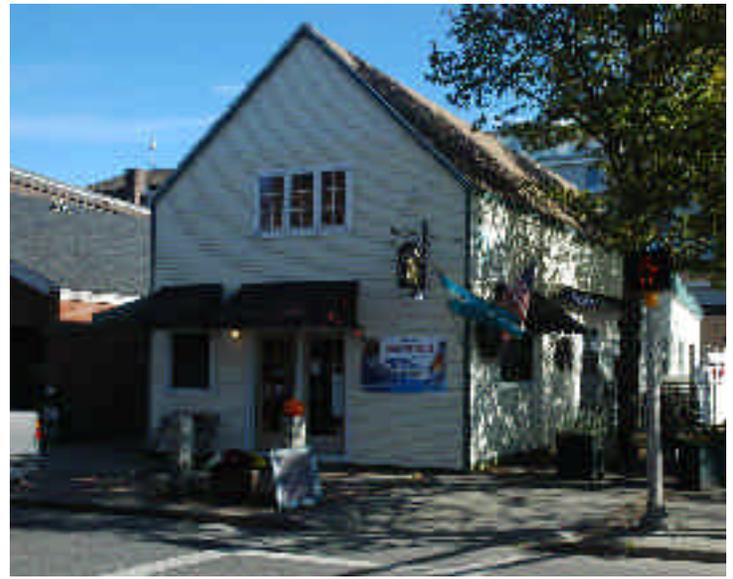
Most aspects of this property are in good condition with exception of window trim condition. Upper level window trim facing Main Street requires repair and/or paint.

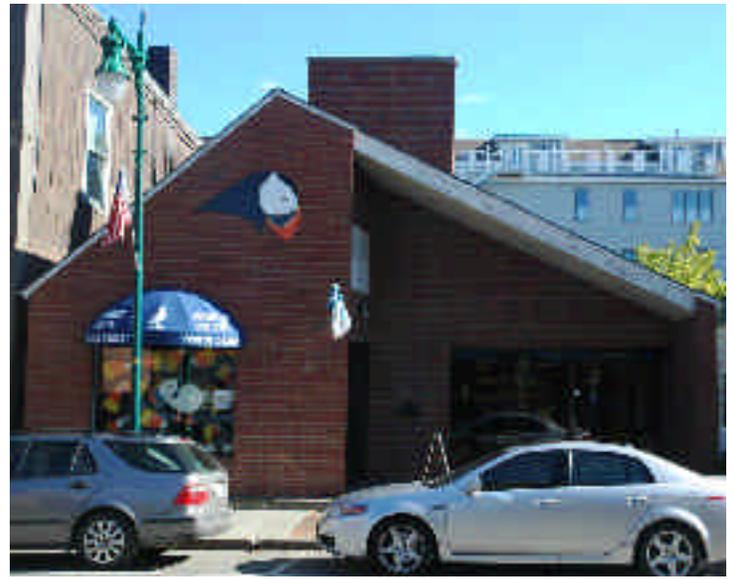
Most aspects of this property are in good condition with exception of inconsistent and excessive signage as well as inconsistent painted trim. Signage was too varied and reductions in signs (multiple puffins) would be in better keeping with the historic context. Trim at street level and along roof eaves requires new paint.

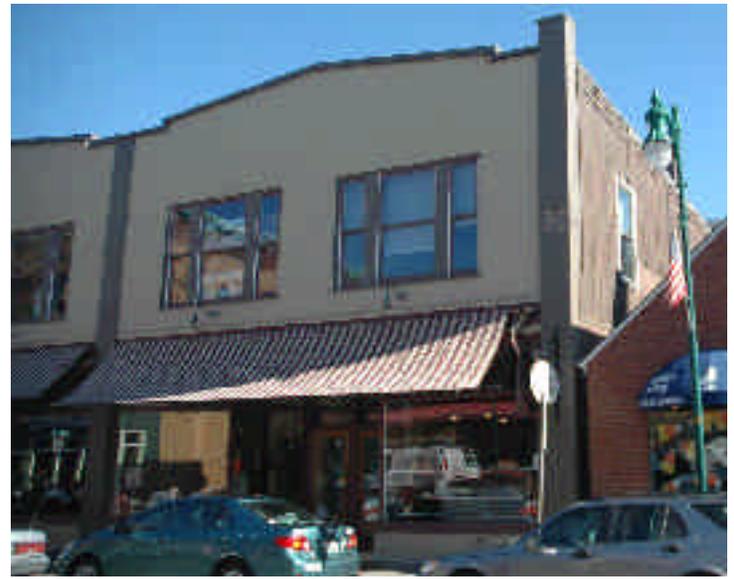
Most aspects of this property are in good condition with exception of one ripped awning and facade details. The awning on the south portion of the building has a tear along its entire depth and requires replacement. The painted medallion details on the outer edges of the brick facade should be repainted to improve the visibility of the building's original detailing.

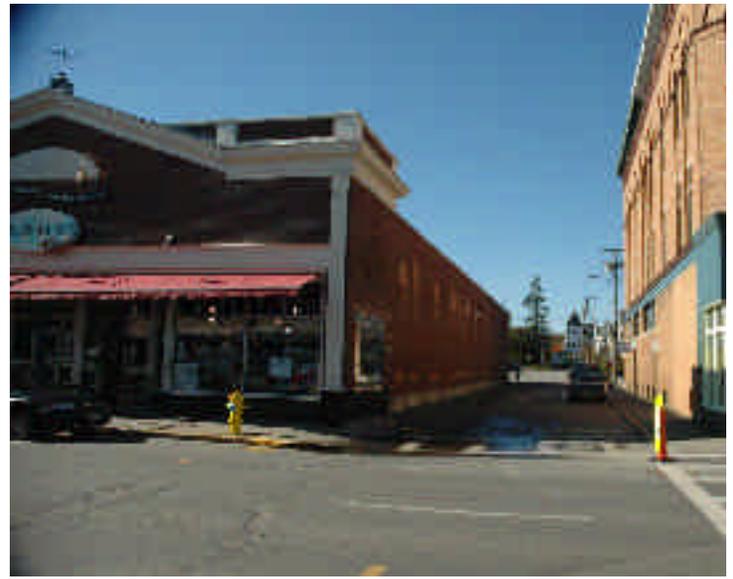
Most aspects of this property are in good condition with exception of awning condition and painted trim condition. Awning is faded and torn and requires replacement in the near future. Wood trim along the building edges and roofline requires new paint and potentially wood repair preparation.

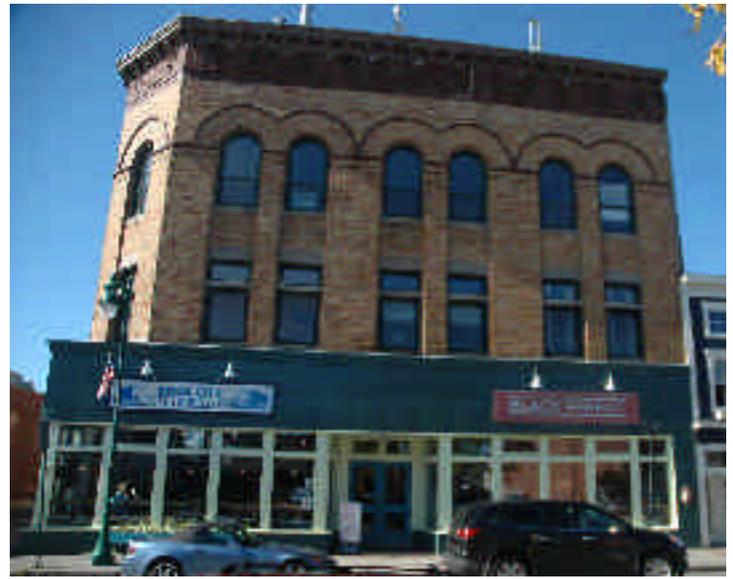
Most aspects of this property are in good condition with exception of inconsistent painting at street level windows, cornice, and roofline as well as metal panels at street level bumpout. All areas in question should be scraped if necessary and repainted to provide consistency. Metal panels are not in keeping with the historical context of the street and the building itself. These panels should be removed so the original facade may be analyzed. Restoration of the street level to a condition equal to or similar to the original construction is recommended.

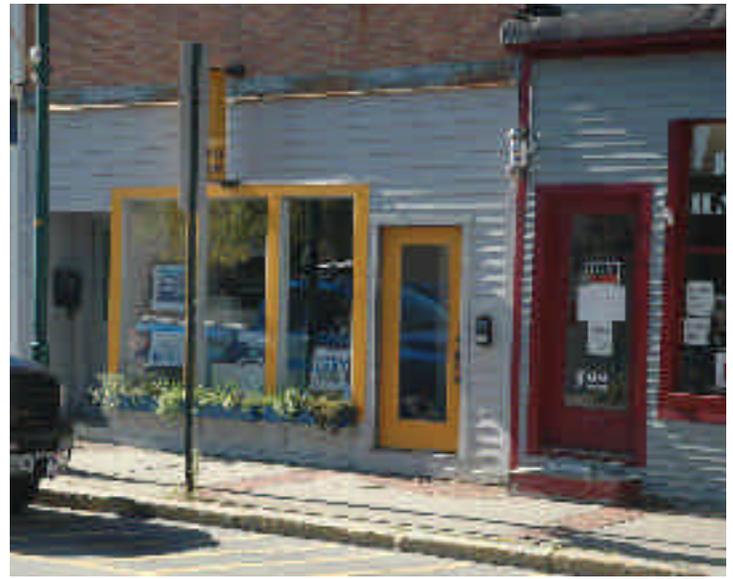
Most aspects of this property are in good condition with exception of inconsistent painting at street level and roofline / cornice. All areas in question should be scraped and repainted to provide consistency. Metal cornice should be properly prepared prior to applying a new paint or sealer.

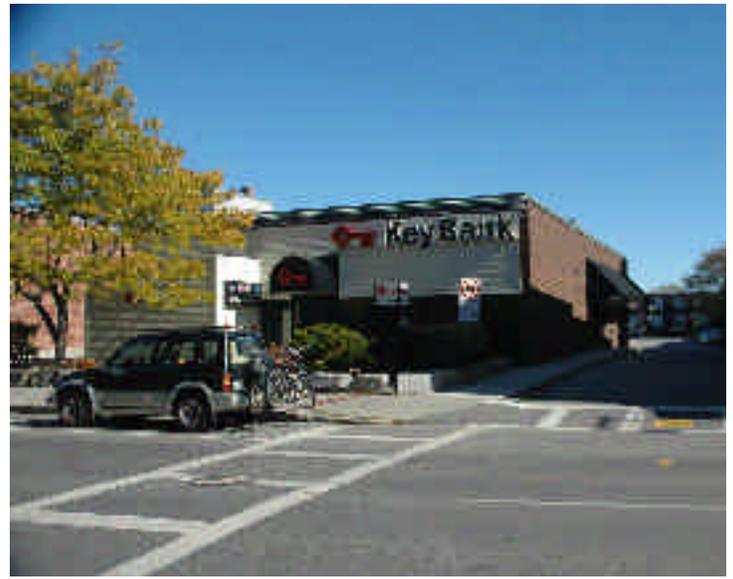
Most aspects of this property are in good condition with exception of excessive signage. The corporate identification of the bank company is not in keeping with the historic character of the street. It is recommended that awning signage be removed and facade signage be reduced. All other aspects of the building are in good condition.

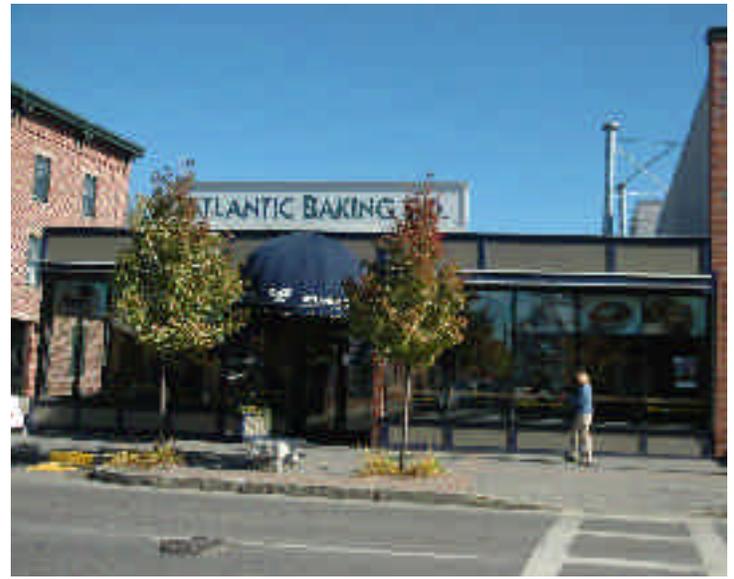
Most aspects of this property are in good condition with exception of excessive signage. The awning was rolled up and not reviewed. The combination of the awning sign, the sign over the building, and the graphics on the facade windows are excessive. The recommendation is to limit window graphics and text to create a less busy facade. All other aspects of the building are in good condition.

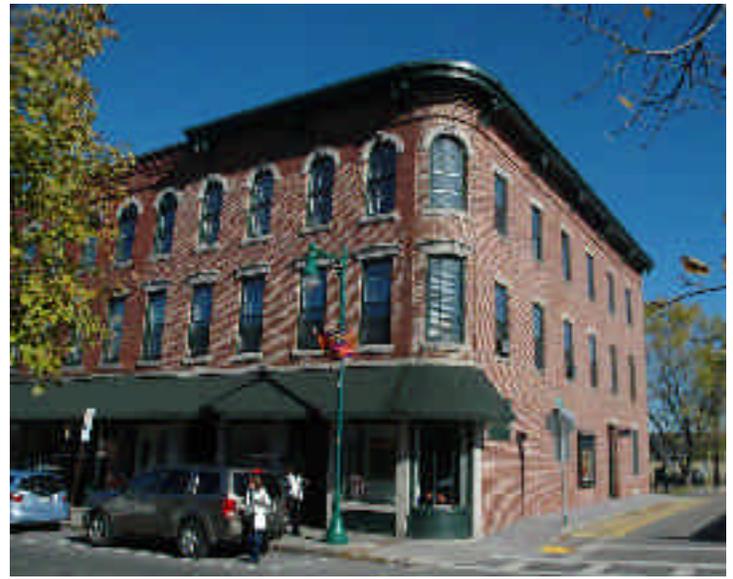
Most aspects of this property are in good condition with exception of selective brick pointing required at the upper facade.

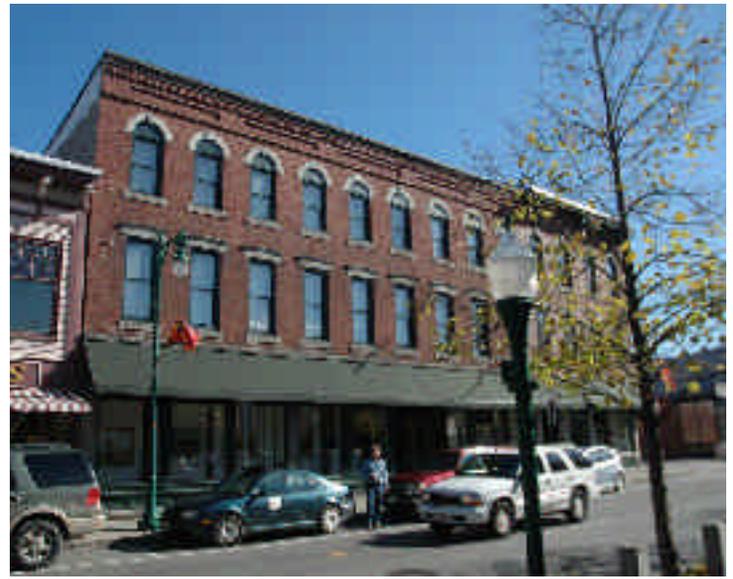
Most aspects of this property are in good condition with exception of selective brick pointing required at the upper facade.

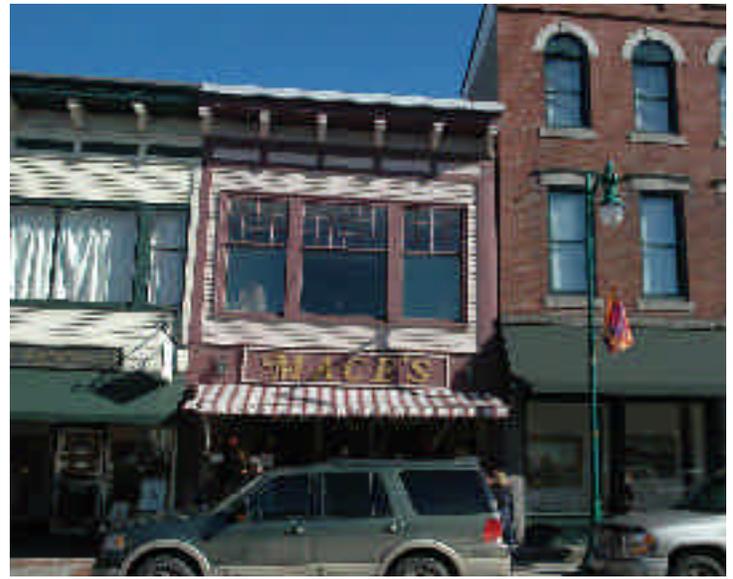
Most aspects of this property are in good condition with exception of poor paint condition over the entire facade, especially at street level paneling. Wood trim, clapboards, and window trim should be repainted.

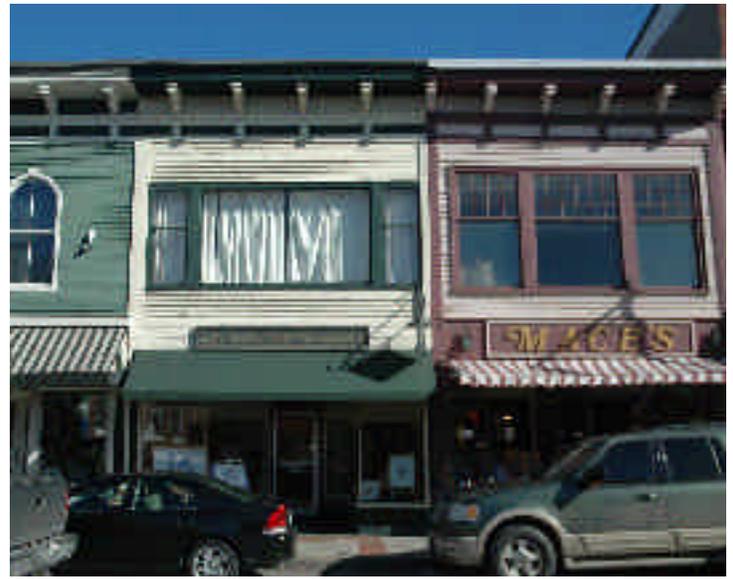
Most aspects of this property are in good condition with exception of poor paint condition over the entire facade and cornice. Wood trim, clapboards, window trim, and cornice should be repainted.

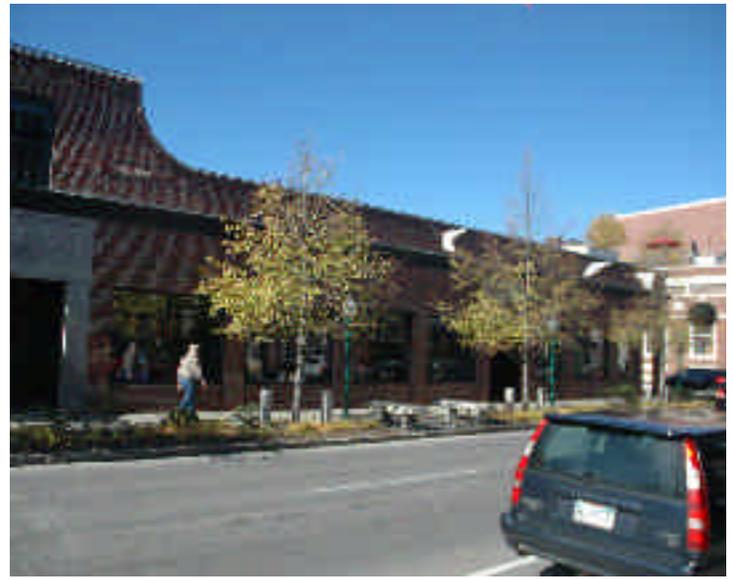
Most aspects of this property are in good or excellent condition with exception of poor paint condition at roof gutter. This area should be repainted.

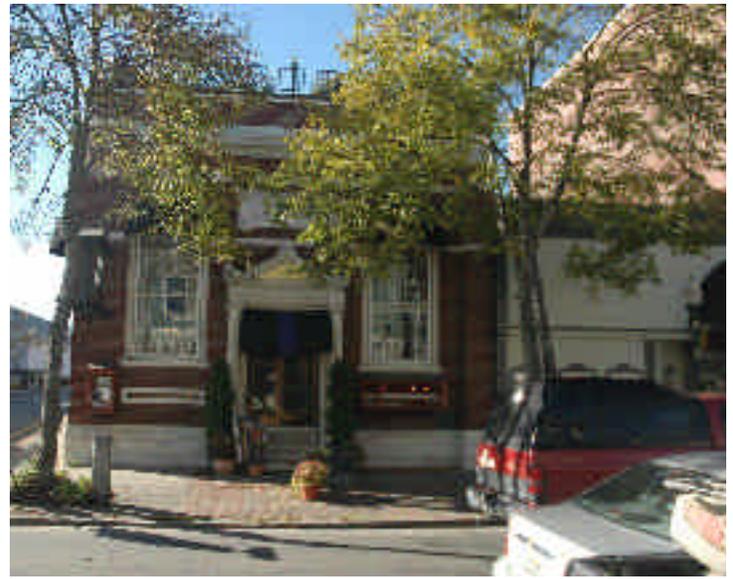
Most aspects of this property are in good or excellent condition with exception of the cornice. This area should be repointed.

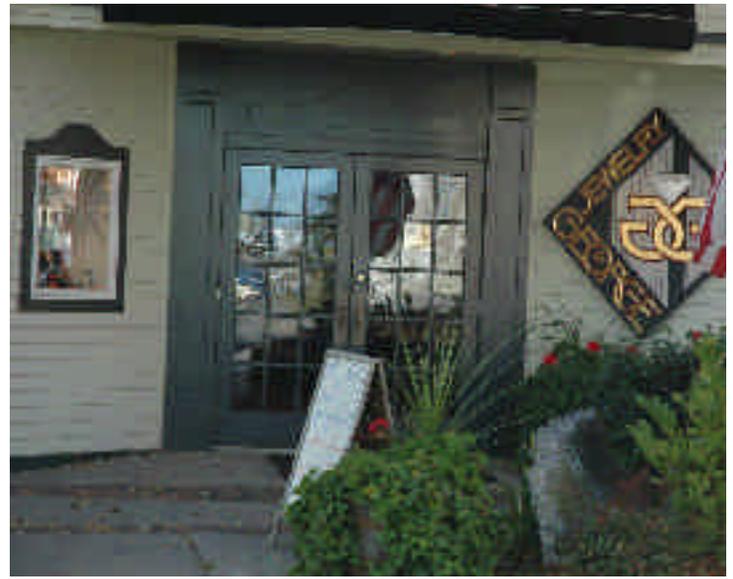
Most aspects of this property are in good or excellent condition with exception of excessive signage and poor paint condition at the cornice. The facade signage should be reduced in scale and the cornice area should be repainted.

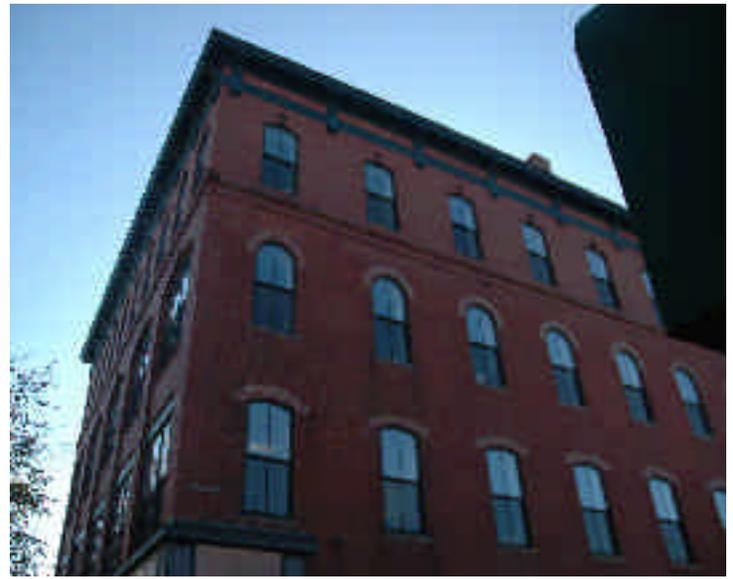
Most aspects of this property are in good or excellent condition with exception of minor painting and caulking on facade.

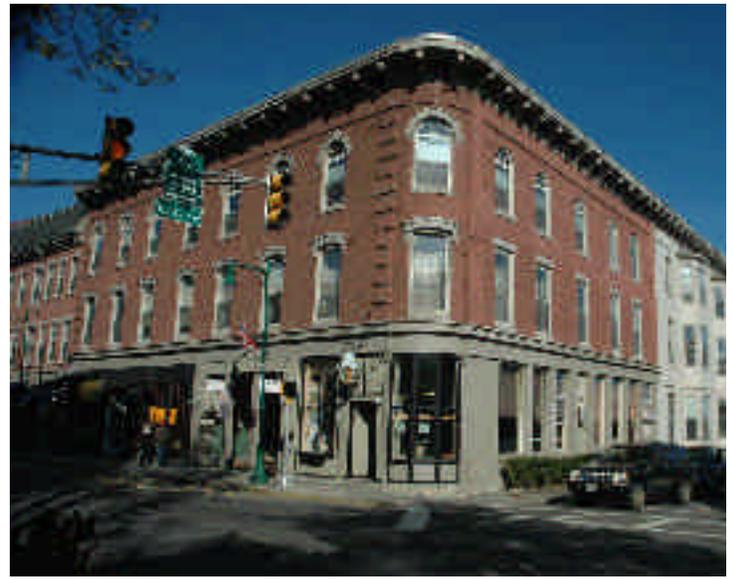
Most aspects of this property are in good or excellent condition with exception poor paint condition across the facade and cornice. The facade and cornice area should be repainted.

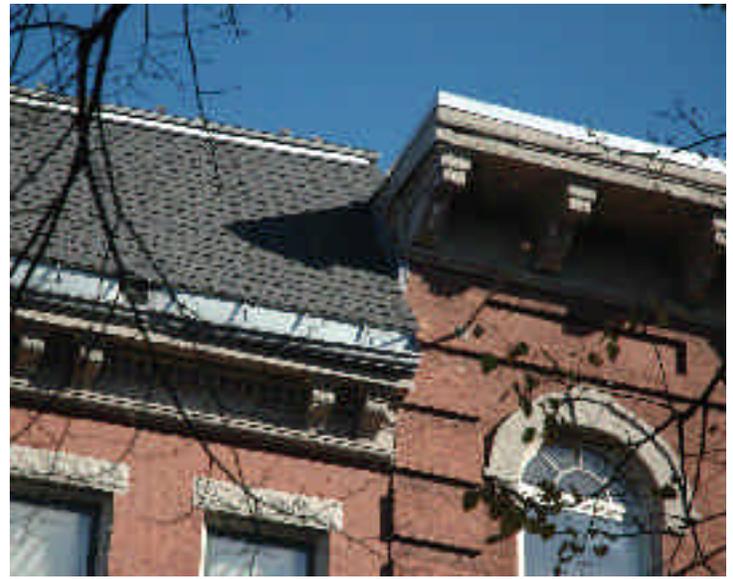
Most aspects of this property are in good or excellent condition with exception of inappropriate signage and poor paint condition at the cornice. The facade signage at Embroidery Shop should be changed in scale and the cornice area should be repainted.

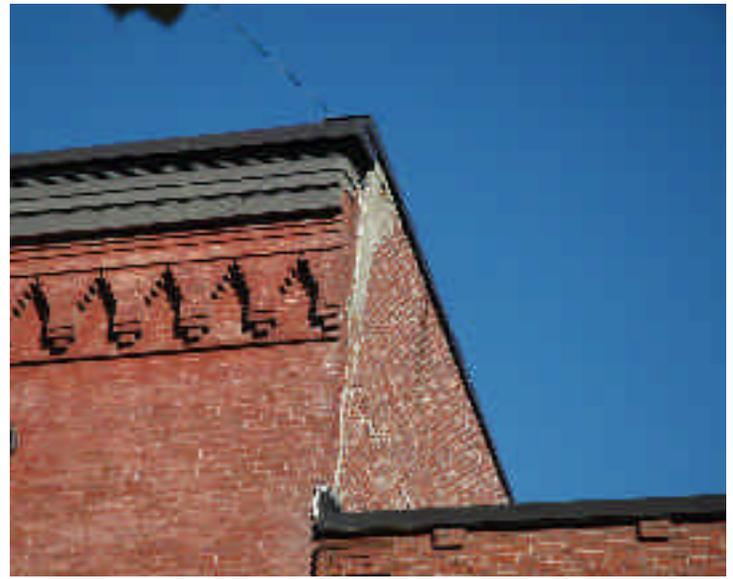
Most aspects of this property are in good or excellent condition with exception of poor window frame condition at storefront and poor paint condition across the facade. The wood trim and painted metal should be repainted.

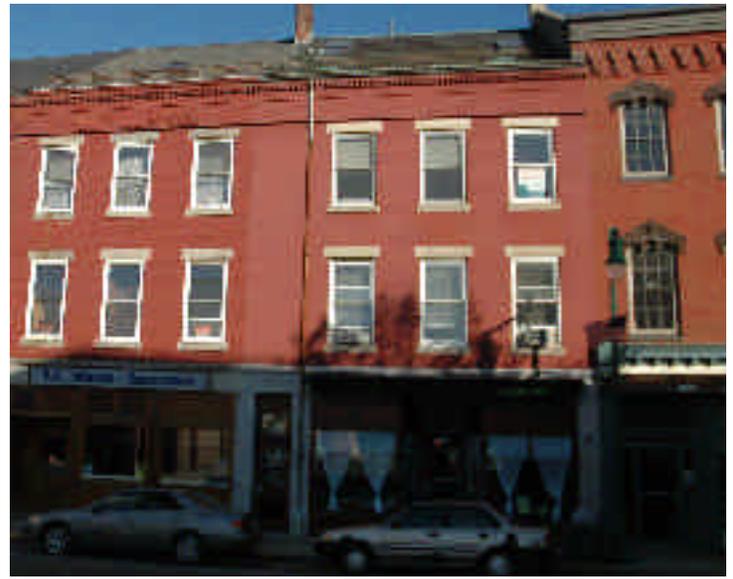
Most aspects of this property are in good or excellent condition with exception of poor paint condition at street level and at cornice as well as poor brick facade condition. The wood trim should be repainted and brick facade should be repointed.

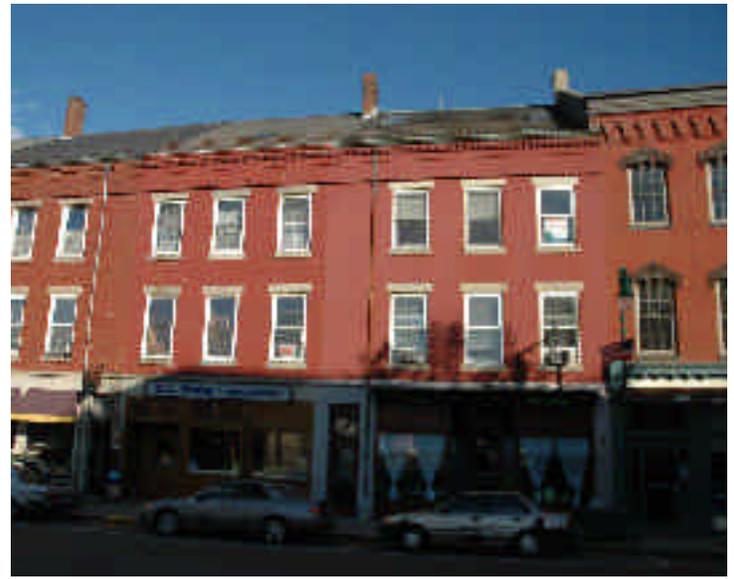
Most aspects of this property are in good or excellent condition with exception of poor paint condition at street level and at cornice as well as poor brick facade condition. The wood trim should be repainted and brick facade should be repointed.

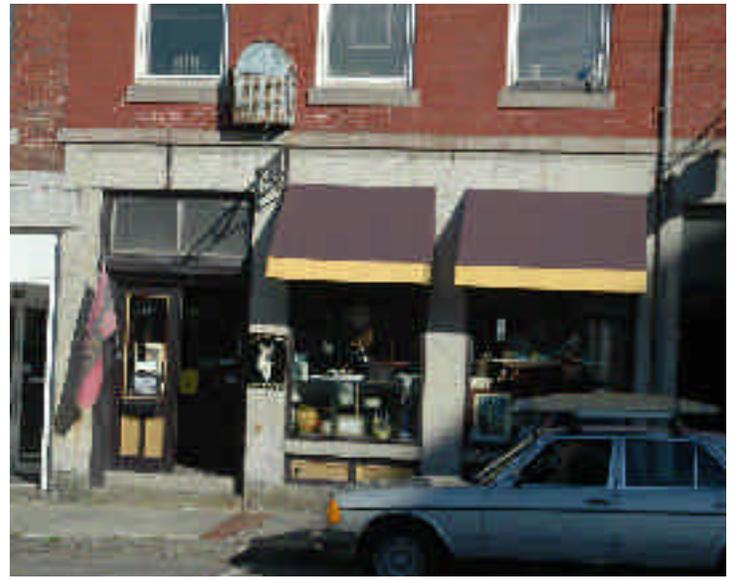
Most aspects of this property are in good or excellent condition with exception of poor brick facade condition at the upper levels. The upper brick facade should be repointed.

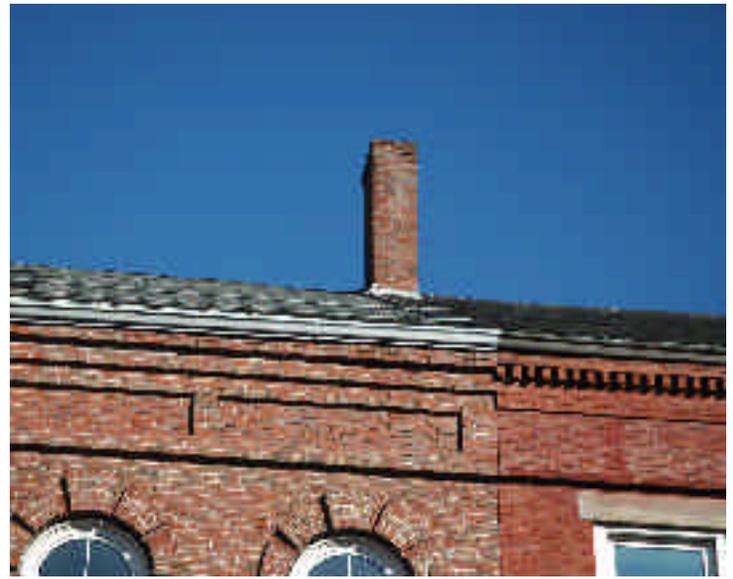
Most aspects of this property are in good or excellent condition with exception of poor paint condition at street level and upper window trim as well as poor brick facade and cornice condition. The wood trim should be repainted and brick facade should be repointed.

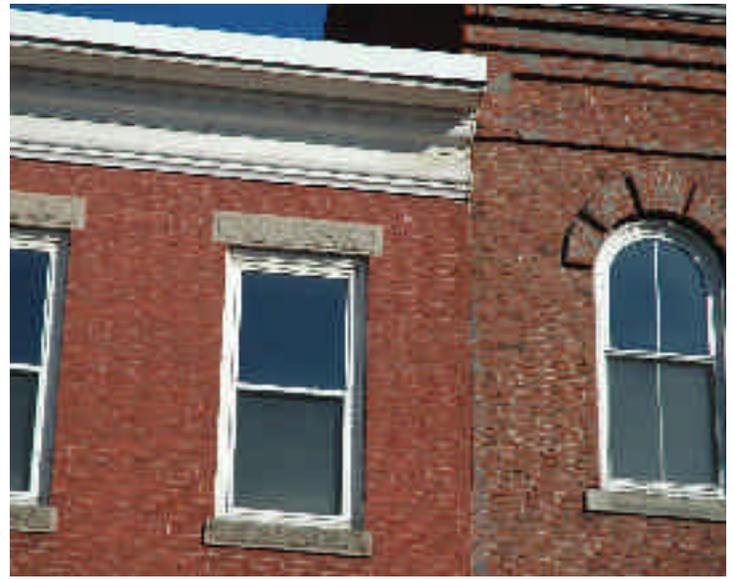
Most aspects of this property are in good or excellent condition with exception of excessive signage, poor paint condition at street level as well as poor brick facade condition. The net amount of signage (facade, windows, and awning) should be reduced if possible. Wood trim should be repainted and brick facade should be repointed.

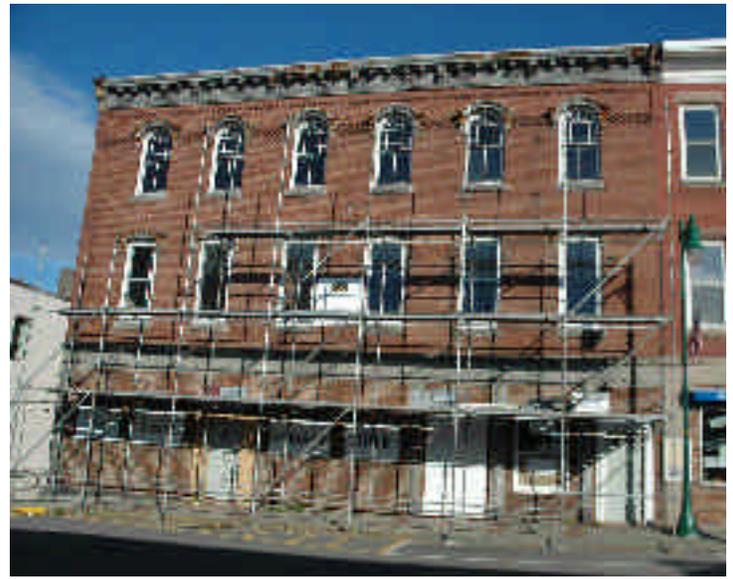
This property is currently under construction. Conditions relating to evaluative criteria are to be determined. Harbor side facade requires significant upgrades in fenestration to transform it to a primary commercial storefront facade.

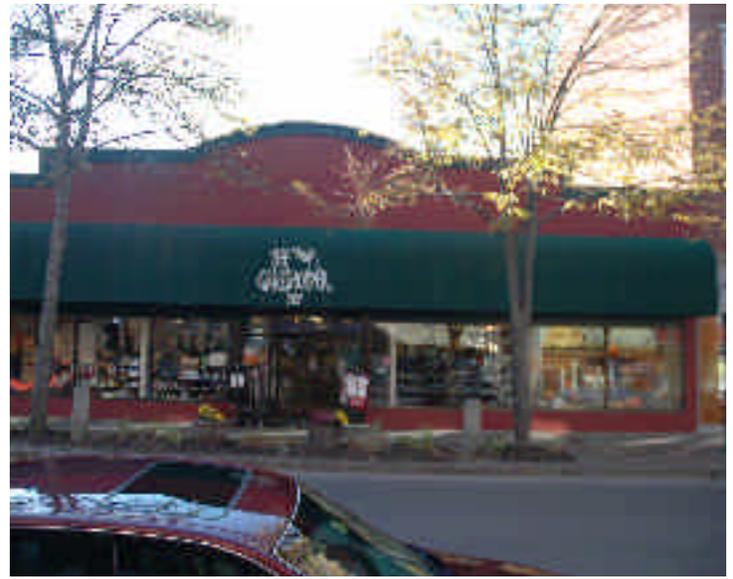
Most aspects of this property are in good condition with exception of excessive signage in the form of banners added to the large quantity of permanent awning signs.

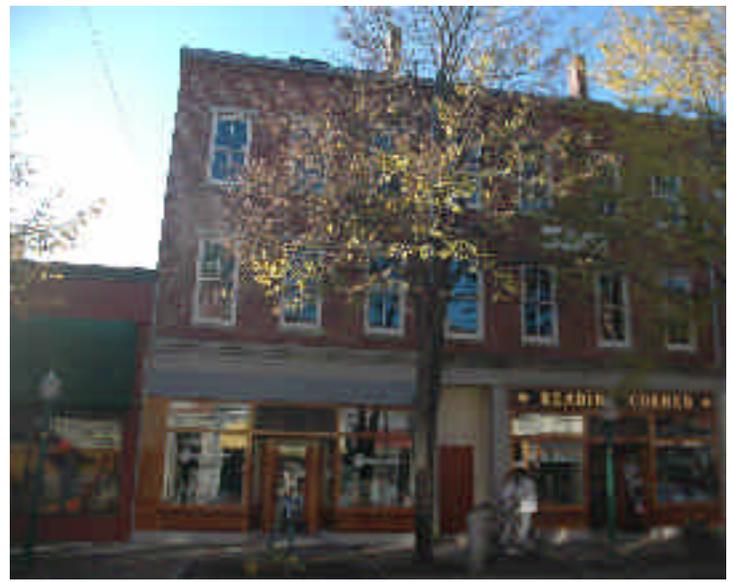
All aspects of this building are in good condition with the exception of small signage applied to the storefront windows. Aside from a recommendation to add a historically correct hanging sign off the facade, no repair recommendations were identified.

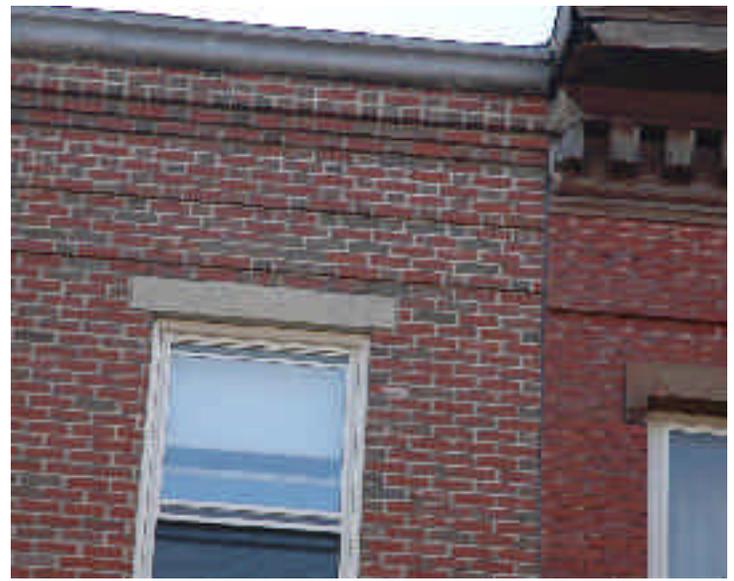
Most aspects of this property are in good condition with exception of inadequate signage applied directly to the storefront windows, poor paint condition on upper window trim, and potential wood cornice trim. It is unclear whether the wood cornice trim belongs to property 420 or 410. If it belongs to 410, the recommendation is that they should be replaced with historically appropriate restoration. Signage should be improved. Window trim should be repainted.

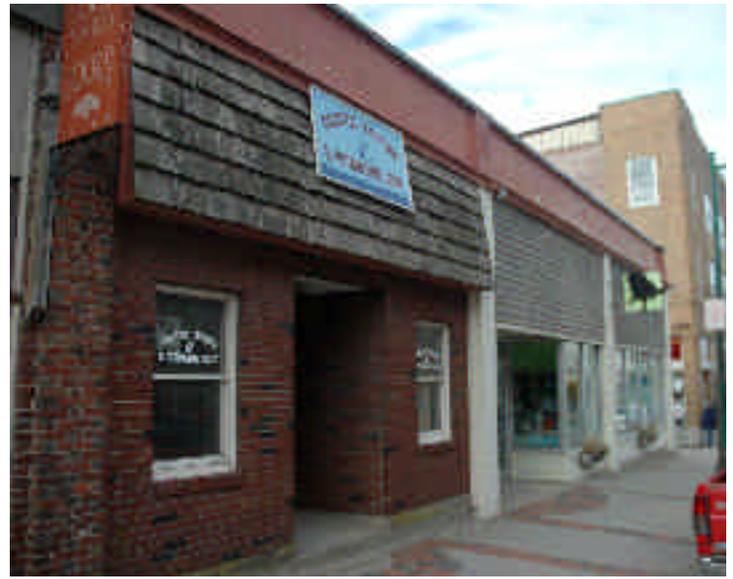
Many aspects of this property are in poor condition including: inconsistent signage across multiple storefronts, unsightly awning bump outs, poor paint condition, poor awning condition, and poor upper facade / cornice conditions. Shingled bump outs should be removed to provide a consistent facade surface. Signage should be reconfigured to fit into each facade bay over doorways in a consistent way. Paint on facade, at enties, and cornice areas should be scraped and painted.

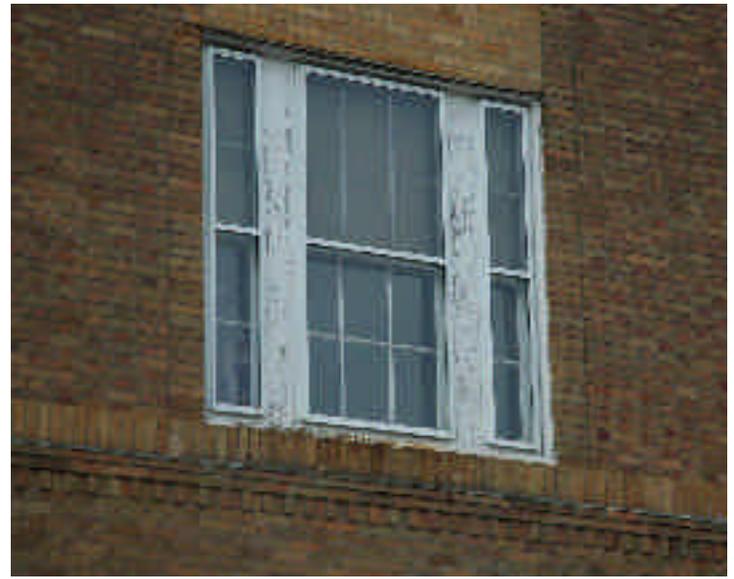
Several aspects of this property are in poor or unsatisfactory condition including: excessive signage, poor condition of storefront window frames and metal panels as well as poor condition of upper window frames and bricks. Facade signage is not in keeping with the historic character of both the building and the street and should be modified in the near future. Storefront system includes aluminum frames that require replacement or improvement and metal panels that interrupt the original portions of the facade. The metal panels should be removed and replaced with insulated glazing or spandrel glass. Upper floor window trim paint is in poor condition and new paint should be applied. Upper floor brick requires pointing in some locations.

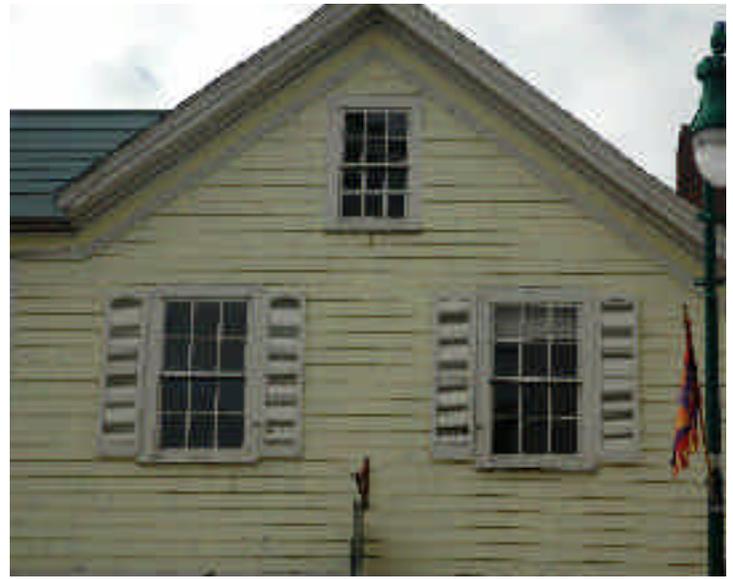
Most aspects of this property are in good condition with exception of excessive signage, unsightly shingle bump out condition at street level, and poor paint condition on upper window trim. Signage on south side is very large yet difficult to read. Relocating a new sign off the facade may be more successful. Wood trim at upper window areas should be scraped and painted.

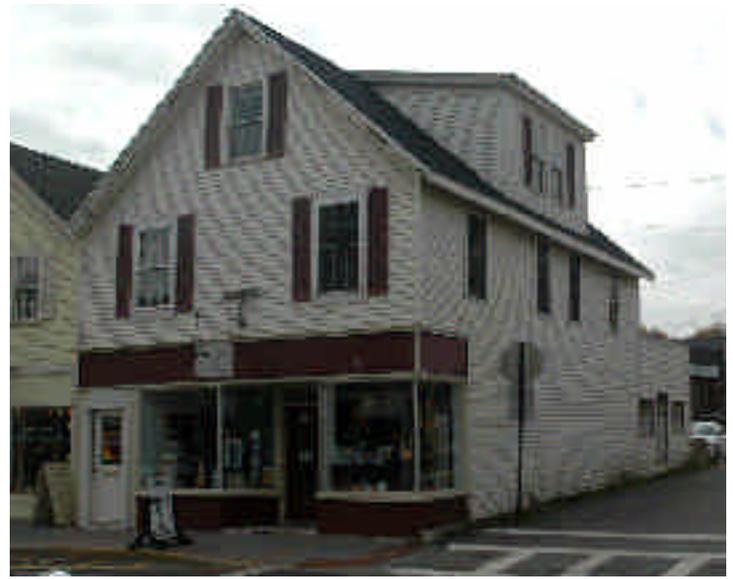
Most aspects of this property are in good condition with exception of poor trim condition at street level, odd infill at upper windows, and poor paint condition at facia. Paint at street level should be touched up. Upper windows appear to have replacement windows that are significantly smaller than the original opening. Existing windows should be replaced with properly sized units to fit the existing window opening. Facia trim is rotten and should be replaced.

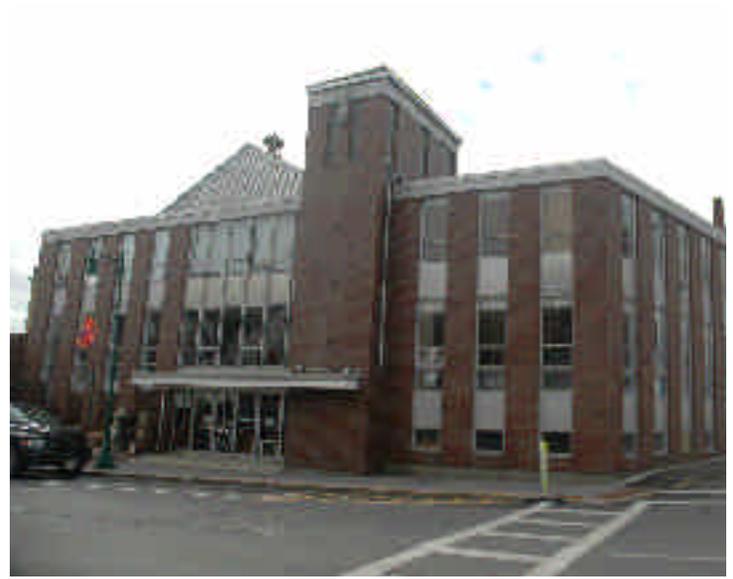
Several aspects of this property are in poor or unsatisfactory condition including: poor canopy condition, poor condition of storefront doors, window frames and metal panels as well as poor condition of upper window frames and panels. Given the style of this building, it is recommended that the canopy, window, and door systems be restored and/or updated rather than removing them.
