2009 Downtown Revitalization Plan UPDATE

City of Rockland, Maine

2009 DOWNTOWN REVITALIZATION PLAN UPDATE

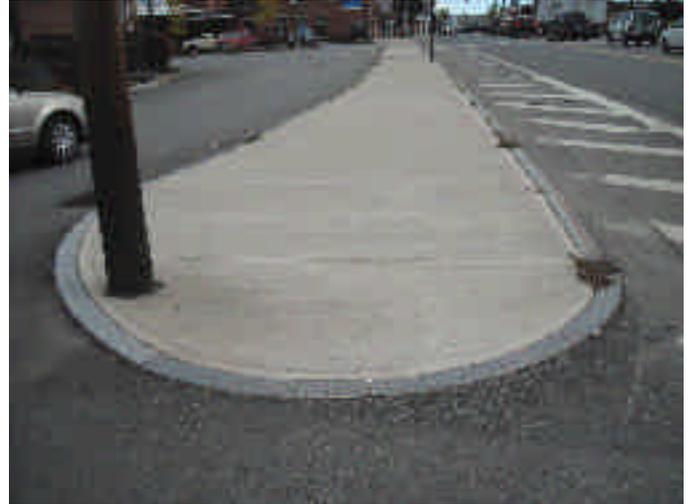
48. Park St. (S)

48	Park Street (S)	asphalt	55"-72"	granite	5"-7"	3	Some minor surface cracks; plant growth
49	Park Street (N)	concrete	60"	granite	7"	1	Newer concrete
50	Orient Street (S)	concrete	48"-60"	granite	5"-6"	2	Newer concrete; Union St. end open to driveways
51	Orient Street (N)	brick	42"	granite	2"-10"	3	Narrower width sections fit against building; curb reveal varies significantly; Union St. end open for parking lot
52	Oak Street (S)	none	n/a	none	n/a	n/a	Short piece of concrete sidewalk at Main St. intersection doesn't provide any connectivity, possibly just a curb line for drainage to catch basin; building wall at edge of paved roadway
53	Oak Street (N)	asphalt	56"-66"	granite	3"-4"	3	Some sunken areas of pavement; sidewalk encroached by shrubs in some areas
54	Elm Street (S)	concrete; asphalt	48"-103"	granite; asphalt	2"-5"	5; 2	Union St. end in poor condition with failing asphalt; Main St. end new asphalt pavement connecting to concrete surface in good condition

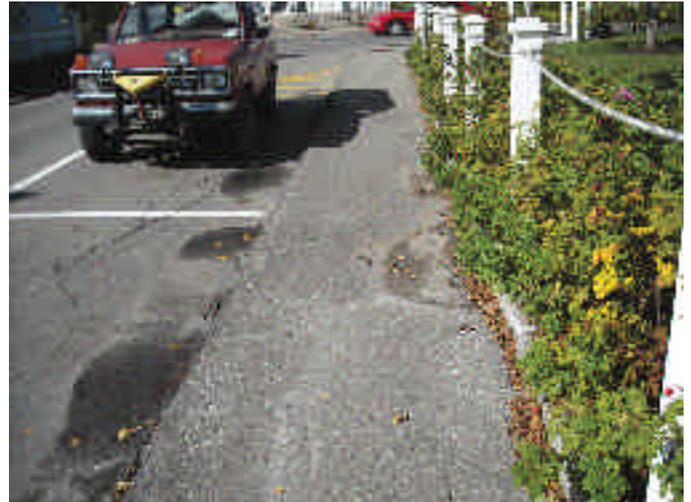
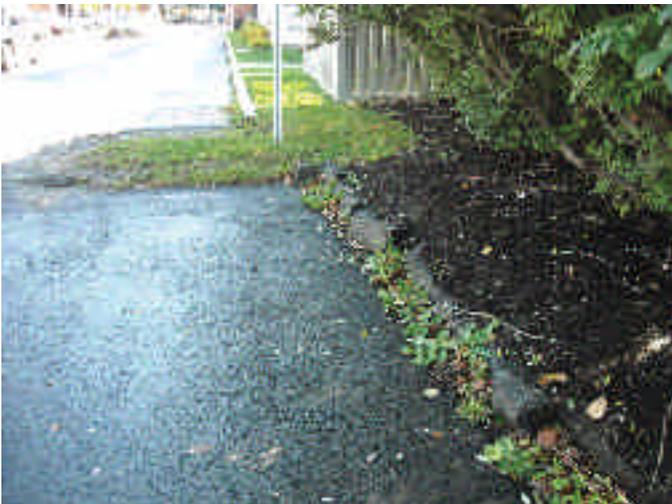
55. Elm St. (N) (View 1)

55	Elm Street (N)	asphalt; concrete	48"-60"	asphalt; granite	3"-10"	3; 5	Concrete sidewalk in good condition; asphalt sidewalk in poor condition in areas; significant pavement failure around fence posts installed along edge of sidewalk
56	Museum Street (S)	concrete; granite blocks; none	50"	granite; asphalt	5"-7"	4	Bump out at Union St. end for change in traffic direction in poor condition with no curb remaining; different sidewalk widths result in lack of connectivity between museum entrance and continuing sidewalk
57	Museum Street (N)	concrete; brick	55"-64"	granite	3"-7"	3; 3; 4	Concrete sidewalk at Main St end in fair condition; brick sidewalk has depressions in areas and there is gapping between bricks; concrete surface at Union Street end is in poor conditions, sunken and cracked; no consistency with three different sections of sidewalk on short street
58	School Street (S)	concrete; asphalt	64"-118"	granite	5"-6"	3; 3	Concrete sidewalk in fair condition; wide to provide entrance to museum; asphalt sidewalk in fair condition with some sunken areas

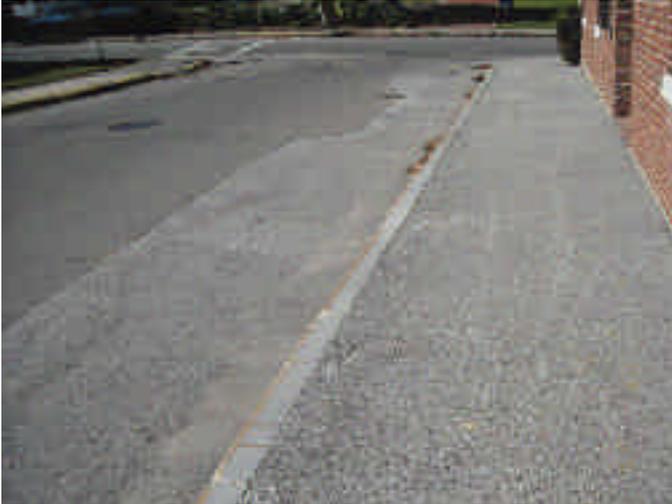
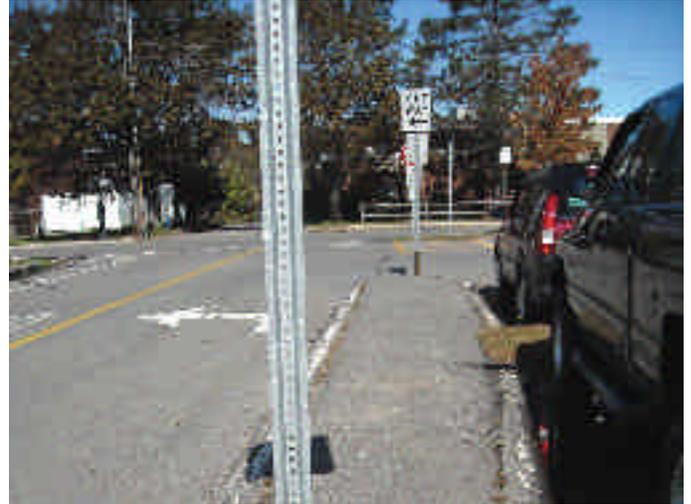
59. School St. (N) (View 1)

59	School Street (N)	asphalt	55"-62"	granite; asphalt	4"-7"	5; 2	Sidewalk from Custom House to Main St. in poor condition with cracks and depressions; Sidewalk at Union St. end in good condition, newer
60	Custom House (E)	none	n/a	none	n/a	n/a	No sidewalk; asphalt island w/ 4" reveal; open to parking lot

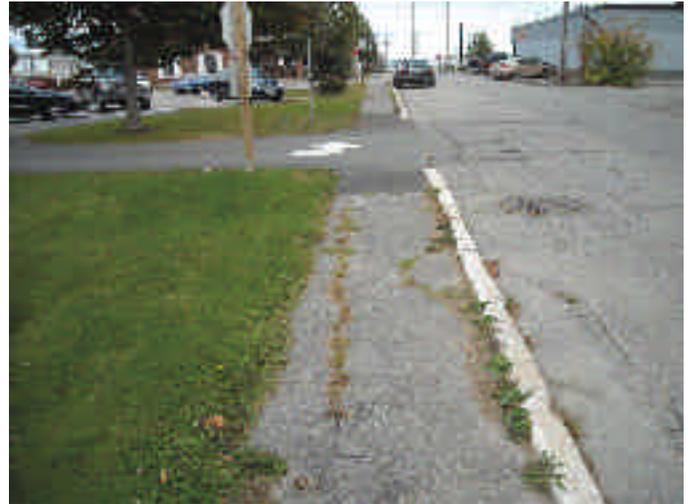
70. Granite St. (S)

69	Talbot Avenue (N)	none	n/a	none	n/a	n/a	No sidewalk
70	Granite Street (S)	asphalt	48"-56"	asphalt; granite	3"-6"	5	Pavement surface cracking; plants growing into sidewalk, undermining back edge
71	Granite Street (N)	none	n/a	none	n/a	n/a	No sidewalk
72	Willow Street (S)	none	n/a	concrete	3"-6"	n/a	No sidewalk
73	Willow Street (N)	asphalt	42"-46"	concrete; granite	6"-7"	5	Pavement surface cracking; sunken behind curbing; plants growing into sidewalk; island with granite curb at Main Street end
74	Rankin Street (S)	asphalt	48"	granite	3"	3	Sidewalk in fair condition; some cracks and plant growth
75	Rankin Street (N)	asphalt	46"	granite; concrete	3"	3	Some pavement surface cracking and sunken areas; no sidewalk at Union St. intersection

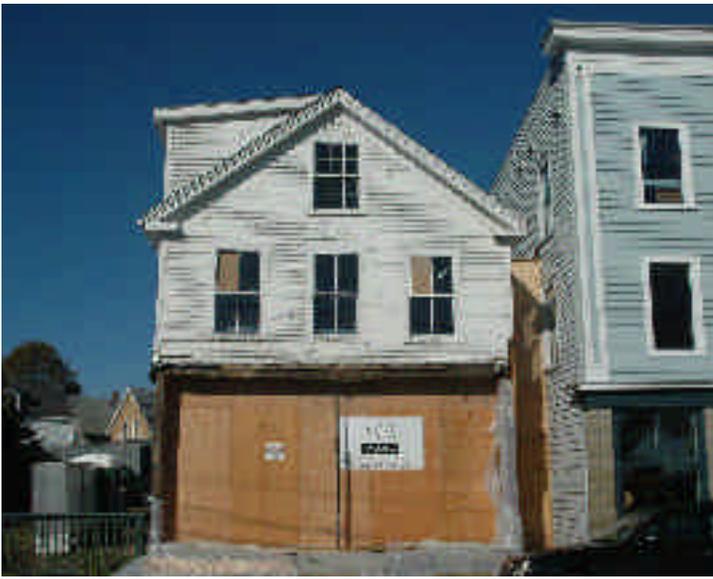
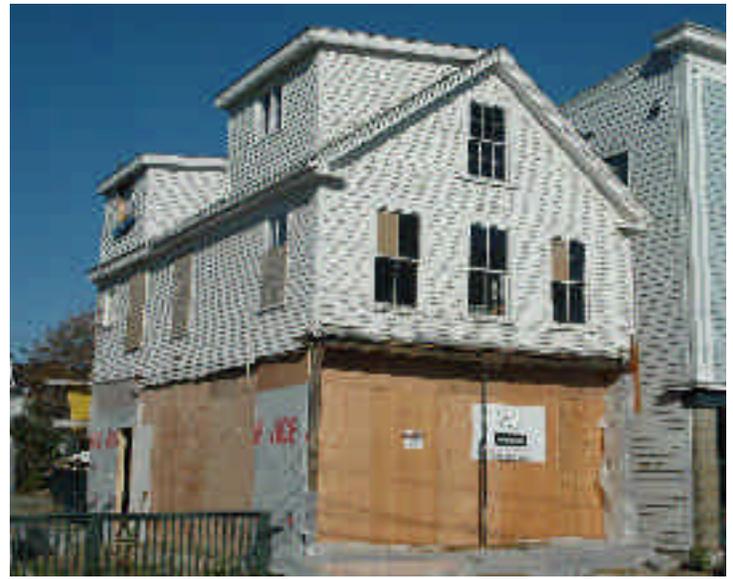
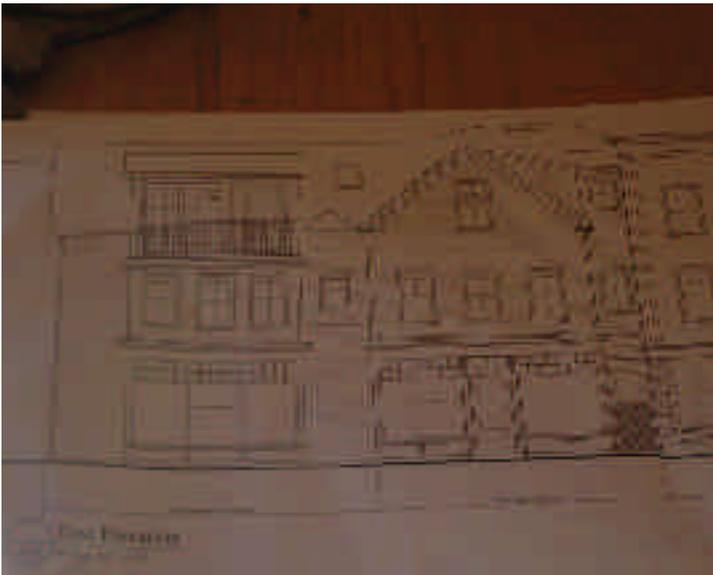
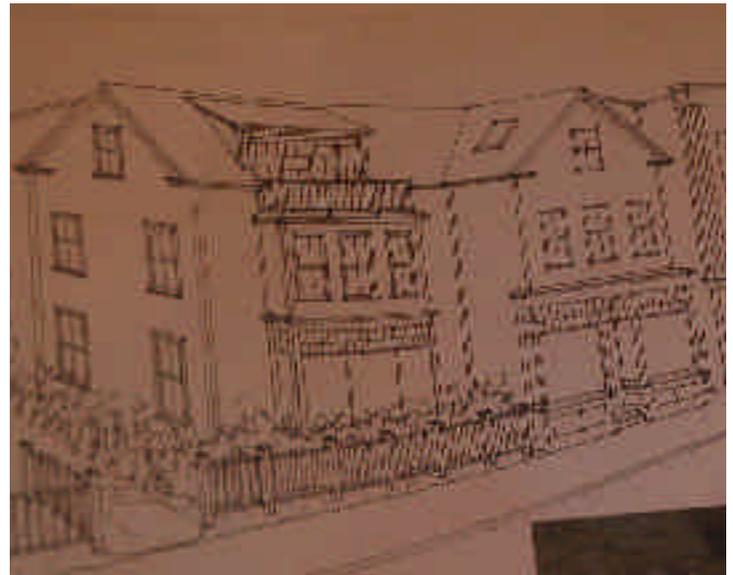
Building is currently under construction. New construction is planned for adjacent empty lot. Completed construction will connect lots 5E4, 5E5, & 5E6 with a continuous building. Given the quality of construction of 218 Main Street, the phases under construction should be of high quality. However, these lots should be documented once the current construction is complete.

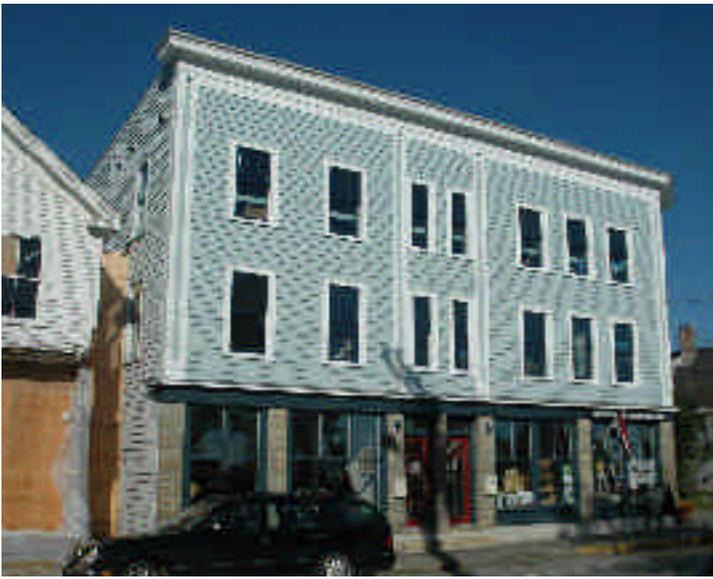
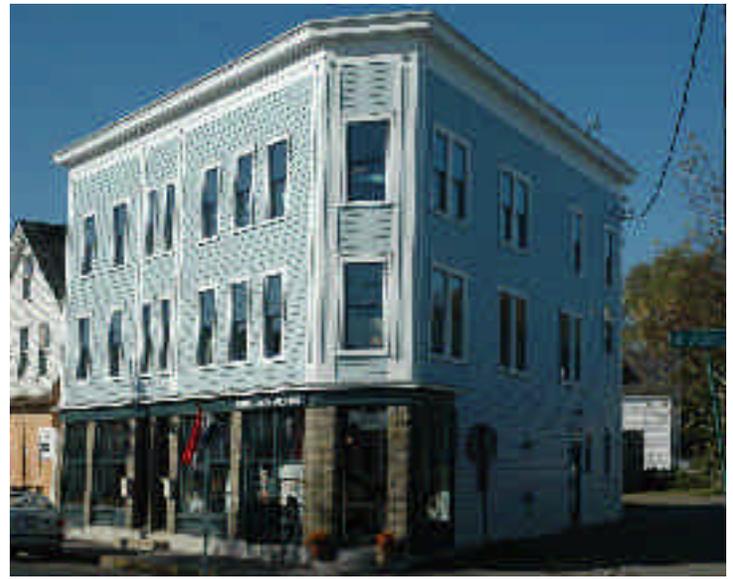
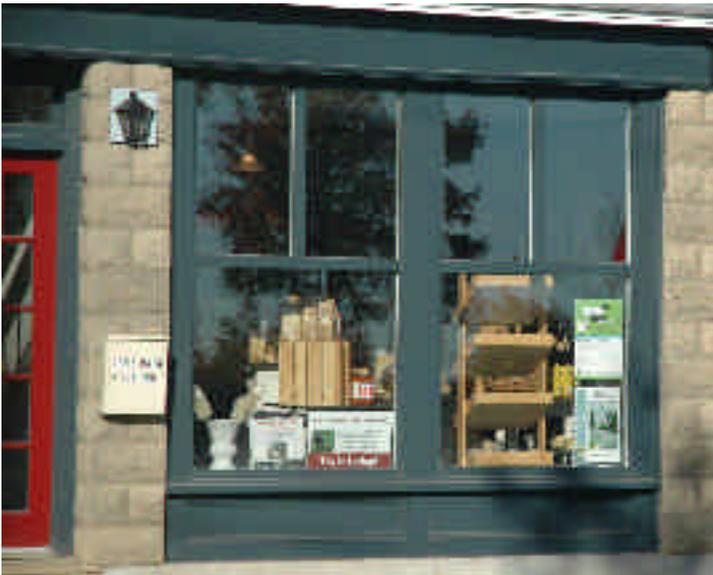
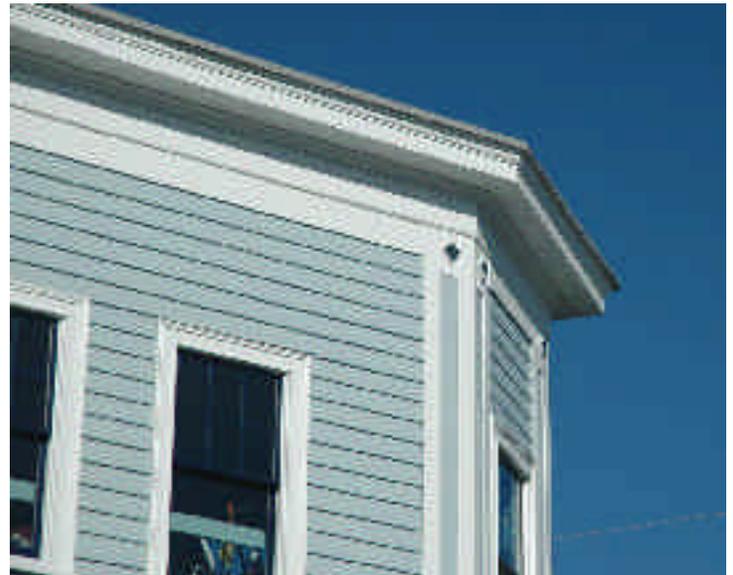
Building is recently renovated and appears to be in excellent condition in all respects.

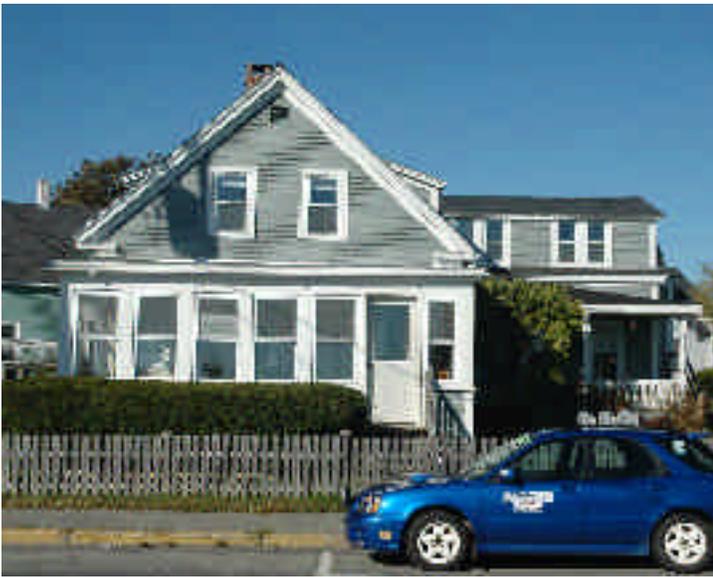
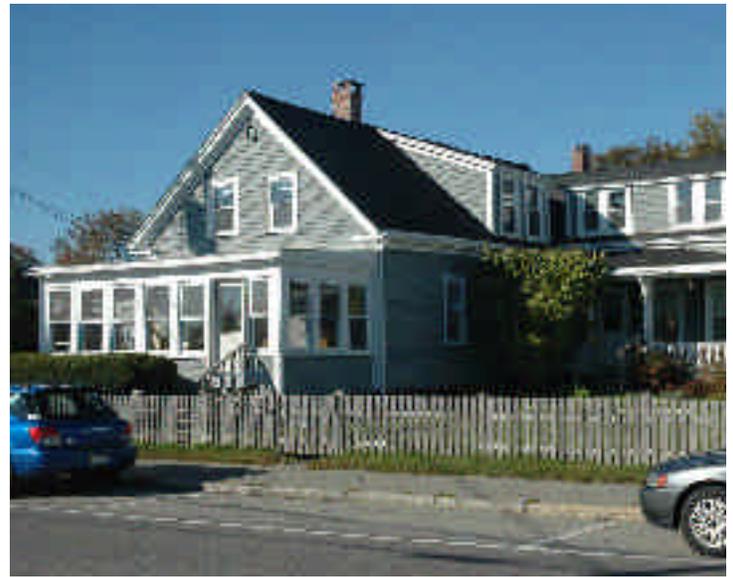
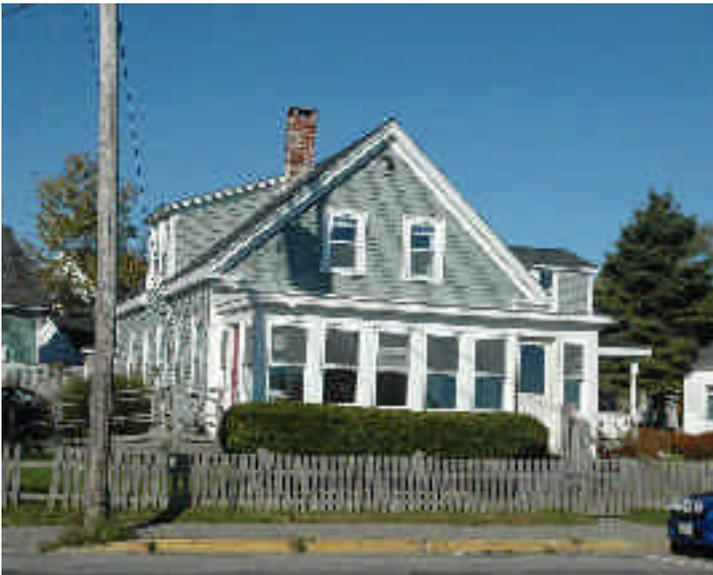
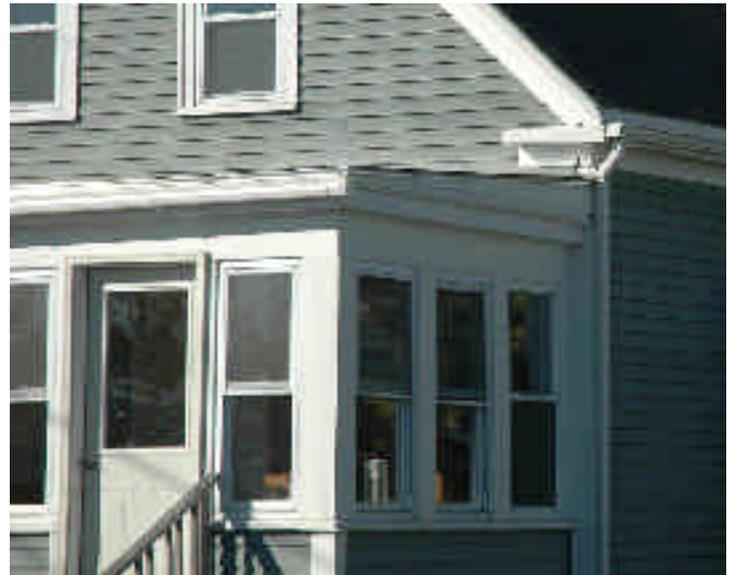
Most aspects of this residential property are in good condition with exception of the dormered roofline facing Main Street. The eaves are in fair condition but will require improvement in the near future. This eave line is set back from Main Street enough that it does not present an aesthetic liability to the historical character of the street.

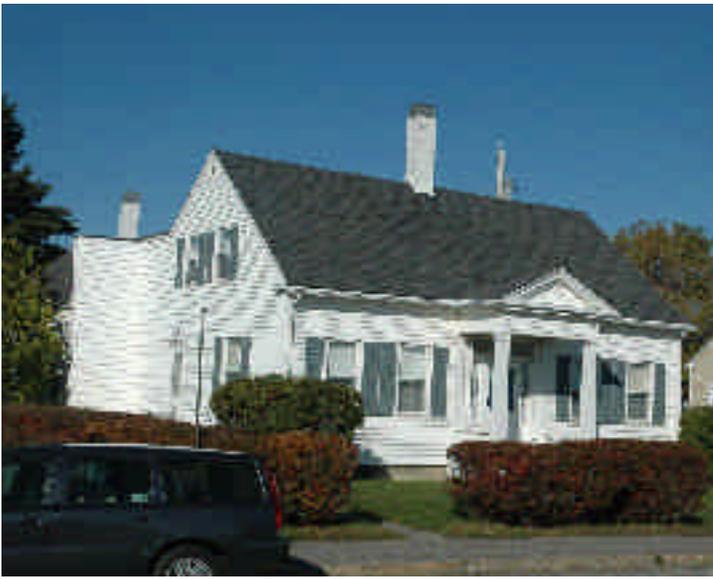
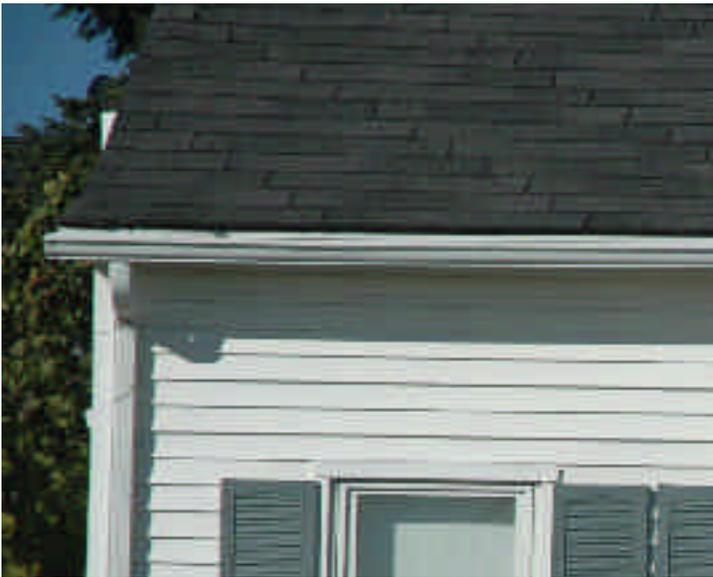
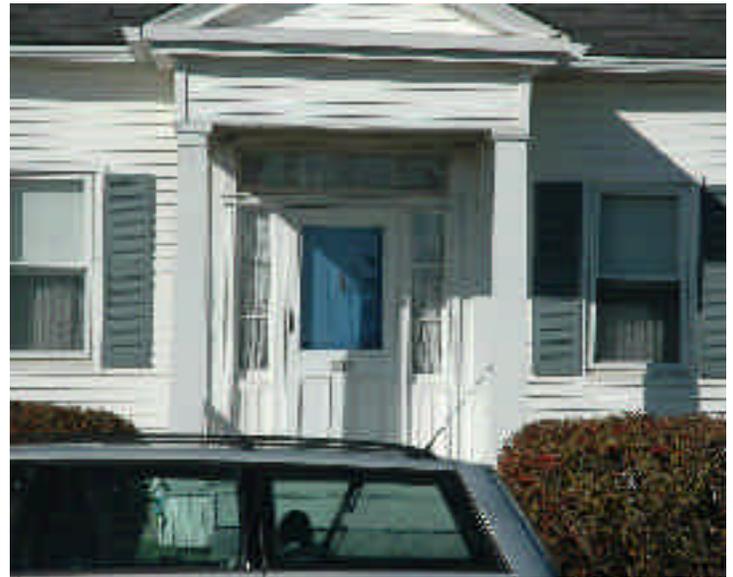
Most aspects of this residential property are in good condition with exception of the eaves and roofline facing Main Street. The eaves and shingles (and potentially the roof sheathing) require improvement. The siding is vinyl which hides a substantial amount of the building's original detailing. The long-term goal for this property should be to remove the vinyl and restore the original siding and detailing.

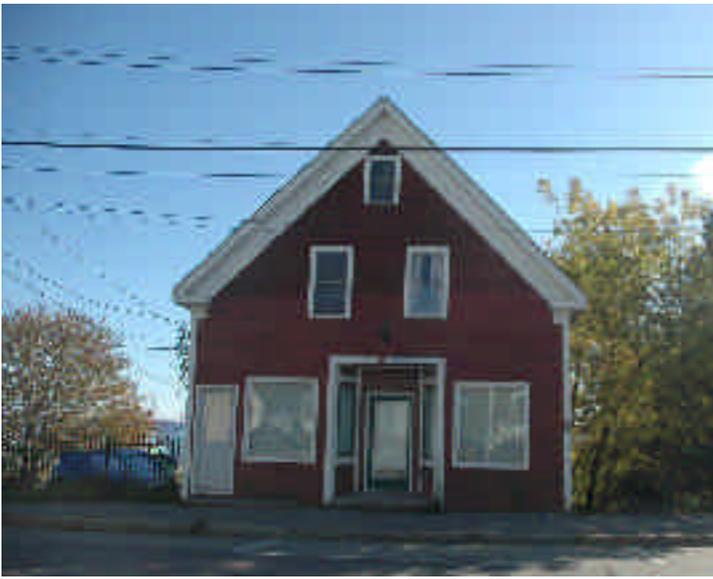
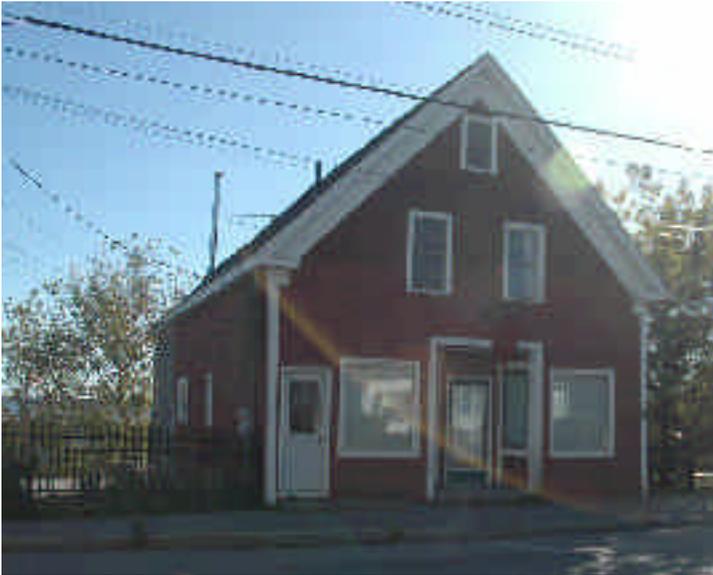
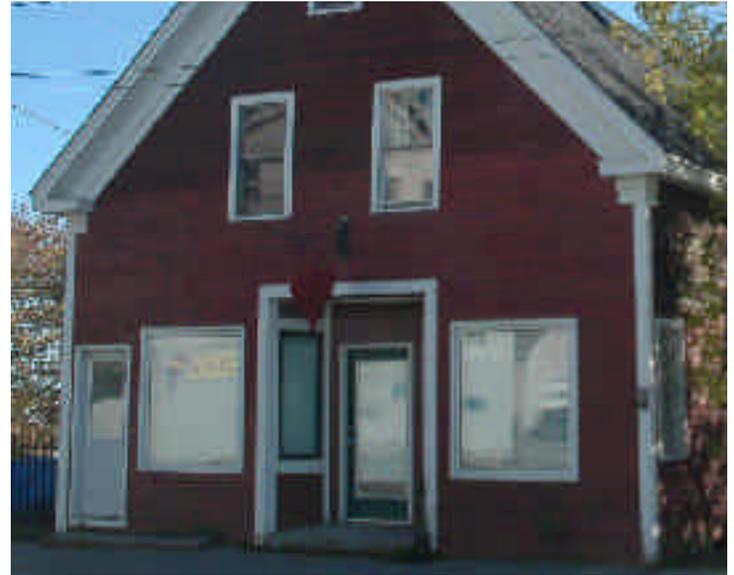
Most aspects of this property are in good condition with exception of the paint and signage. Signage is inadequately small. Painted finish on the clapboard siding is inconsistent in both application and color. Owner should complete painting work or repaint to create consistency especially on the Main Street facade.

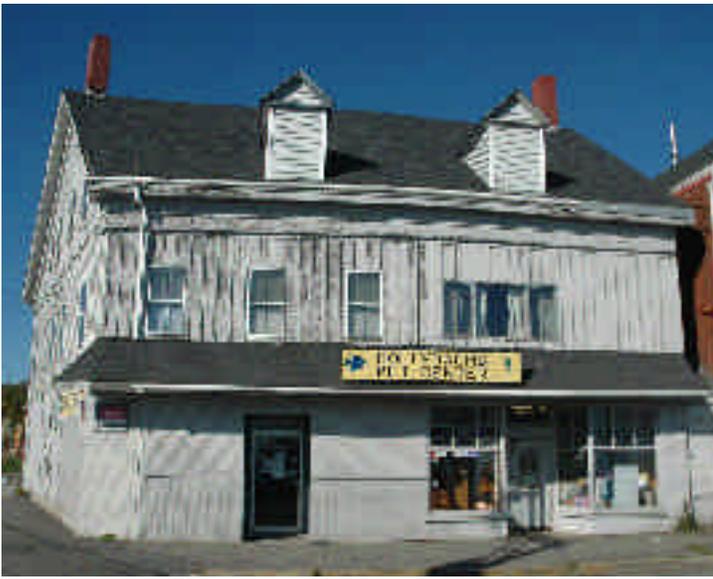
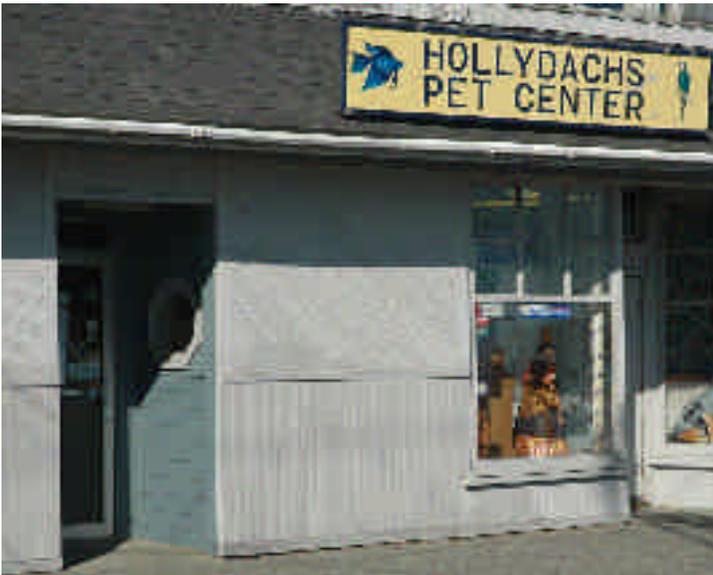
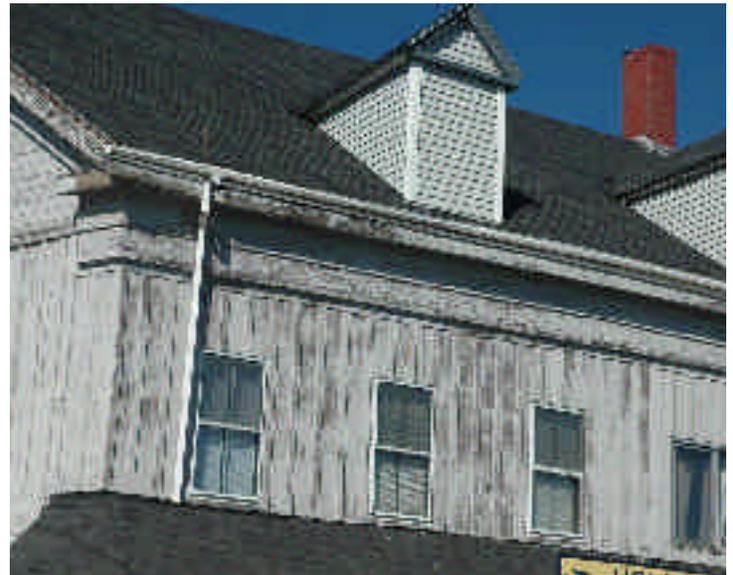
This property has deficiencies in many areas. Signage and facade materials are not in keeping with the historical character of the street. The overall condition of the building is poor. Replacement of sign, repainting, and removal of shingled bump out along Main Street are highly recommended. Siding, and roofline / eave trim replacement are also recommended.

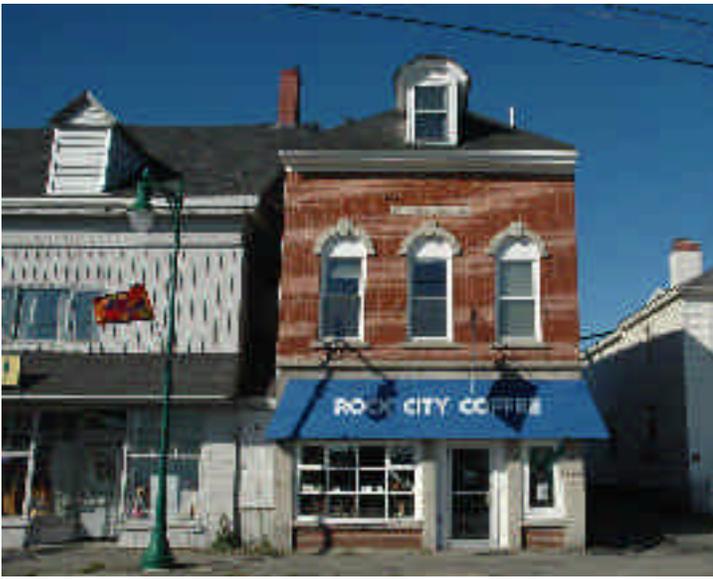
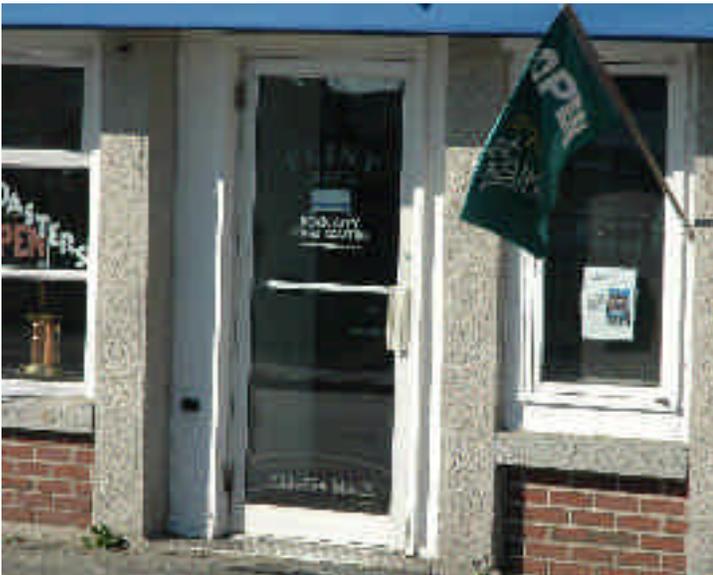
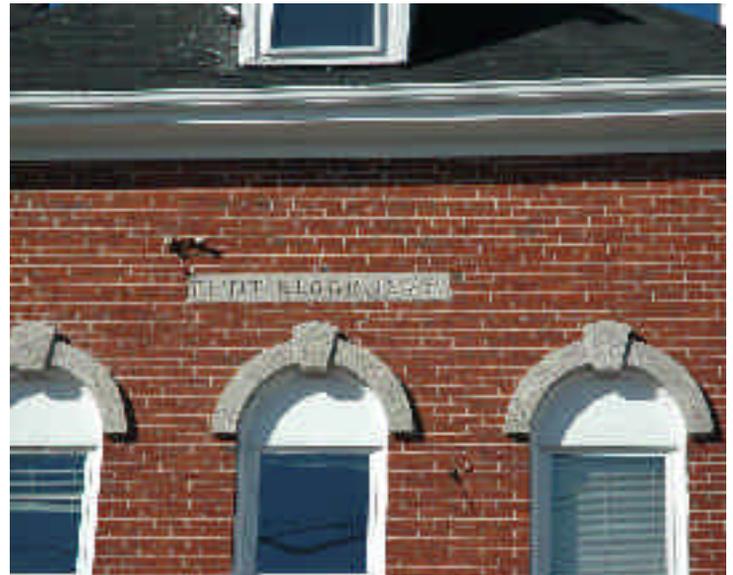
Most aspects of this property are in good condition with exception of the street level windows, signage, and eave trim. Windows on the street level facing Main Street appear to require restoration or replacement. At minimum, the windows require new paint. Signage is excessive: showing up over 4 times on awnings, windows, and on a projecting sign. Elimination of half of these signs is recommended. Eave trim appears to require maintenance or repair from street level observation.

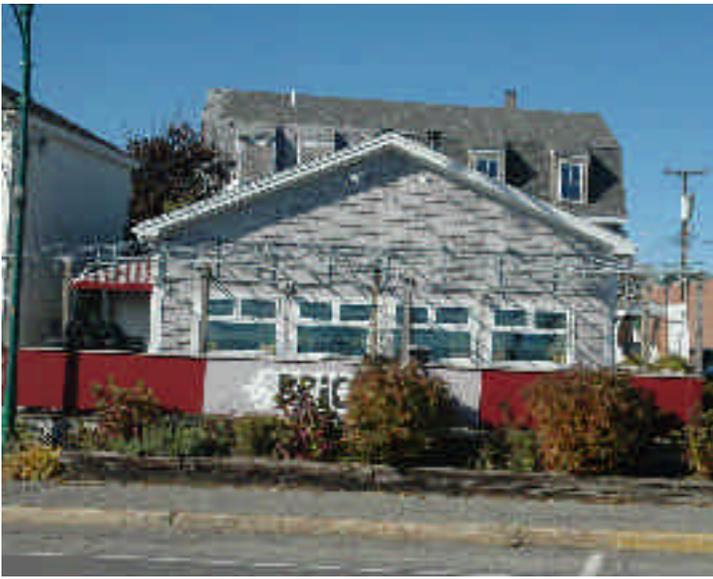
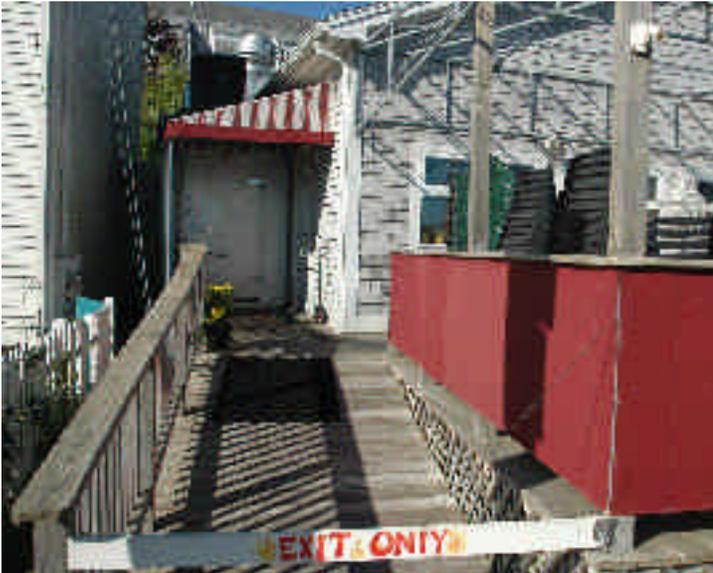
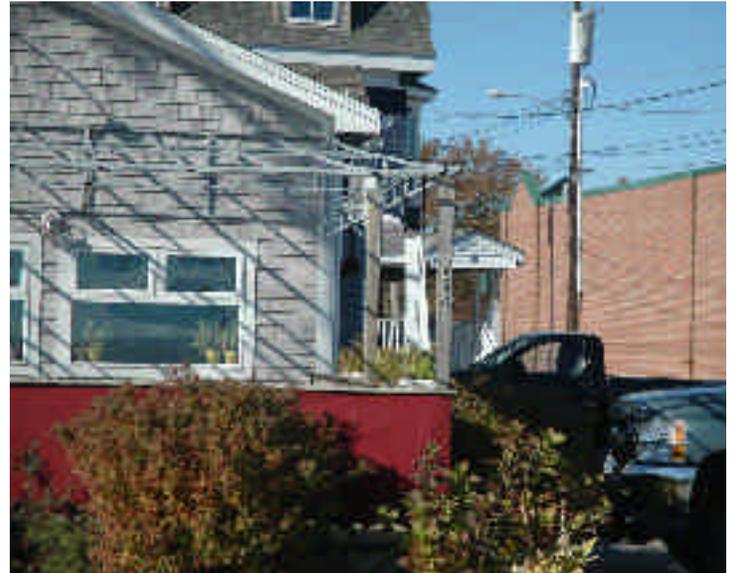
Most aspects of this property are in good condition with exception of excessive signage, and awnings. Signage was too large and some were difficult to read from Main Street due to the fact that it was obscured behind vegetation. Signs should be reduced in number and relocated to a location that provides better visibility. The awning facing Main Street is extremely large and is not in keeping with a historic district. However, its function and importance for the restaurant use is understood. In the event this property changes use, it is recommended that the awning be removed.

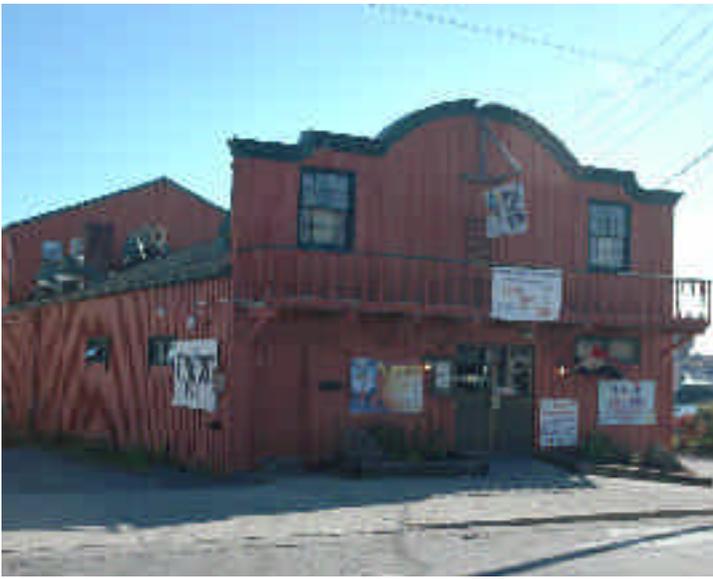
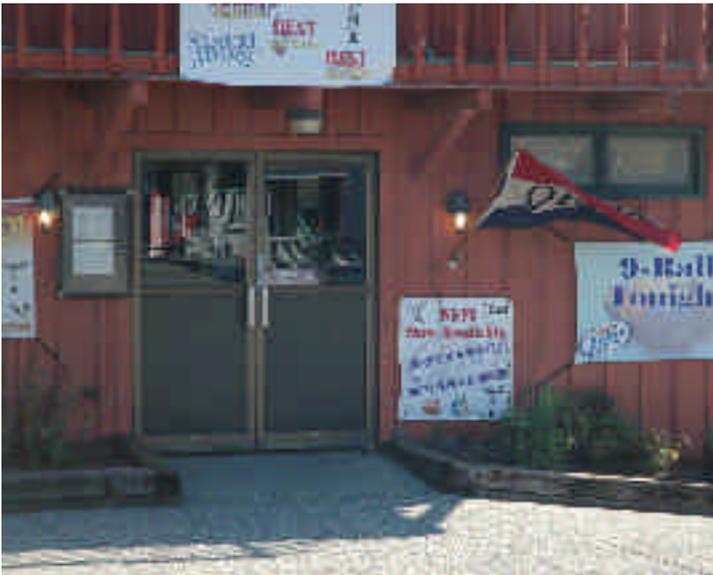
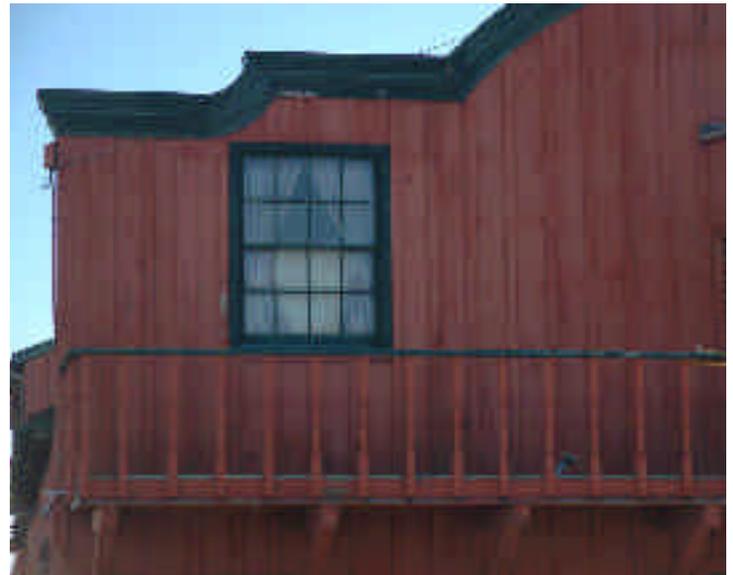
This property has several issues including inconsistent paint, excessive signage, no views from Main Street to the building interior, and poor landscaping. Signs, in the form of promotional banners are not in keeping with the historical context of Main Street and should be removed or controlled by designating areas for banners to be placed. Signs on the sides of the building are excessive and should be removed since the projecting sign over Main Street provides ample designation to the business inside. The entire building should be repainted and exterior trim replaced as needed. Landscaping should be improved to buffer against the lack of windows facing Main Street.

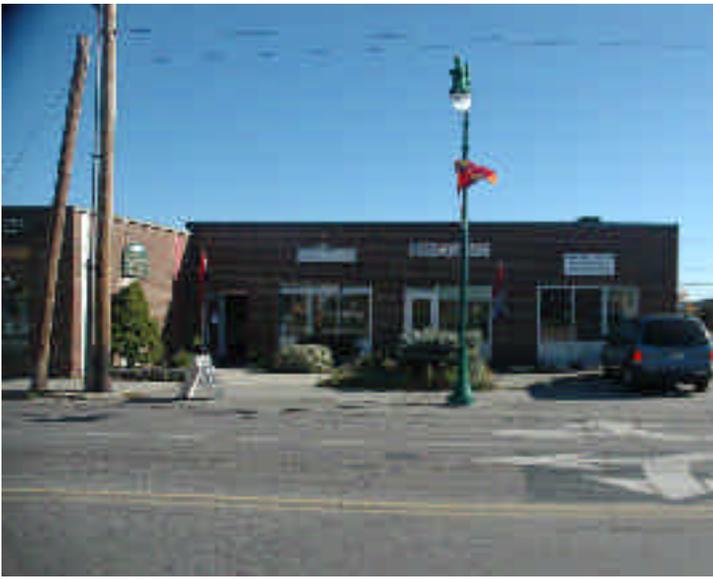
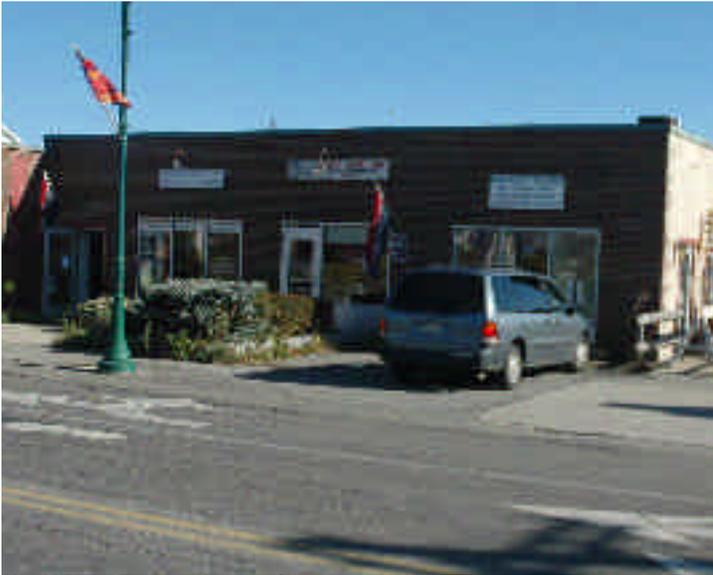
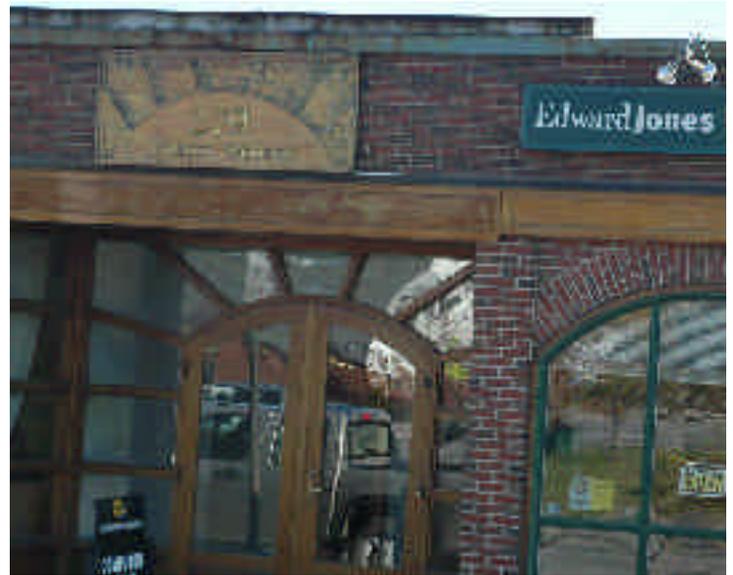
Most aspects of this property are in good condition with exception of excessive signage, inconsistent varnish throughout the exterior wood trim, and roofline metal trim. Signage was too varied, with 8 different signs applied to the facade. Some of these signs are in need of replacement. The main building entrance sign should be replaced with a projecting sign identifying the entrance from Main Street. Other tenant space signs should be organized to either be the same size or to be hung at a consistent height. Wood trim around doorways and windows requires cleaning, scraping, and new clear finish. Roof trim is rusted and should be cleaned, repaired, painted or replaced.

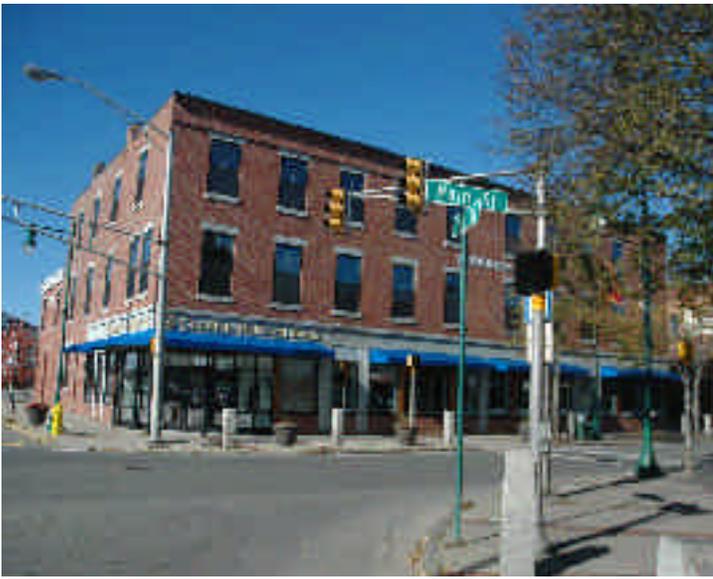
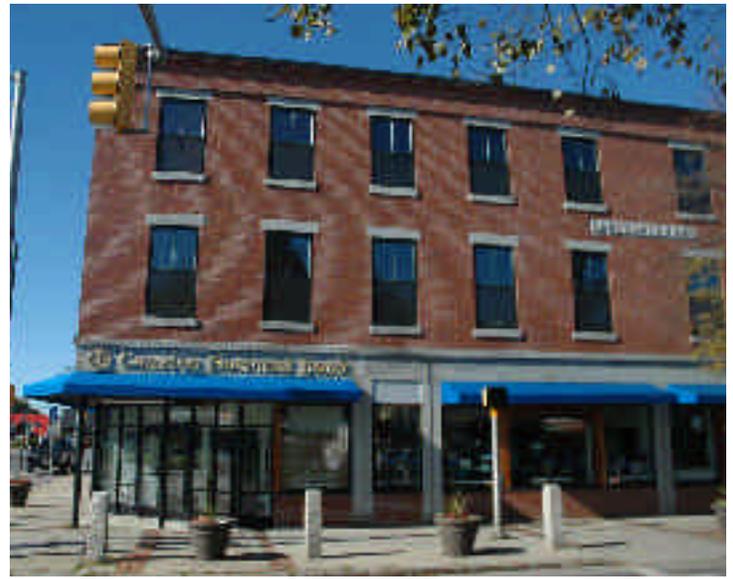
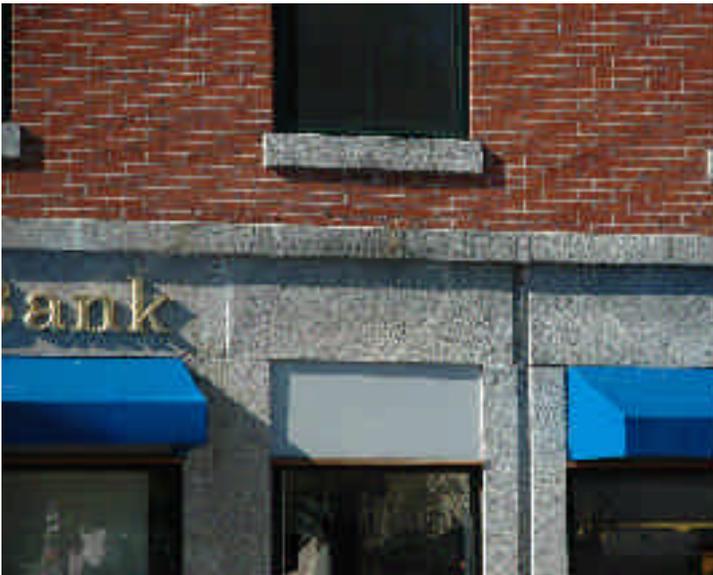
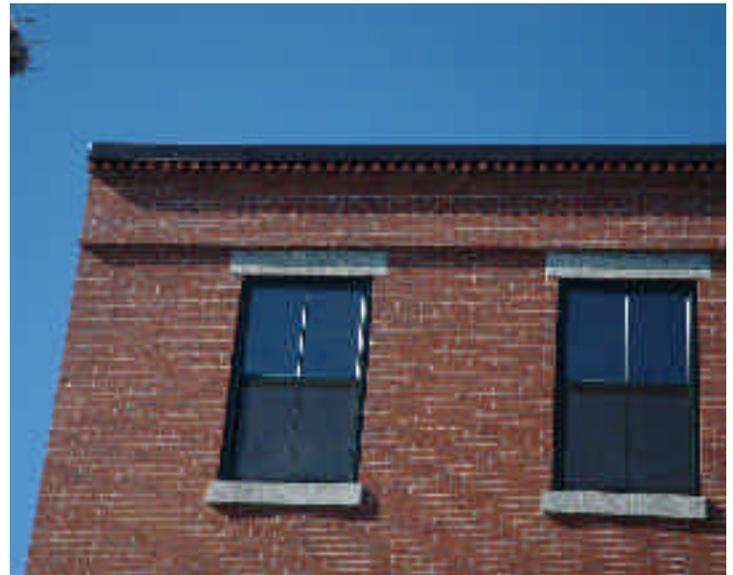
All aspects of this building are in excellent or good condition. No repair recommendations were identified.

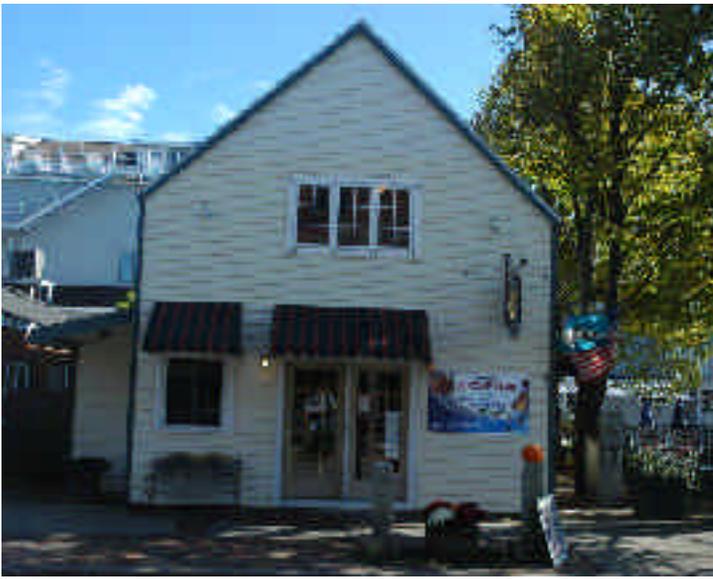
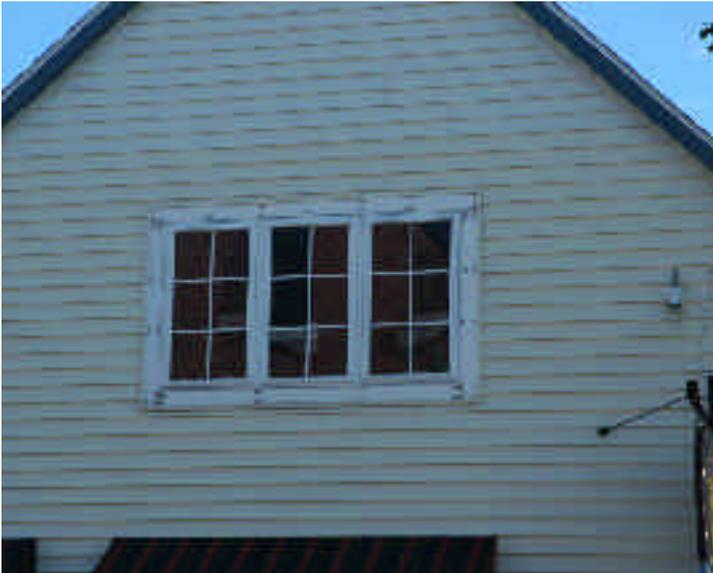
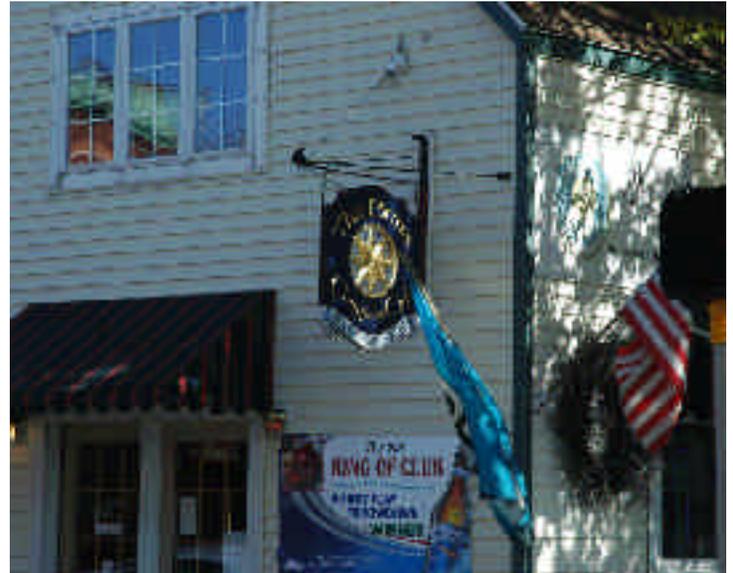
Most aspects of this property are in good condition with exception of window trim condition. Upper level window trim facing Main Street requires repair and/or paint.

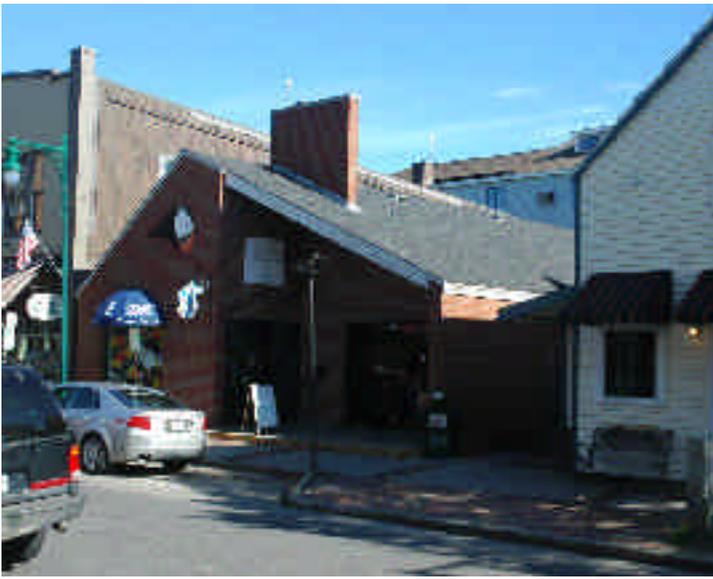
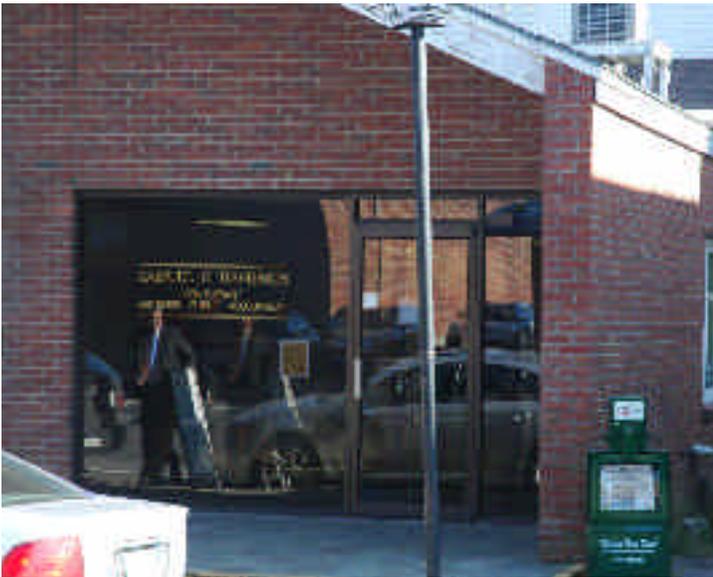
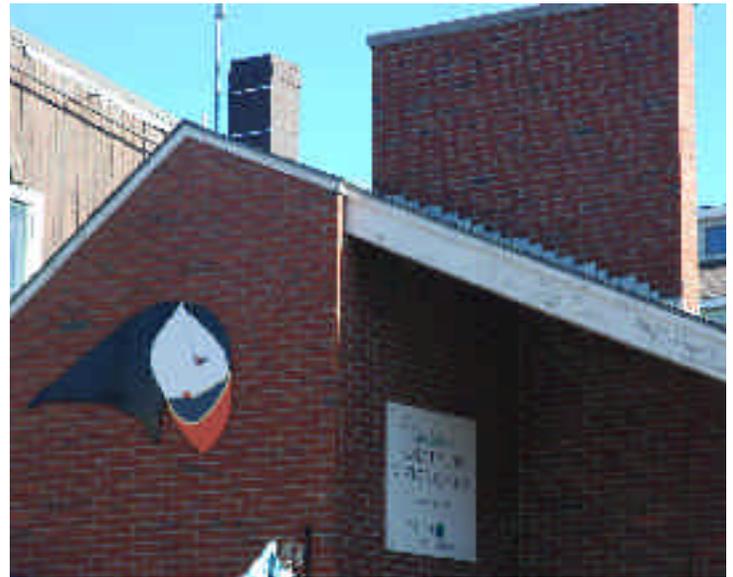
Most aspects of this property are in good condition with exception of inconsistent and excessive signage as well as inconsistent painted trim. Signage was too varied and reductions in signs (multiple puffins) would be in better keeping with the historic context. Trim at street level and along roof eaves requires new paint.
