2009 Downtown Revitalization Plan UPDATE

City of Rockland, Maine

2009 DOWNTOWN REVITALIZATION PLAN UPDATE

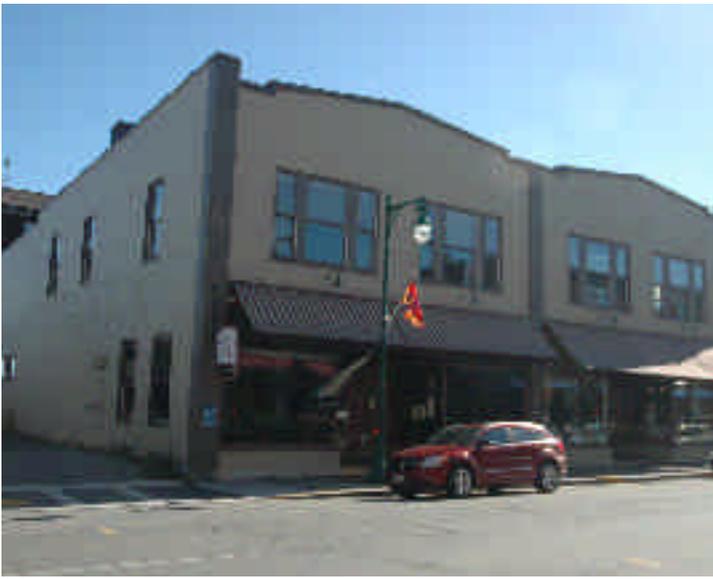
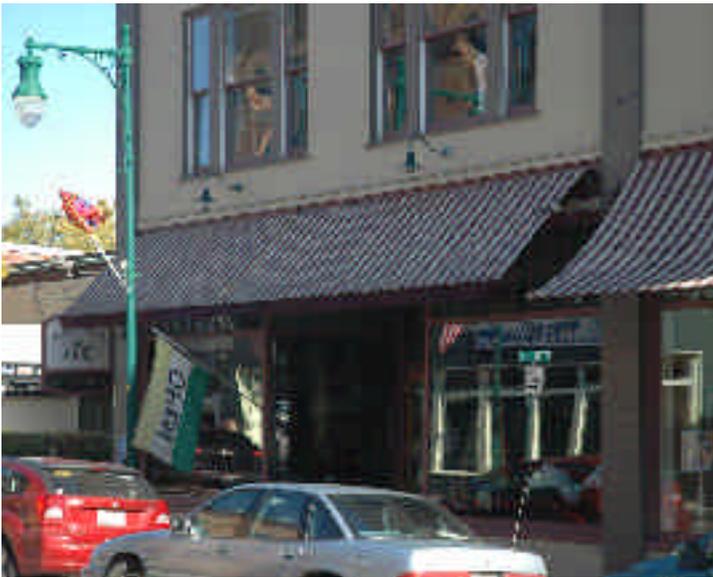
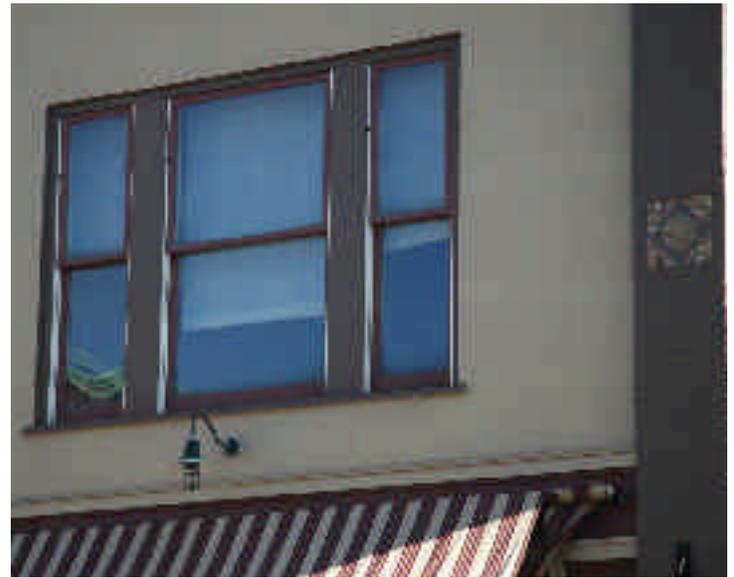
Most aspects of this property are in good condition with exception of one ripped awning and facade details. The awning on the south portion of the building has a tear along its entire depth and requires replacement. The painted medallion details on the outer edges of the brick facade should be repainted to improve the visibility of the building's original detailing.

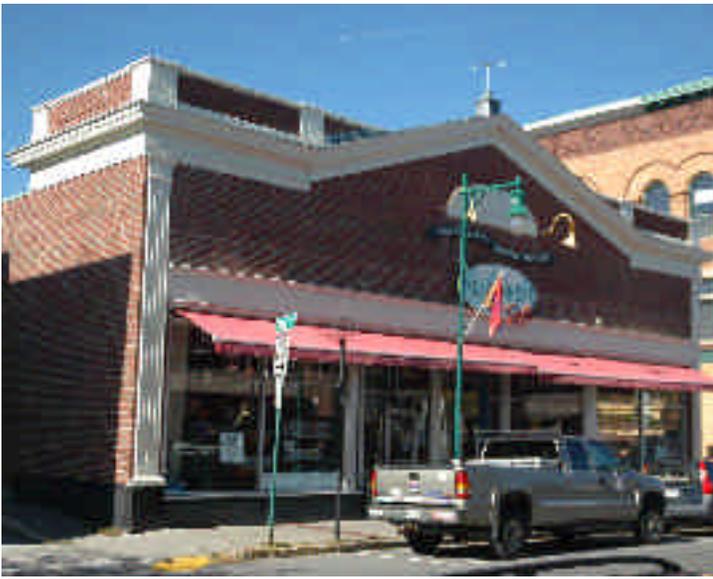
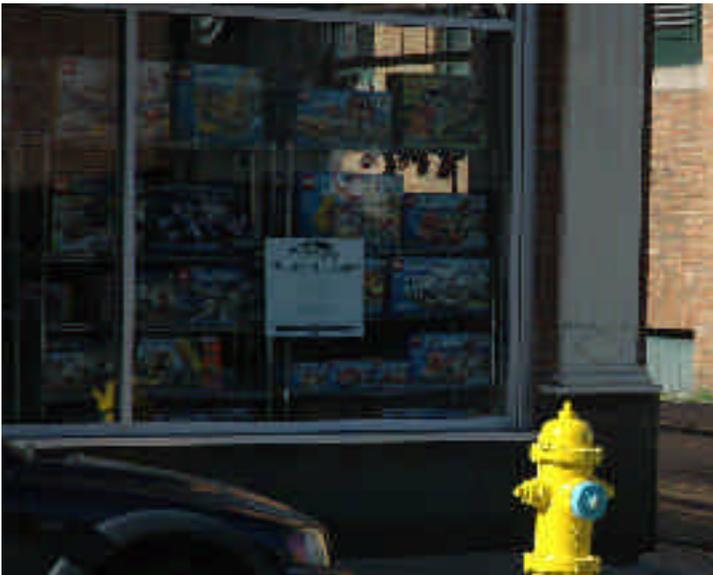
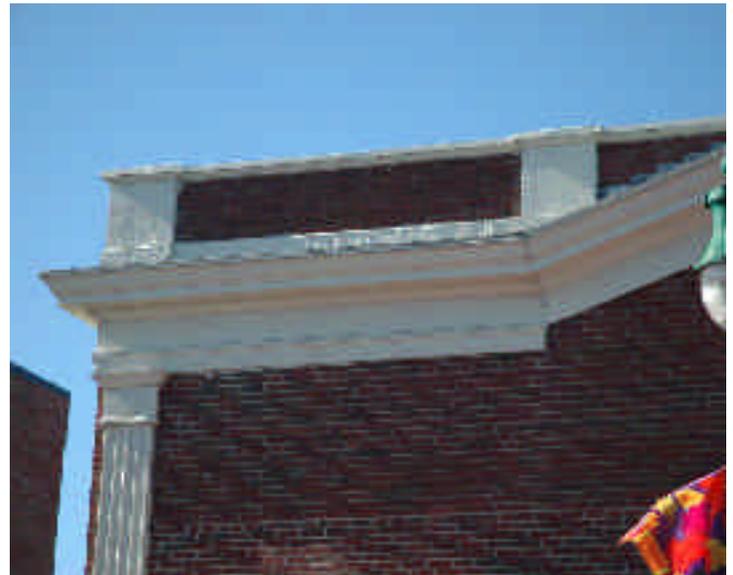
Most aspects of this property are in good condition with exception of awning condition and painted trim condition. Awning is faded and torn and requires replacement in the near future. Wood trim along the building edges and roofline requires new paint and potentially wood repair preparation.

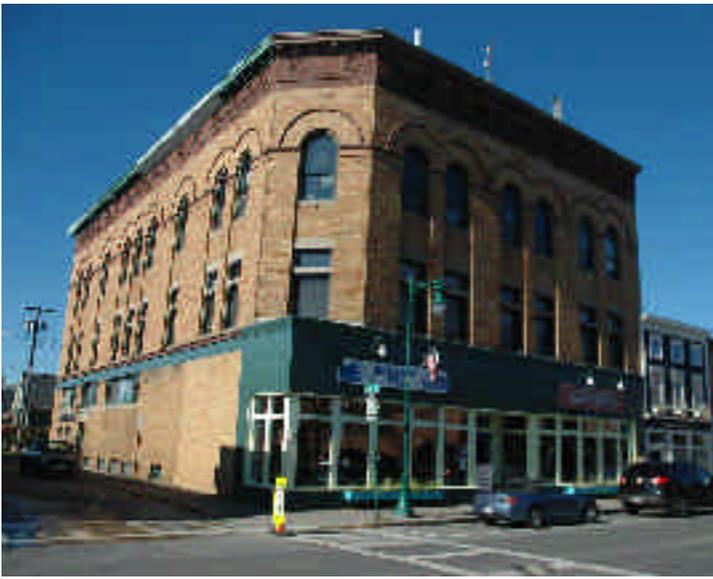
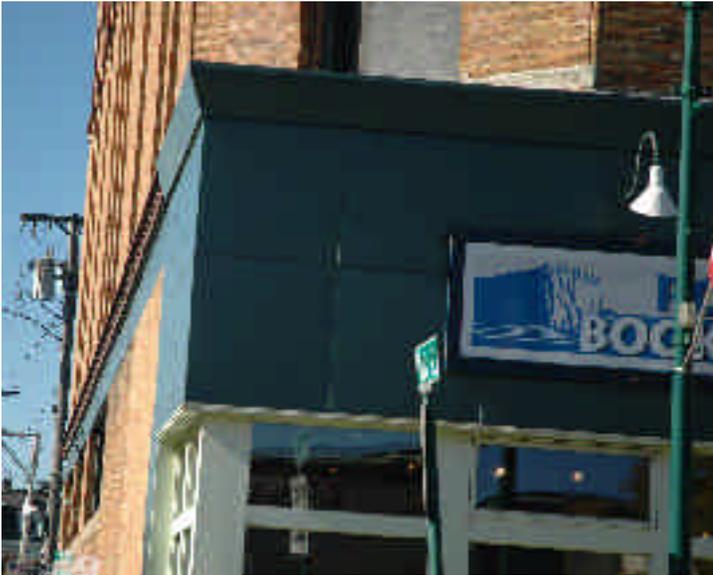
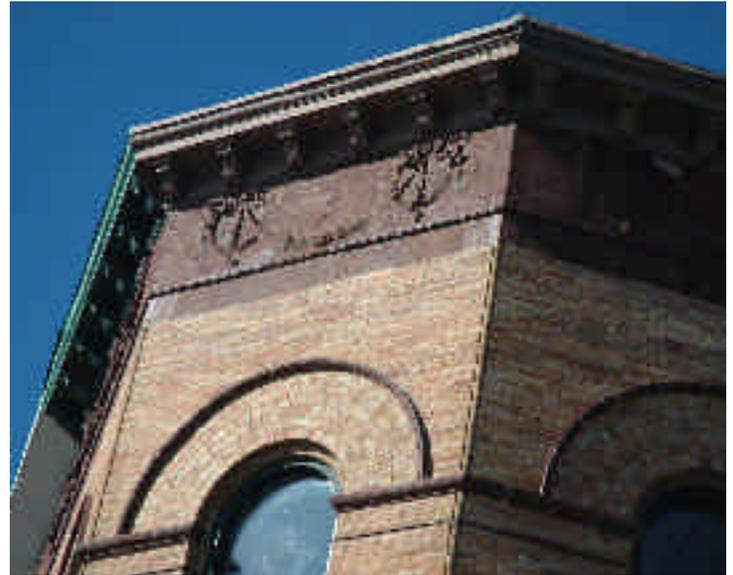
Most aspects of this property are in good condition with exception of inconsistent painting at street level windows, cornice, and roofline as well as metal panels at street level bumpout. All areas in question should be scraped if necessary and repainted to provide consistency. Metal panels are not in keeping with the historical context of the street and the building itself. These panels should be removed so the original facade may be analyzed. Restoration of the street level to a condition equal to or similar to the original construction is recommended.

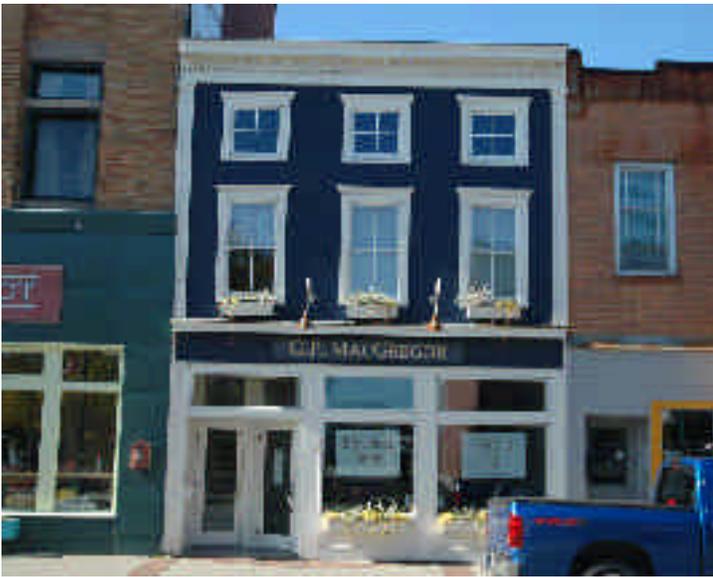
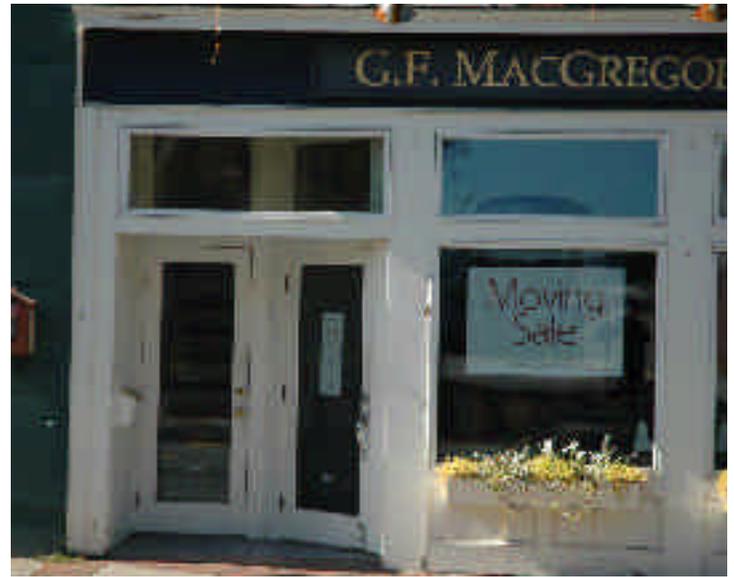
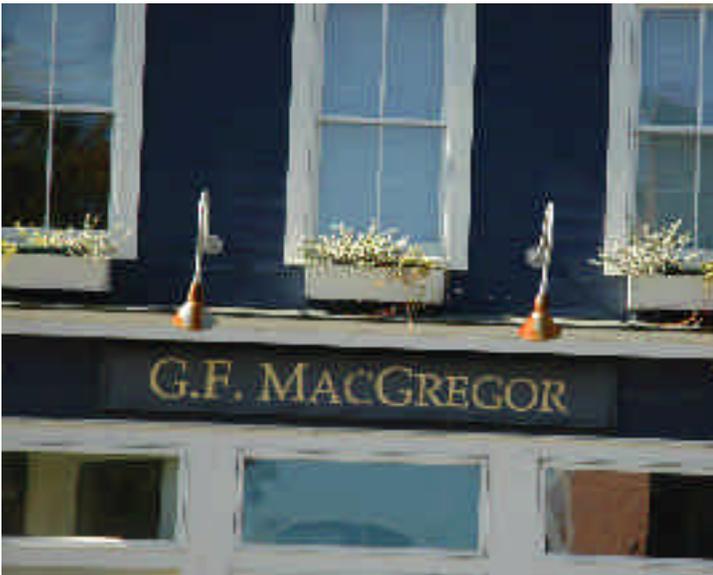
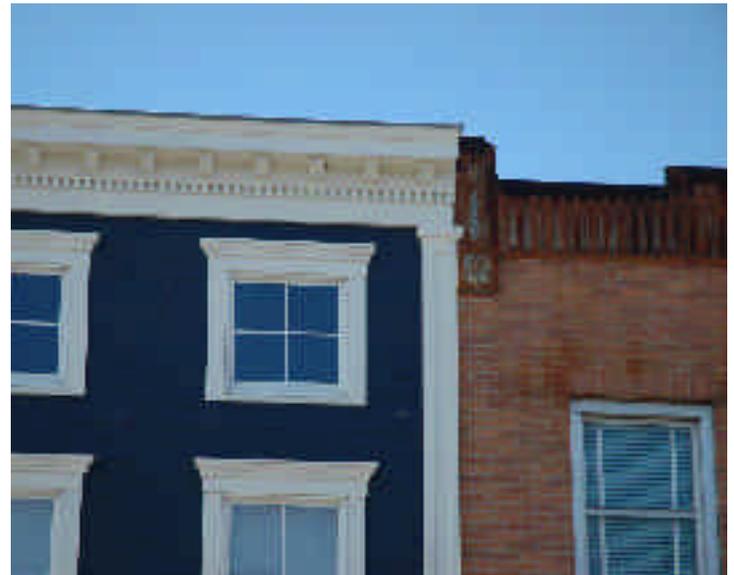
Most aspects of this property are in good condition with exception of inconsistant painting at street level and upper level. All areas in question should be scraped and repainted to provide consistency.

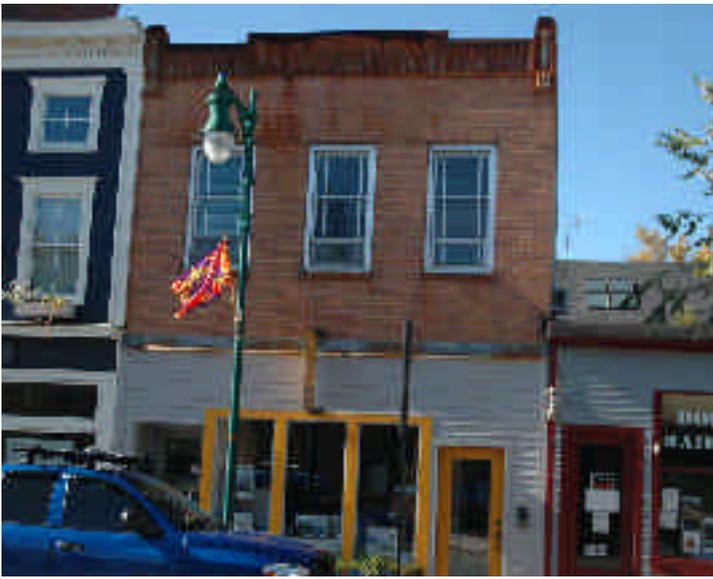
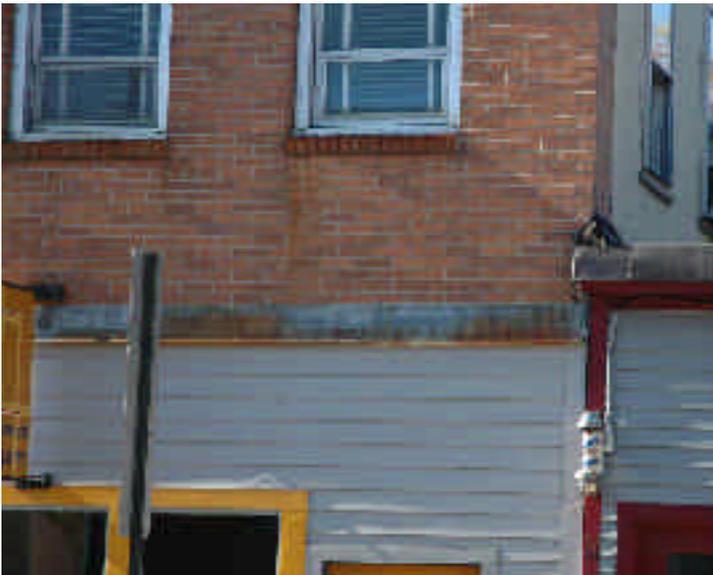
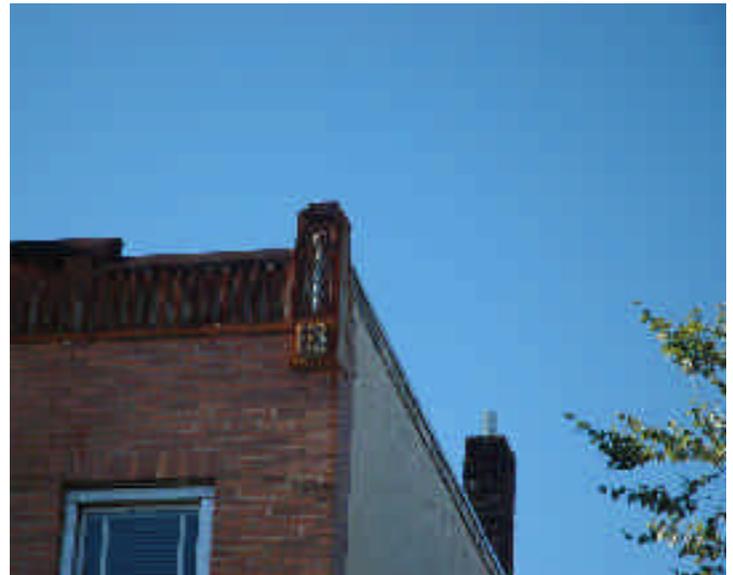
Most aspects of this property are in good condition with exception of inconsistent painting at street level and roofline / cornice. All areas in question should be scraped and repainted to provide consistency. Metal cornice should be properly prepared prior to applying a new paint or sealer.

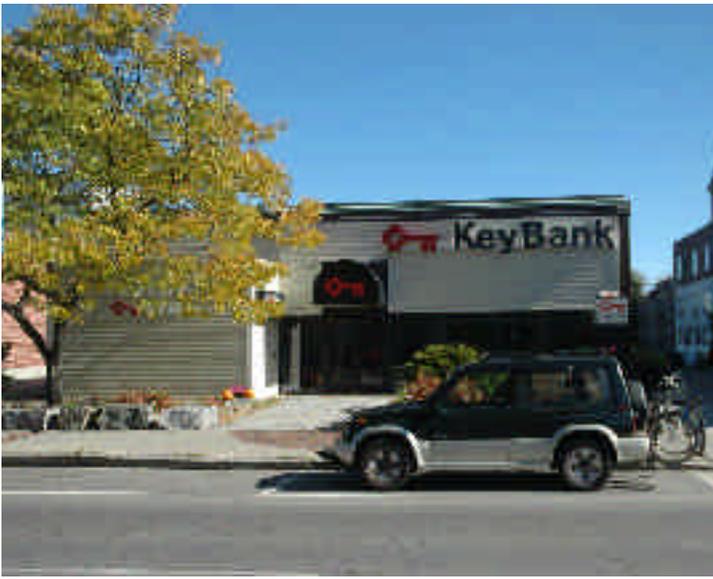
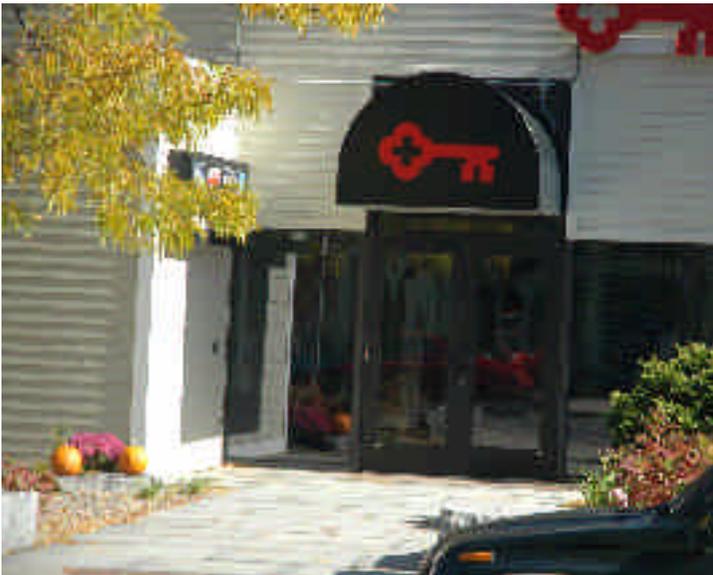
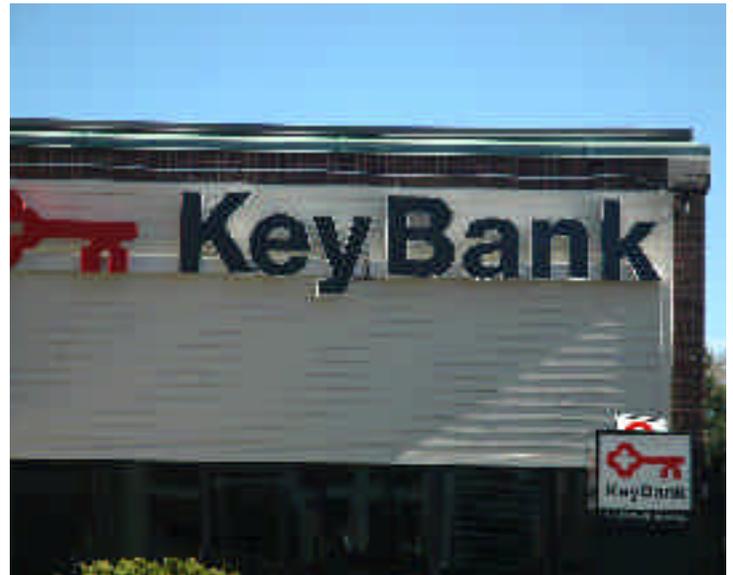
Most aspects of this property are in good condition with exception of excessive signage. The corporate identification of the bank company is not in keeping with the historic character of the street. It is recommended that awning signage be removed and facade signage be reduced. All other aspects of the building are in good condition.

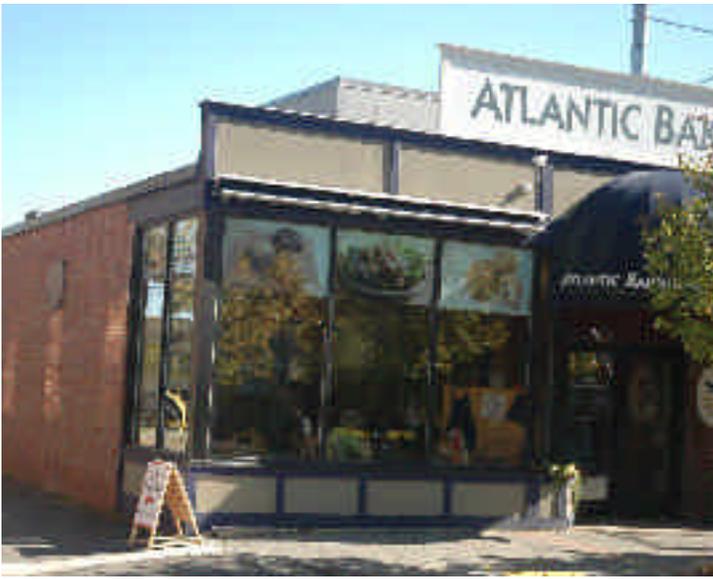
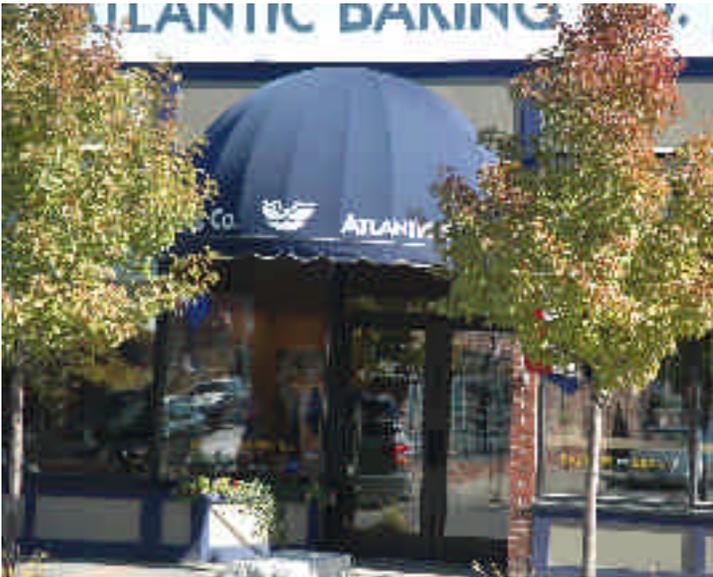
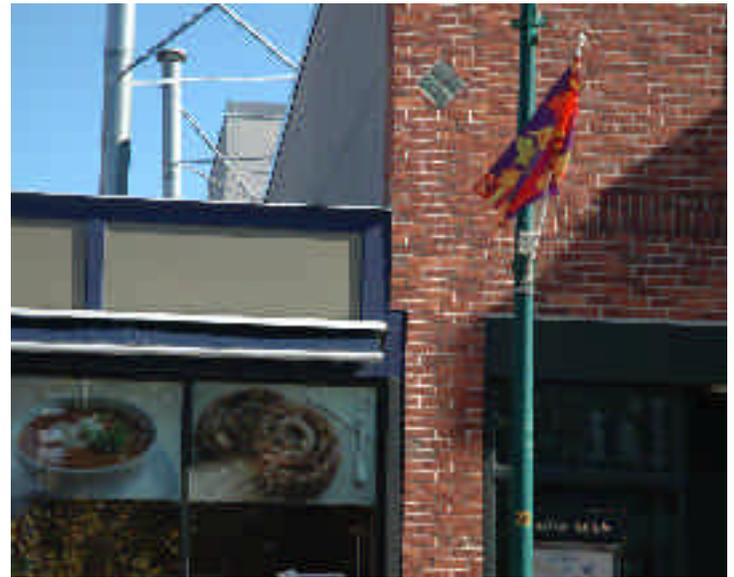
Most aspects of this property are in good condition with exception of excessive signage. The awning was rolled up and not reviewed. The combination of the awning sign, the sign over the building, and the graphics on the facade windows are excessive. The recommendation is to limit window graphics and text to create a less busy facade. All other aspects of the building are in good condition.

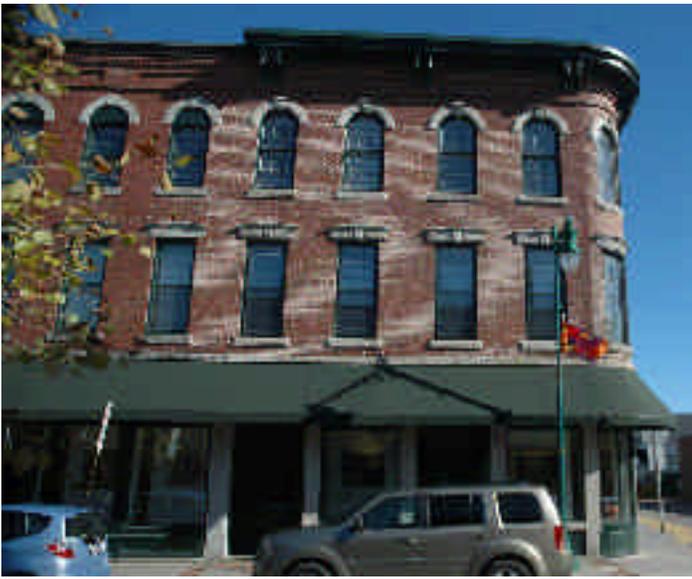
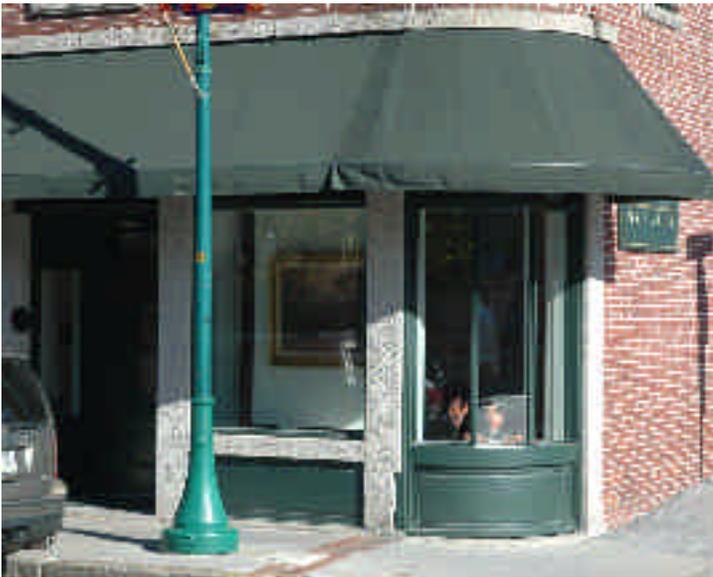
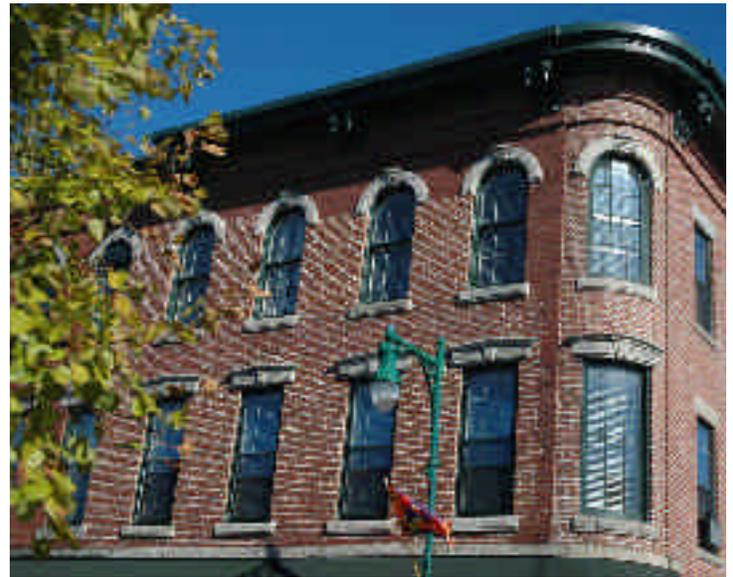
Most aspects of this property are in good condition with exception of selective brick pointing required at the upper facade.

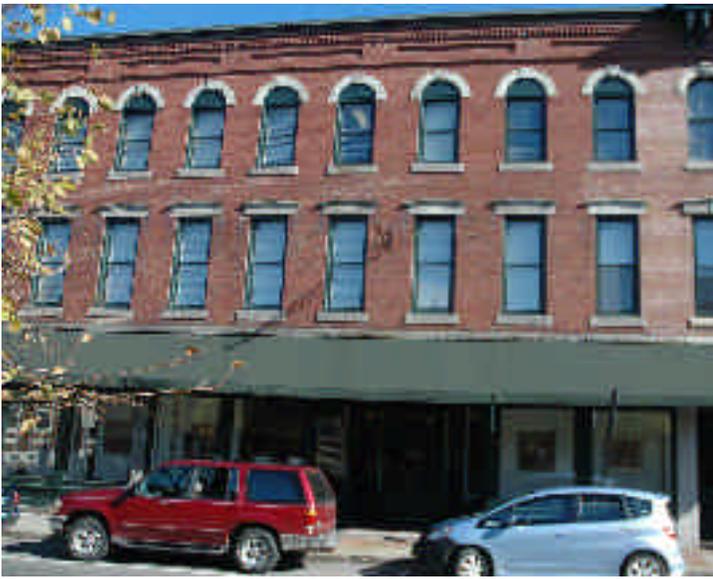
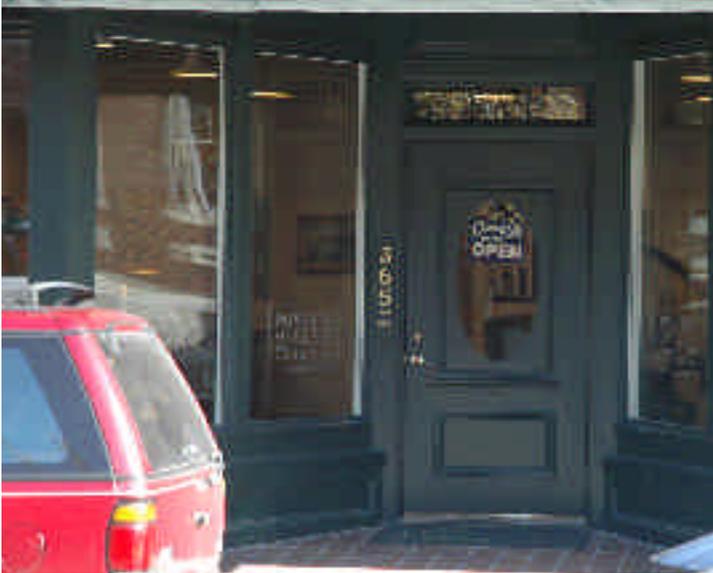
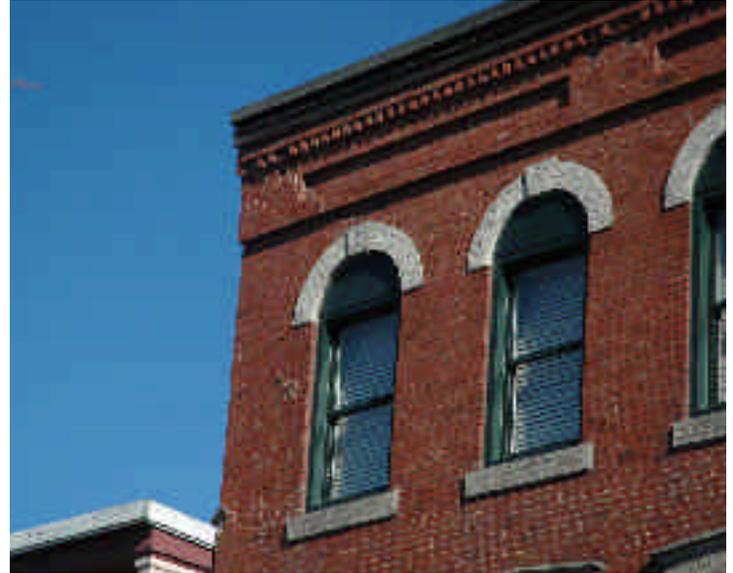
Most aspects of this property are in good condition with exception of selective brick pointing required at the upper facade.

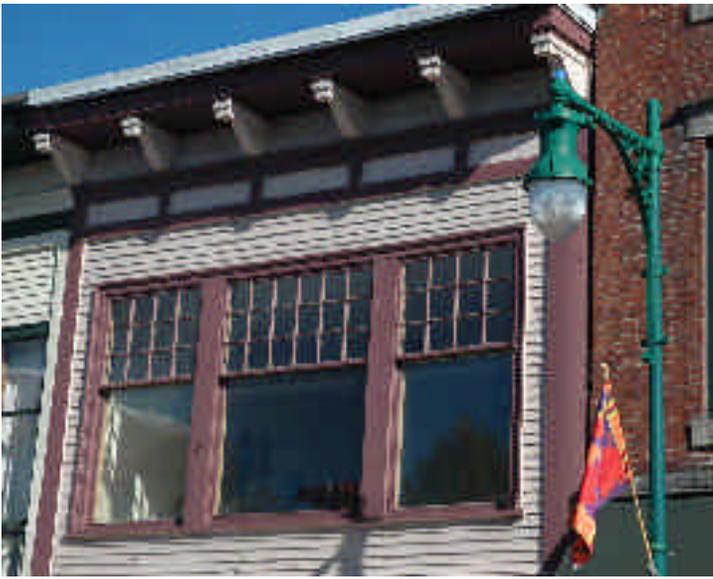
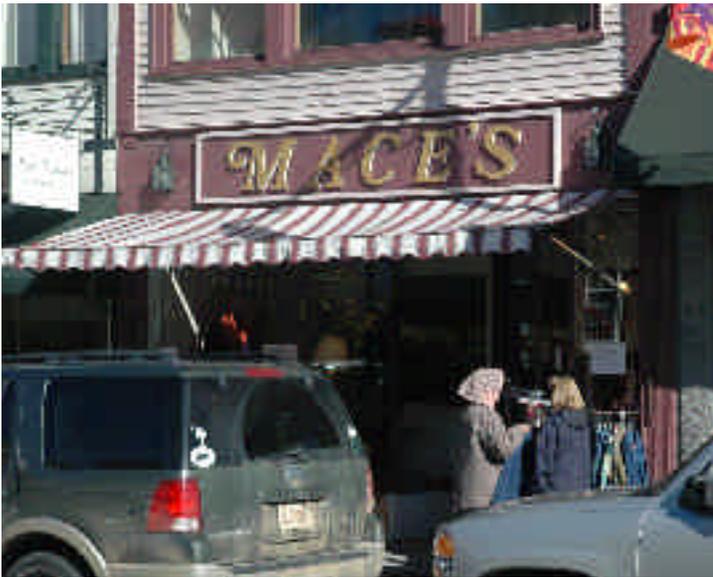
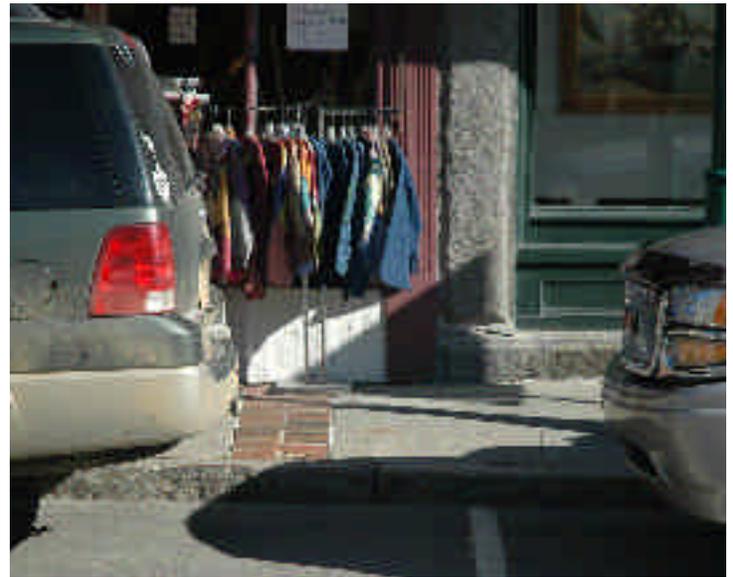
Most aspects of this property are in good condition with exception of poor paint condition over the entire facade, especially at street level paneling. Wood trim, clapboards, and window trim should be repainted.

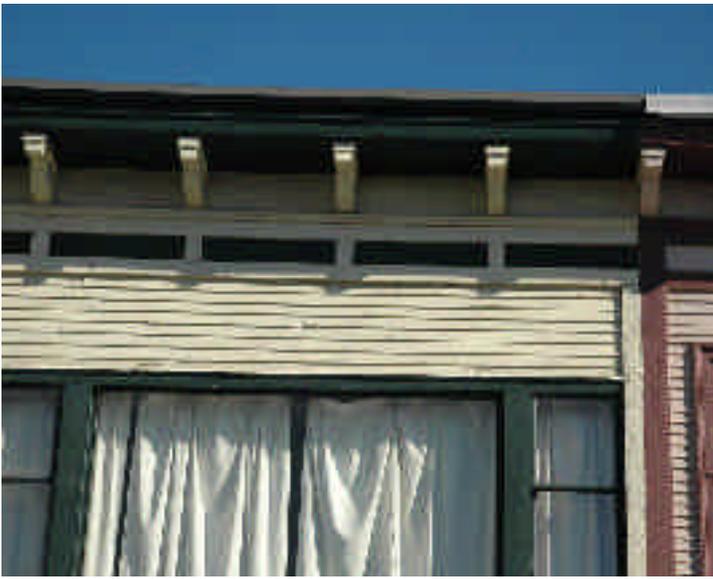
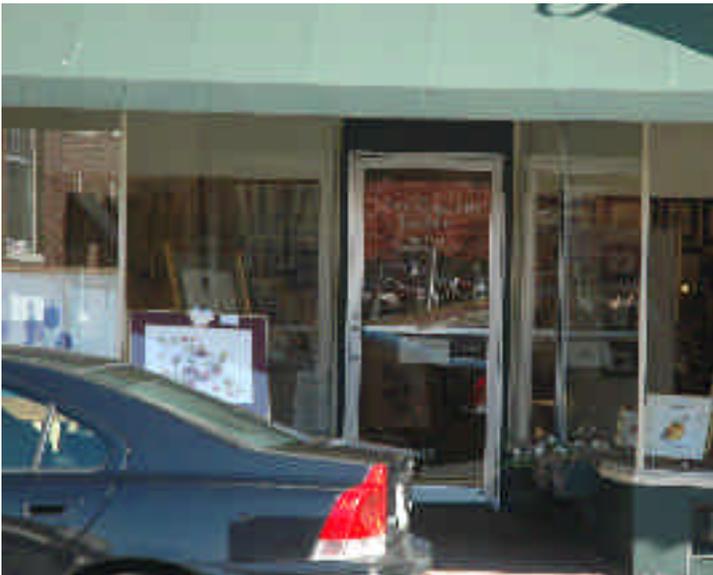
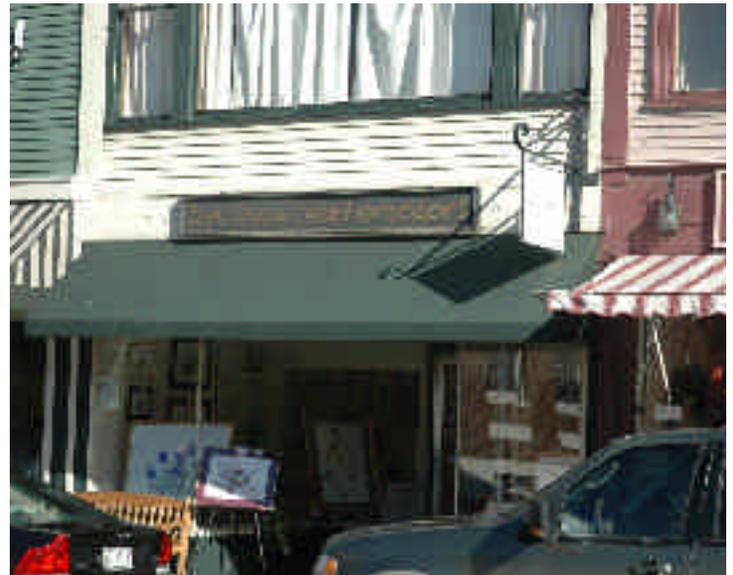
Most aspects of this property are in good condition with exception of poor paint condition over the entire facade and cornice. Wood trim, clapboards, window trim, and cornice should be repainted.

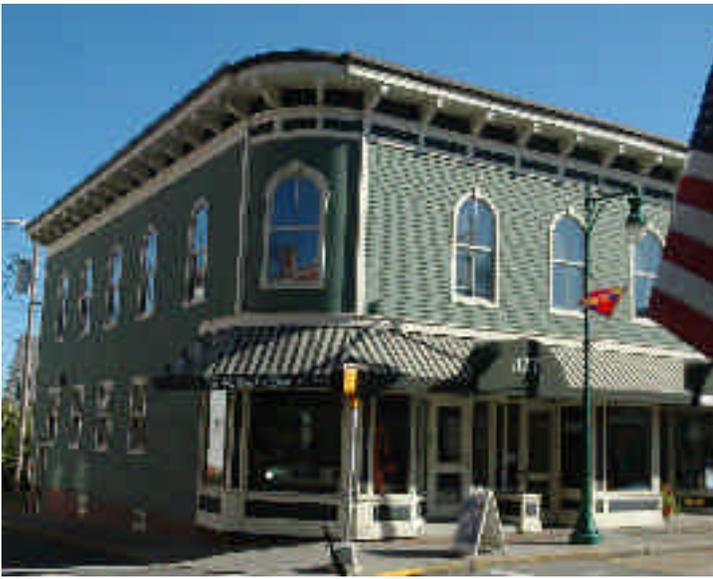
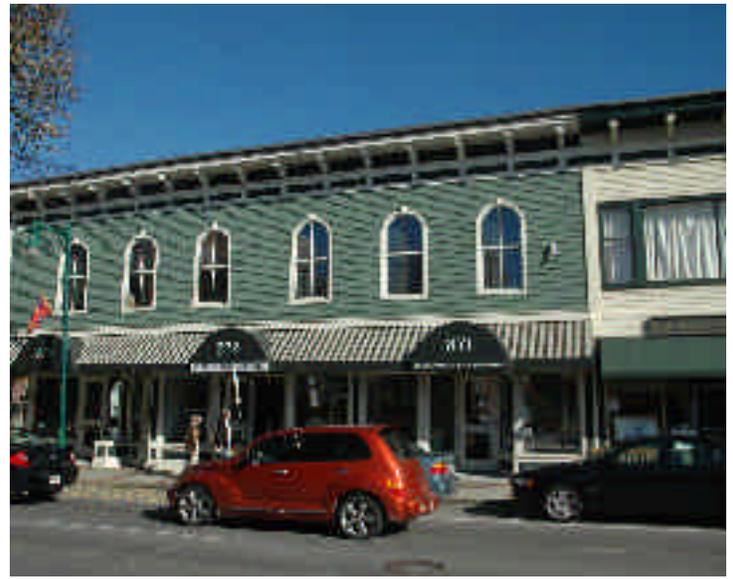
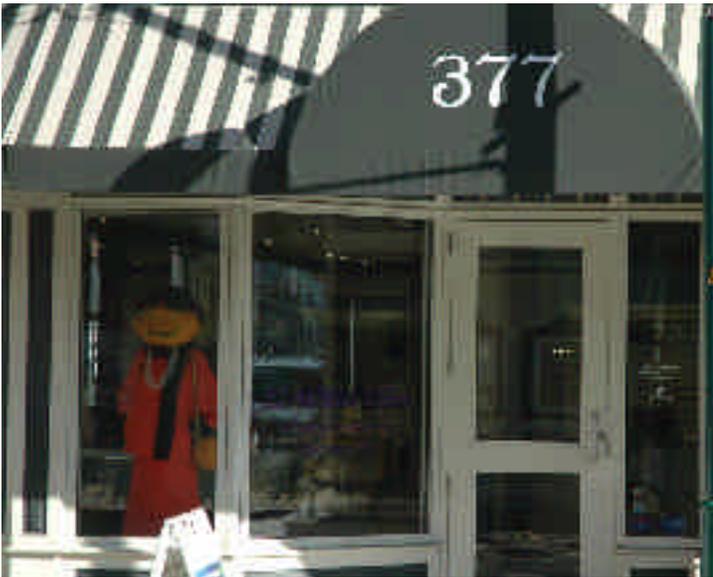
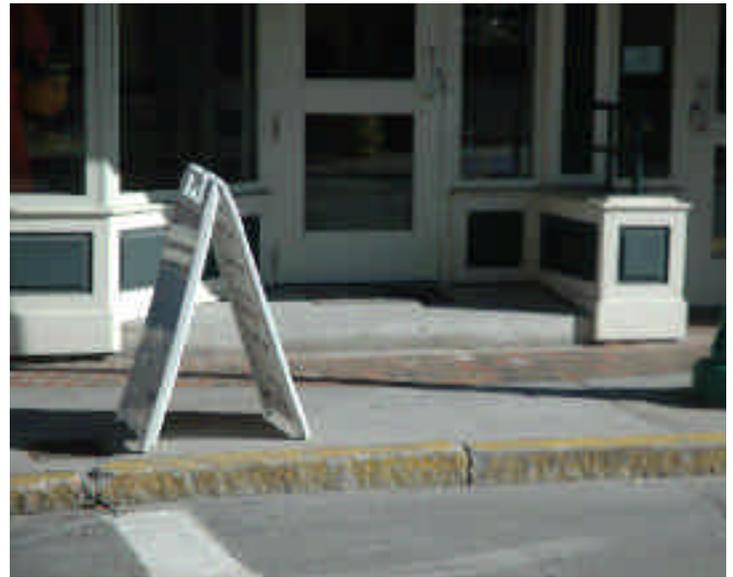
All aspects of this building are in good condition. No repair recommendations were identified.

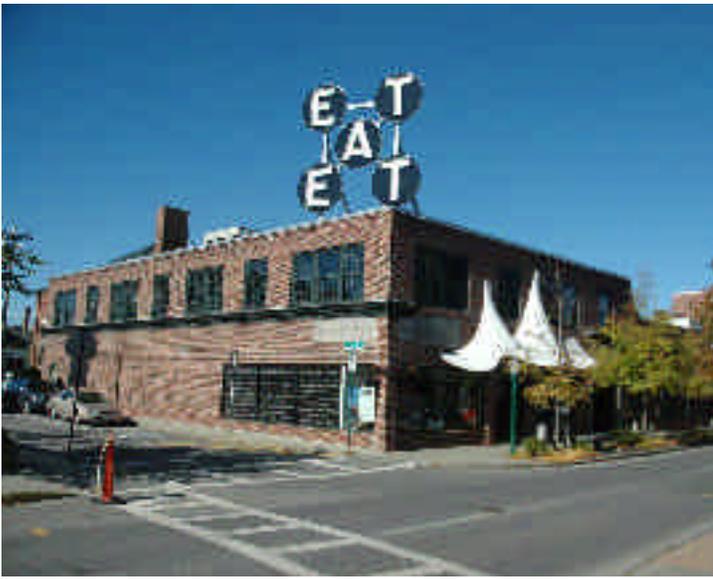
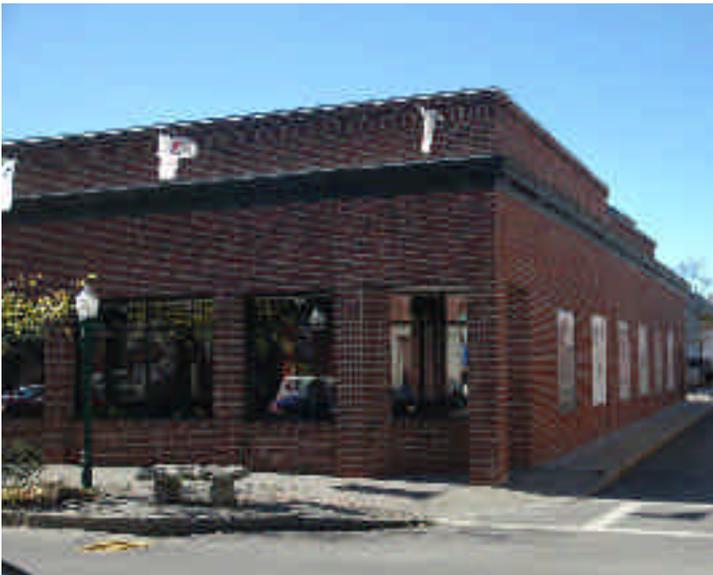
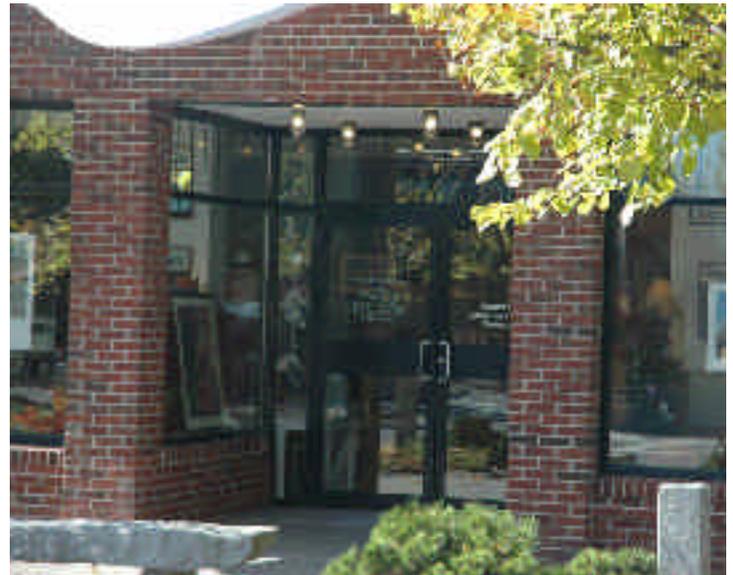
Most aspects of this property are in good or excellent condition with exception of poor paint condition at roof gutter. This area should be repainted.

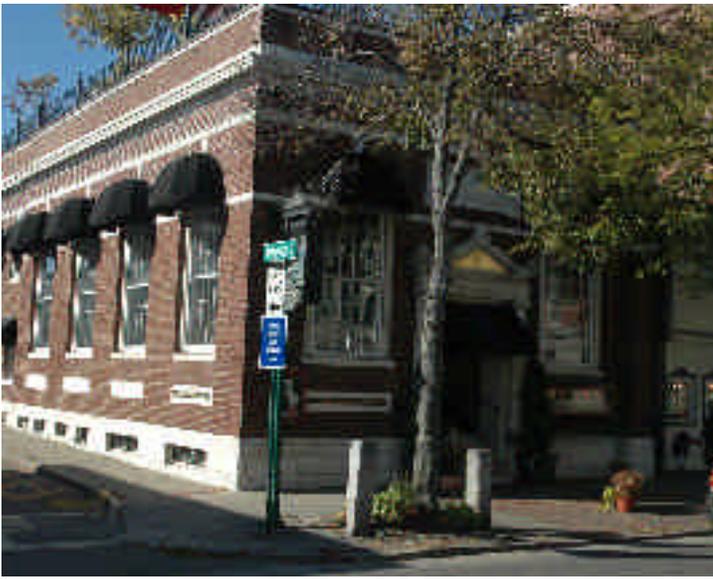
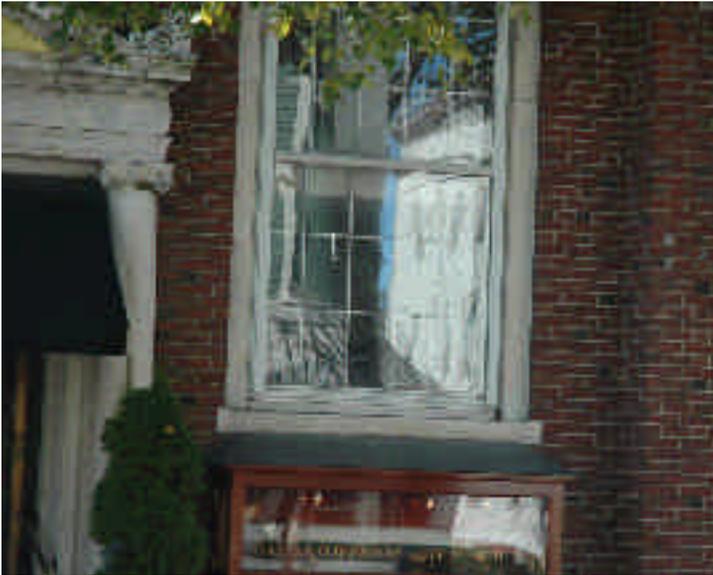
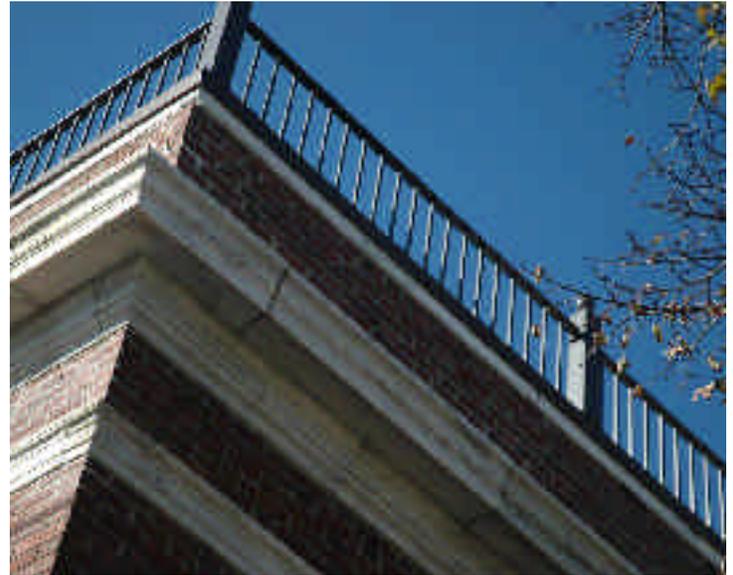
Most aspects of this property are in good or excellent condition with exception of the cornice. This area should be repointed.

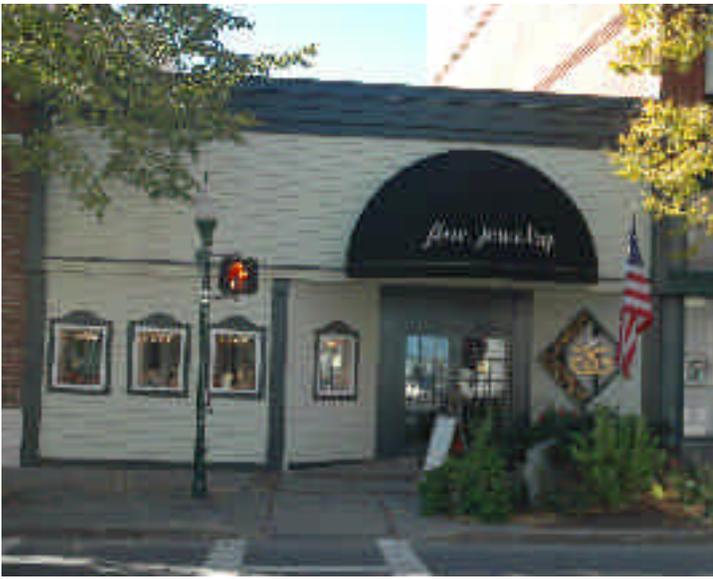
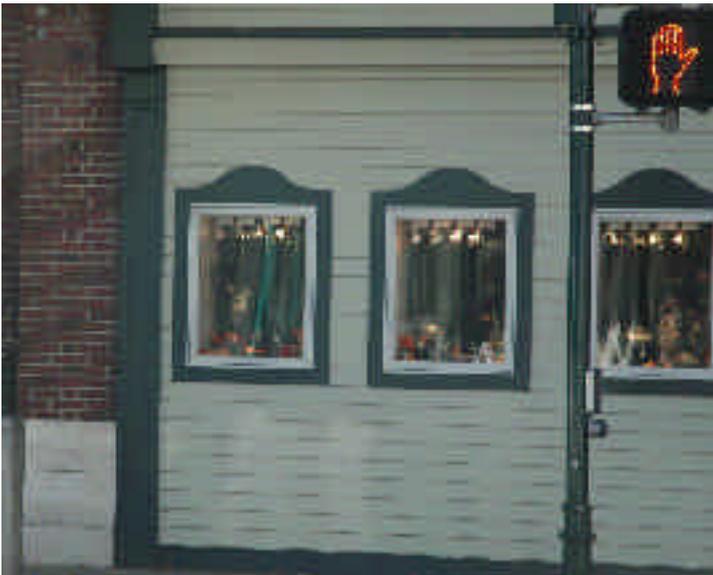
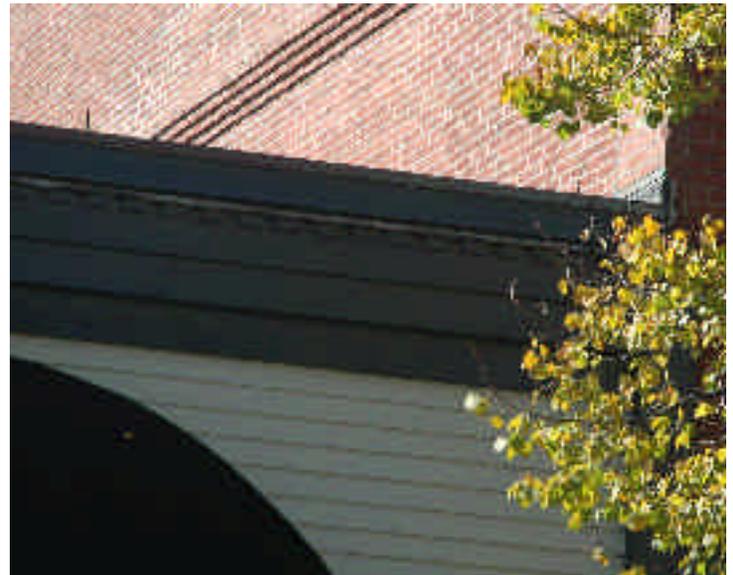
Most aspects of this property are in good or excellent condition with exception of excessive signage and poor paint condition at the cornice. The facade signage should be reduced in scale and the cornice area should be repainted.

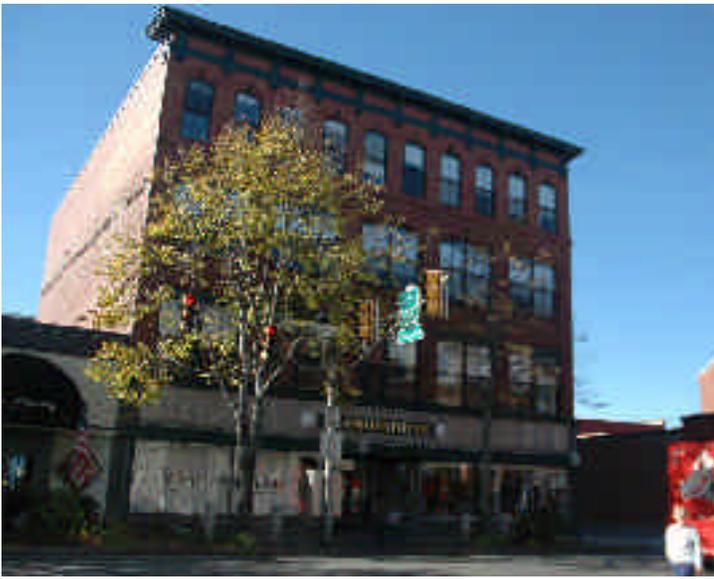
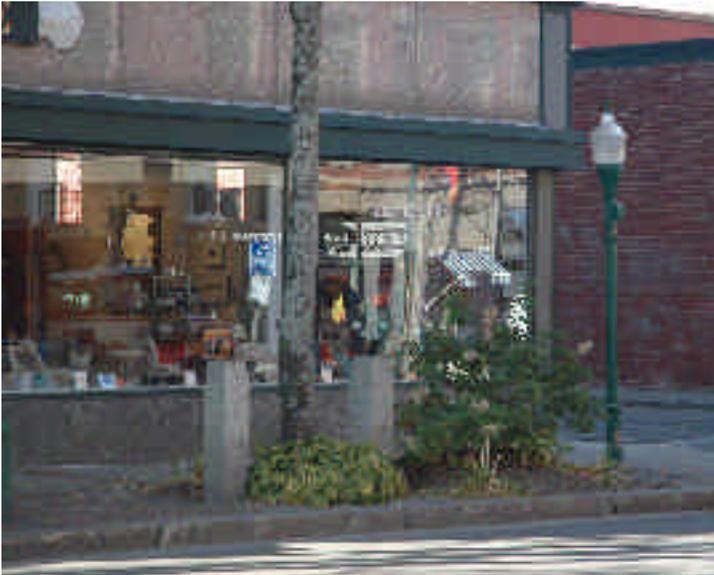
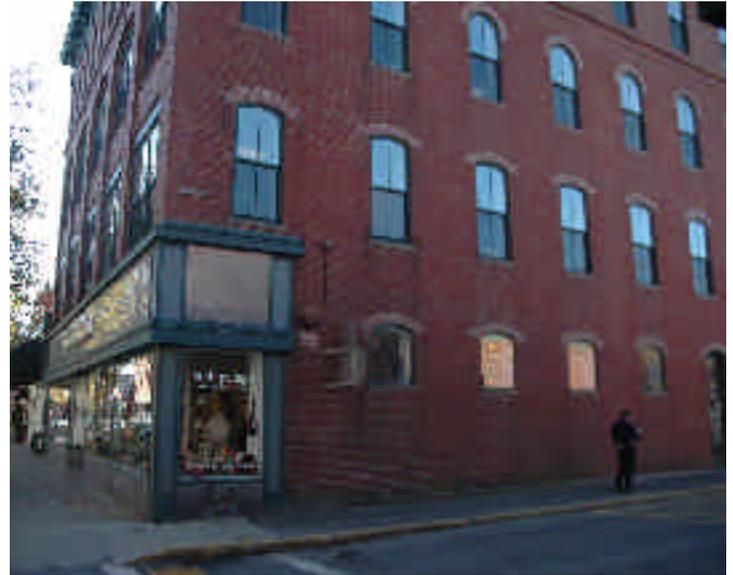
Most aspects of this property are in good or excellent condition with exception of minor painting and caulking on facade.

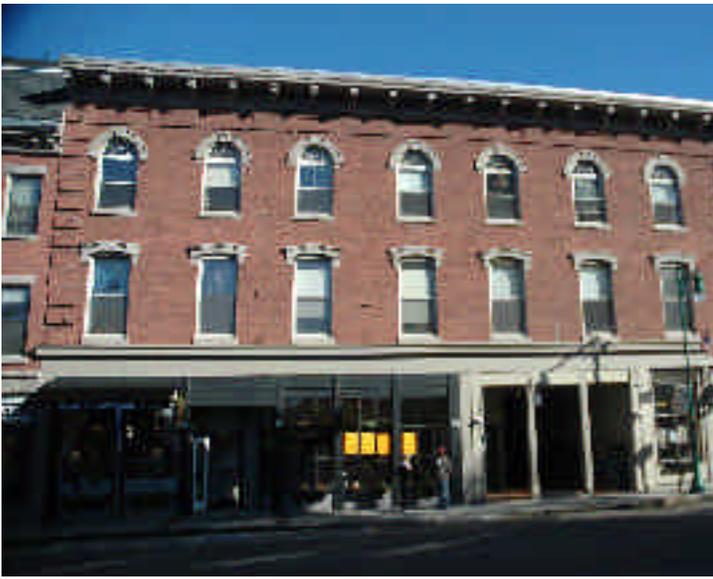
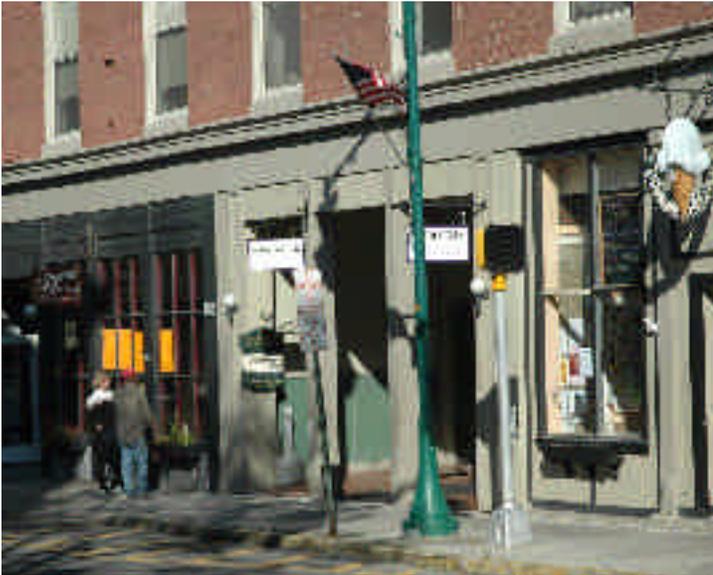
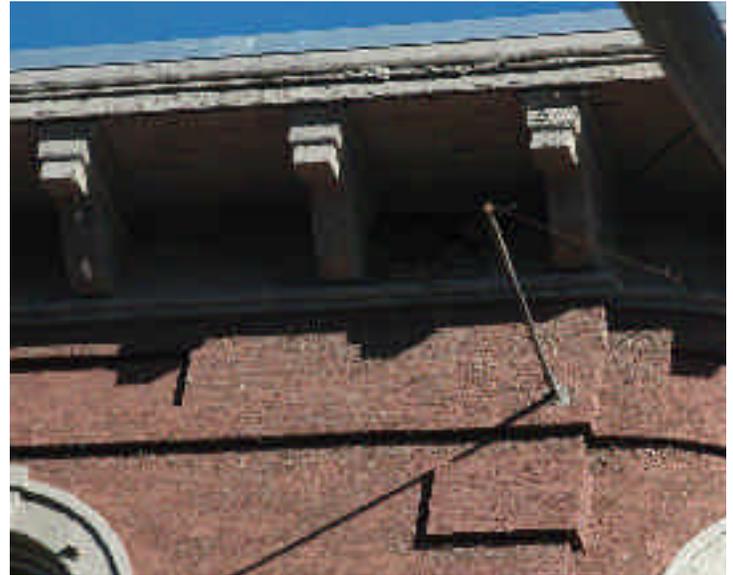
Most aspects of this property are in good or excellent condition with exception poor paint condition across the facade and cornice. The facade and cornice area should be repainted.
