2009 Downtown Revitalization Plan UPDATE

City of Rockland, Maine

2009 DOWNTOWN REVITALIZATION PLAN UPDATE

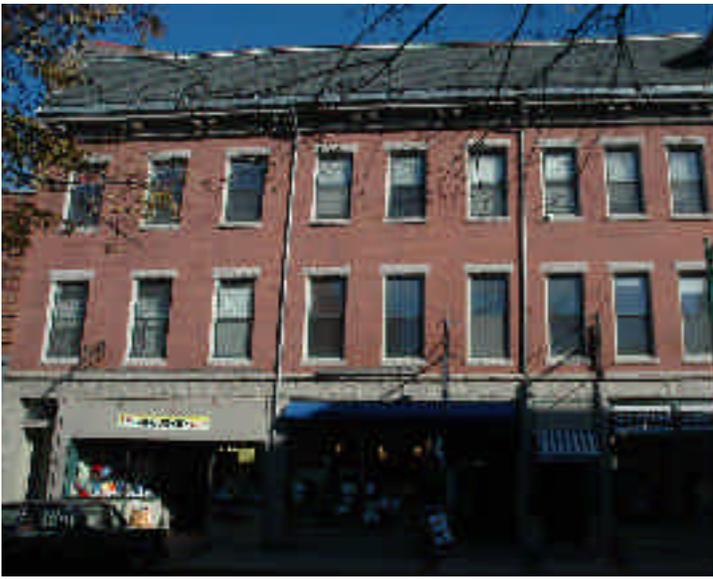
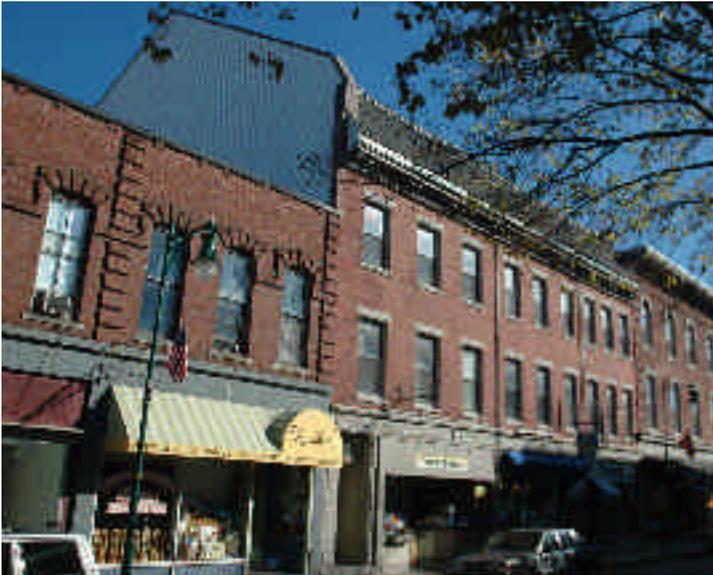
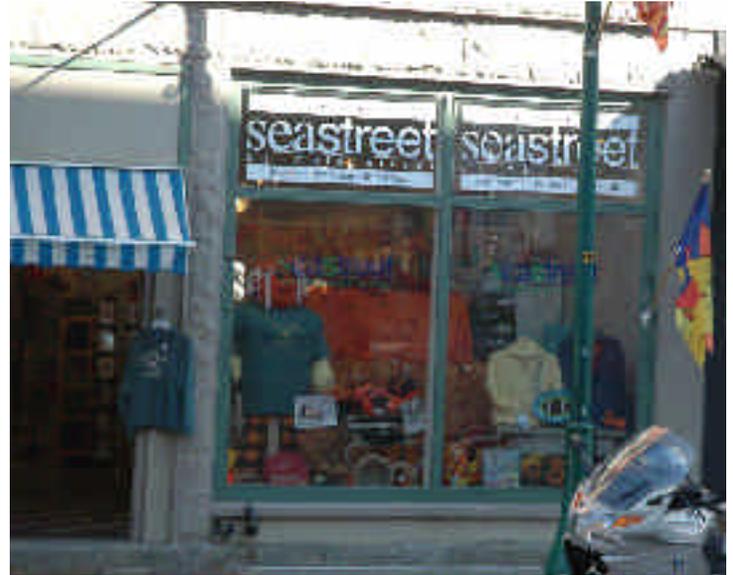
Most aspects of this property are in good or excellent condition with exception of inappropriate signage and poor paint condition at the cornice. The facade signage at Embroidery Shop should be changed in scale and the cornice area should be repainted.

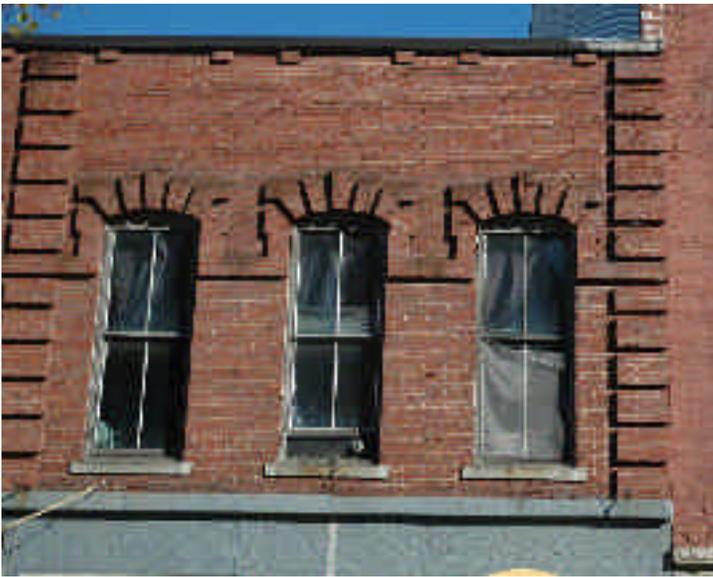
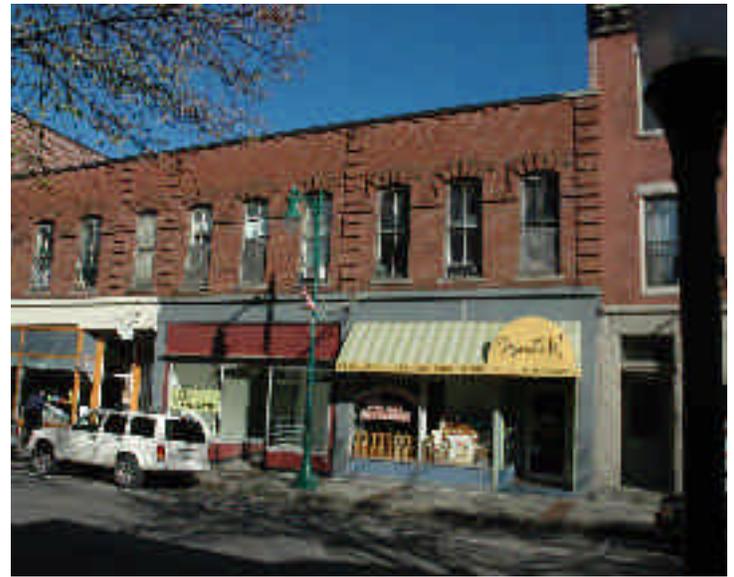
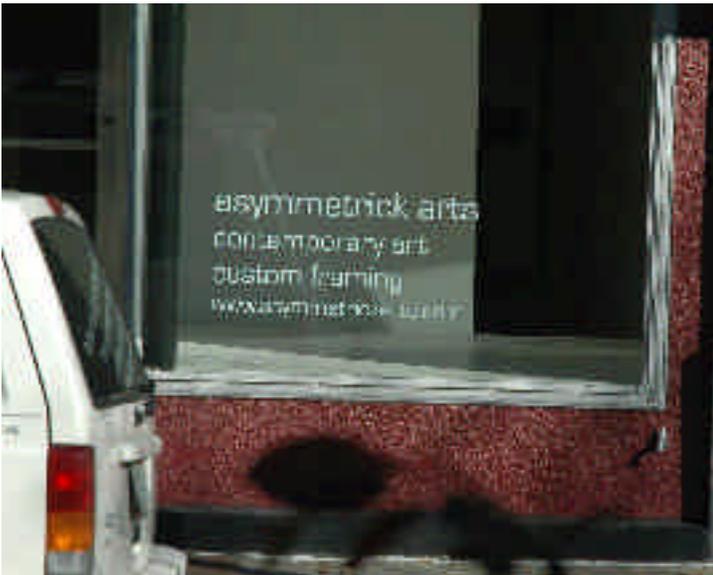
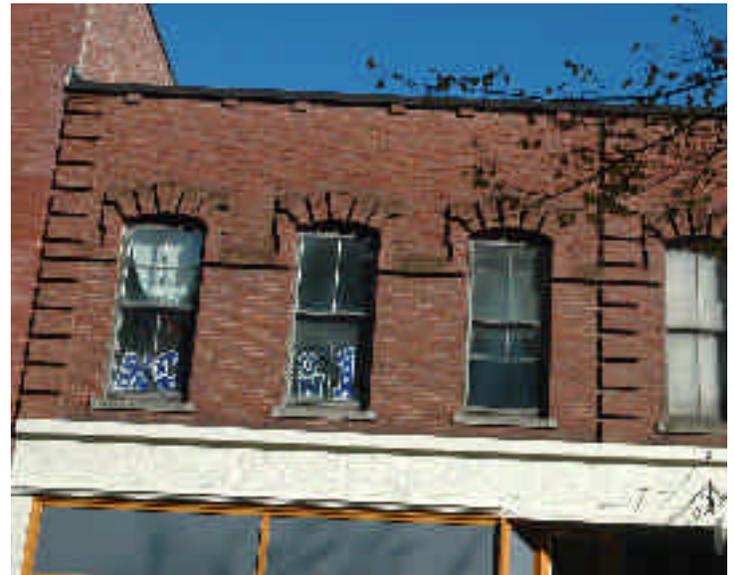
Most aspects of this property are in good or excellent condition with exception of poor window glazing at storefront 405 and poor brick condition across the facade. The window glazing should be replaced and the cornice area should be repointed.

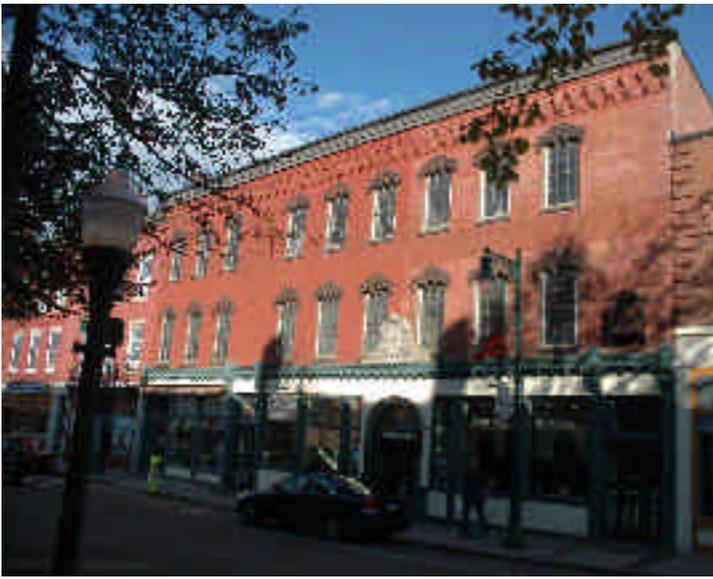
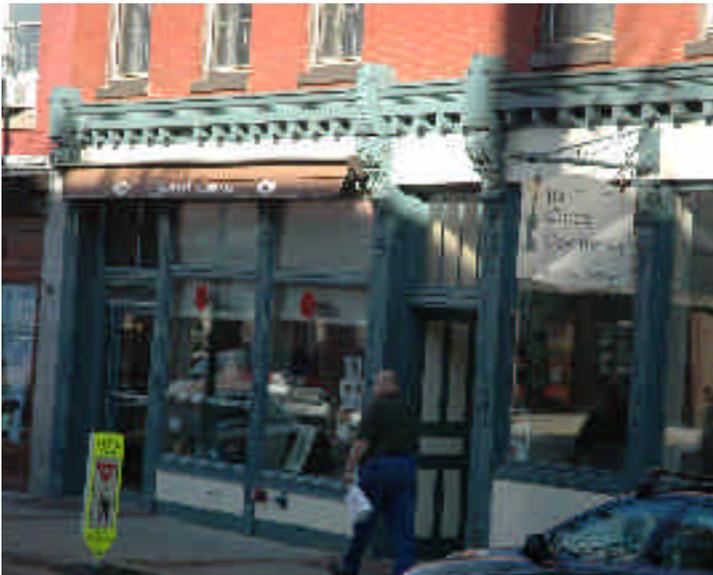
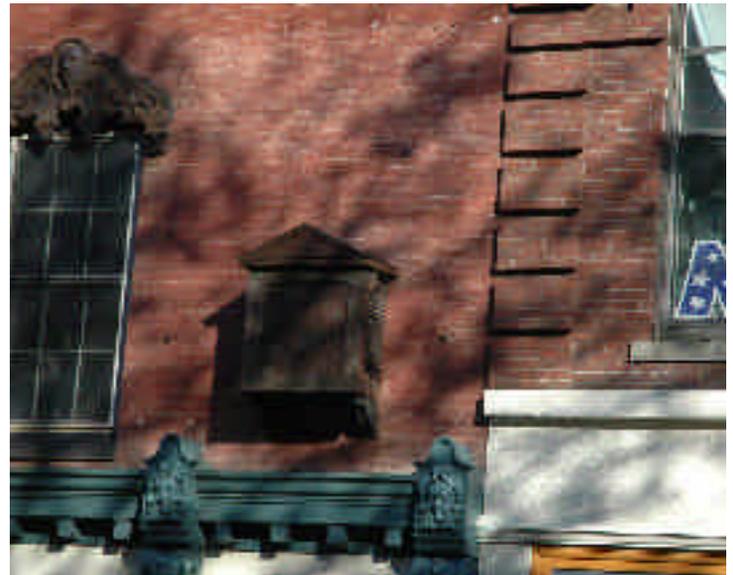
Most aspects of this property are in good or excellent condition with exception of poor window frame condition at storefront and poor paint condition across the facade. The wood trim and painted metal should be repainted.

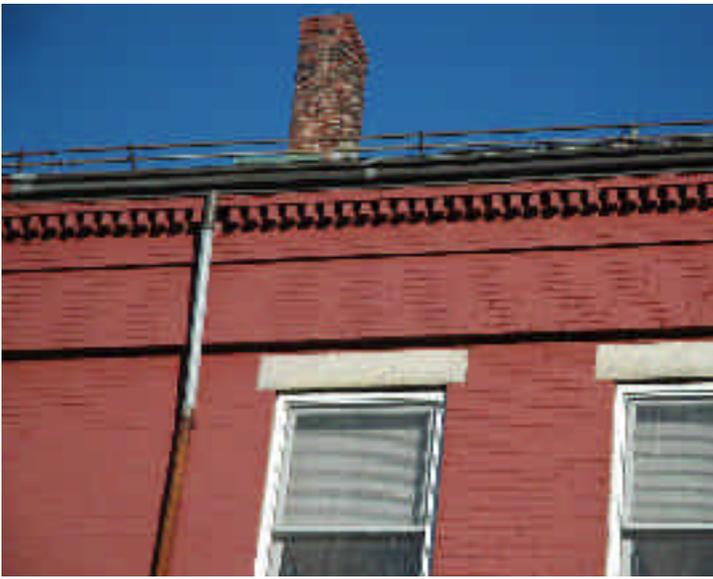
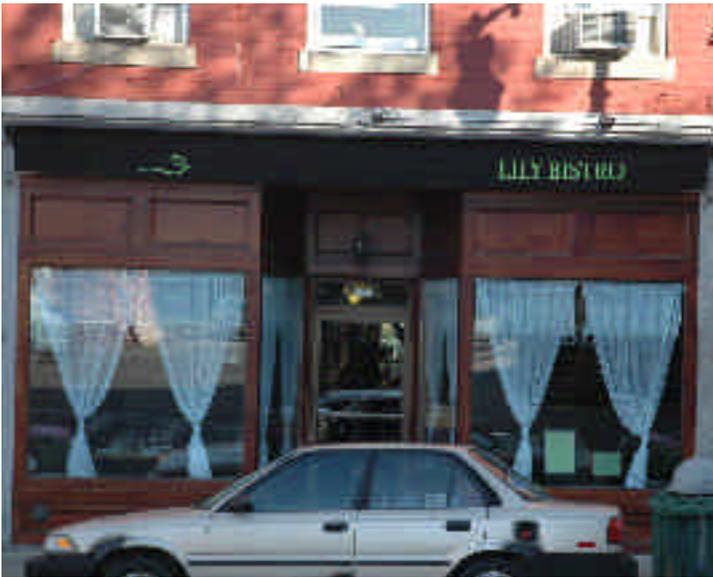
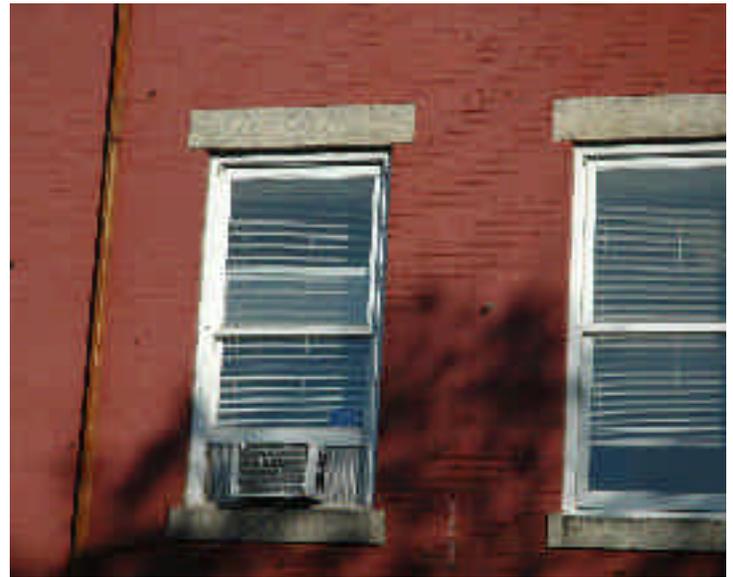
Most aspects of this property are in good or excellent condition with exception of poor paint condition at street level and at cornice as well as poor brick facade condition. The wood trim should be repainted and brick facade should be repointed.

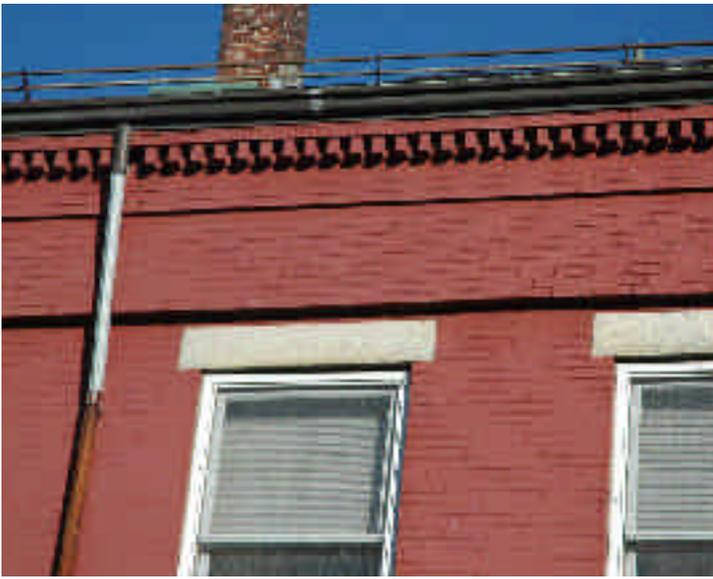
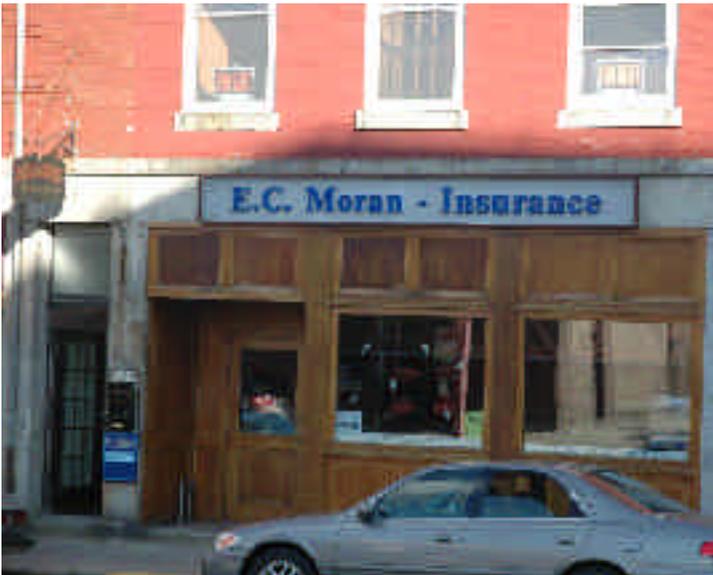
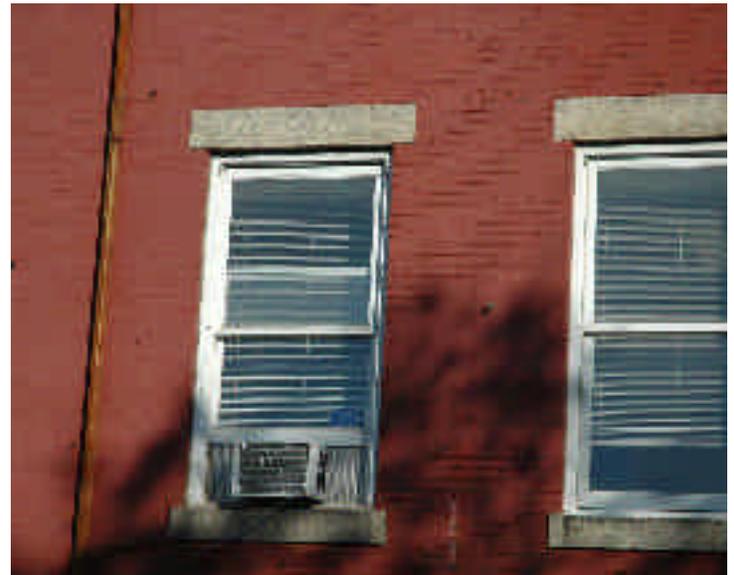
Most aspects of this property are in good or excellent condition with exception of poor paint condition at street level and at cornice as well as poor brick facade condition. The wood trim should be repainted and brick facade should be repointed.

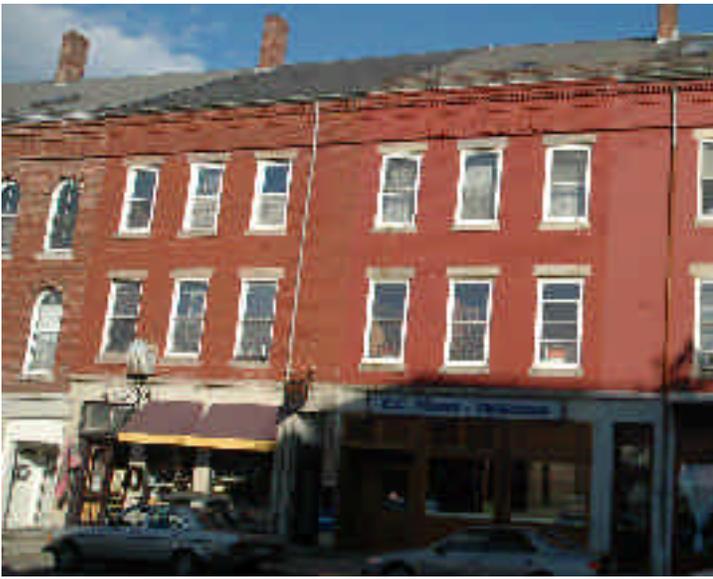
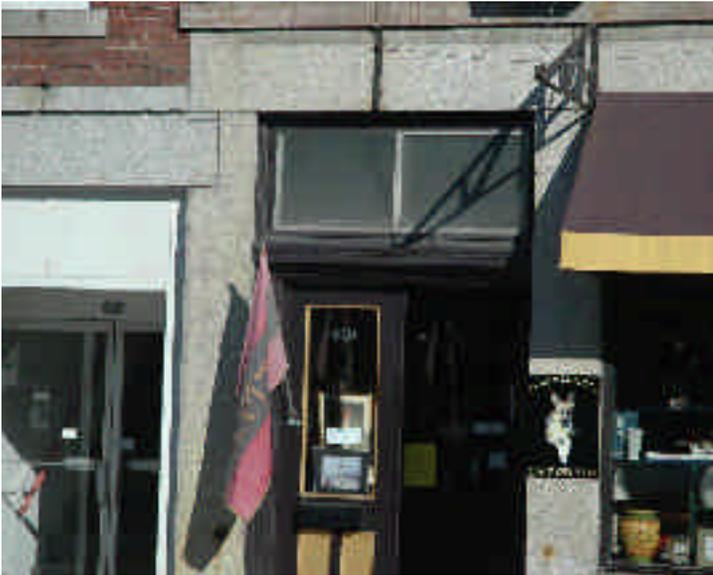
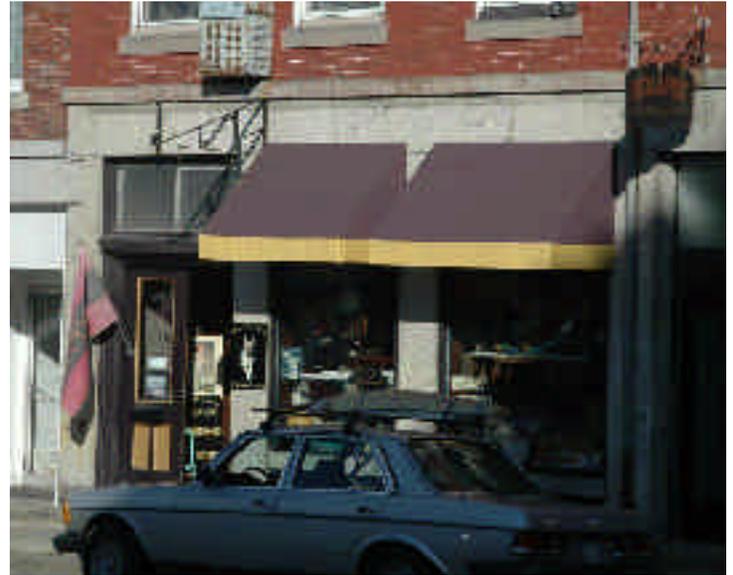
Most aspects of this property are in good or excellent condition with exception of poor brick facade condition at the upper levels. The upper brick facade should be repointed.

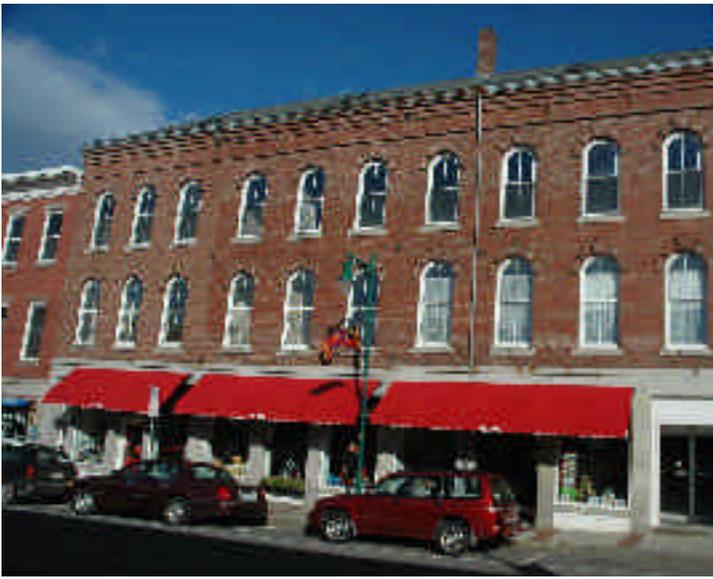
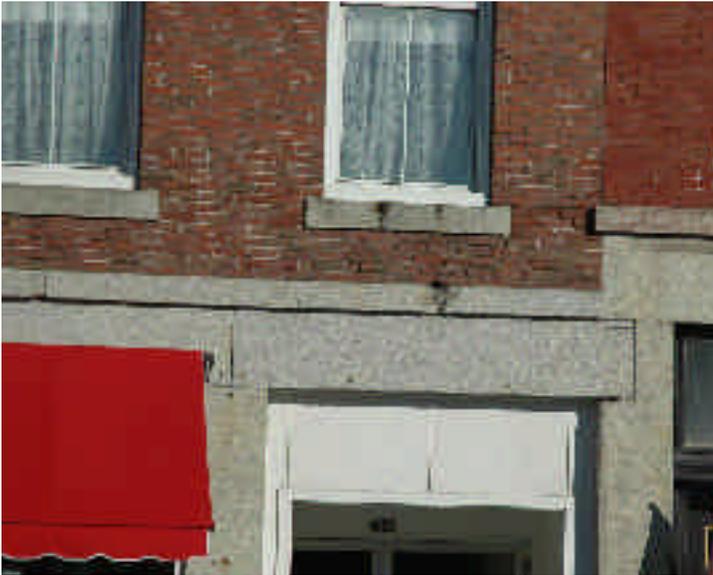
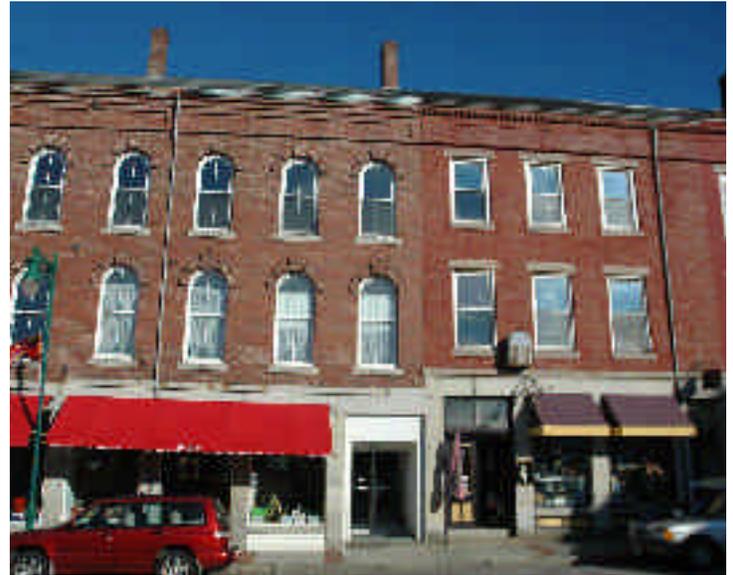
Most aspects of this property are in good or excellent condition with exception of poor paint condition at street level and upper window trim as well as poor brick facade and cornice condition. The wood trim should be repainted and brick facade should be repointed.

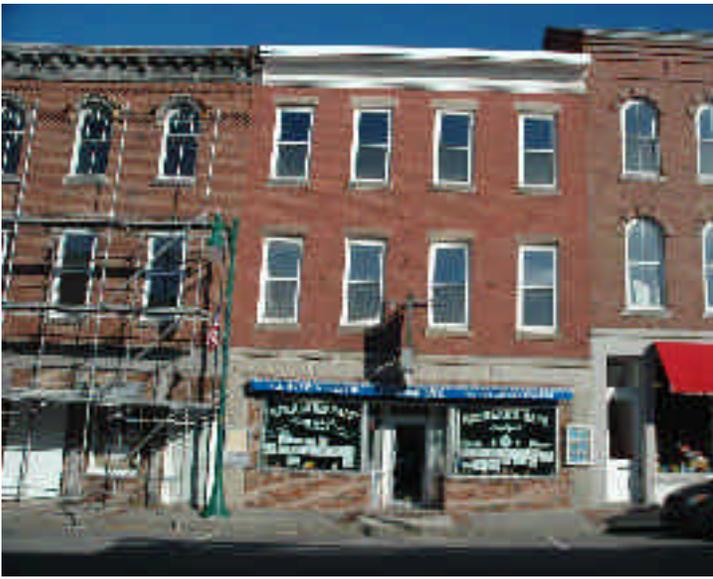
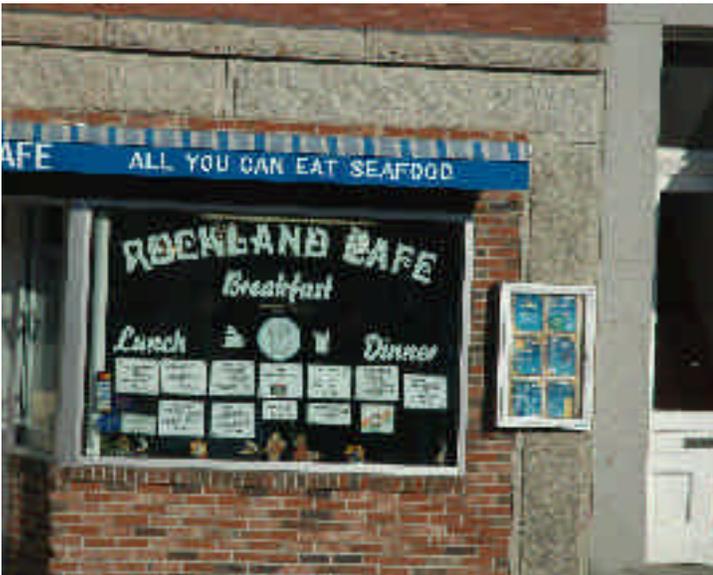
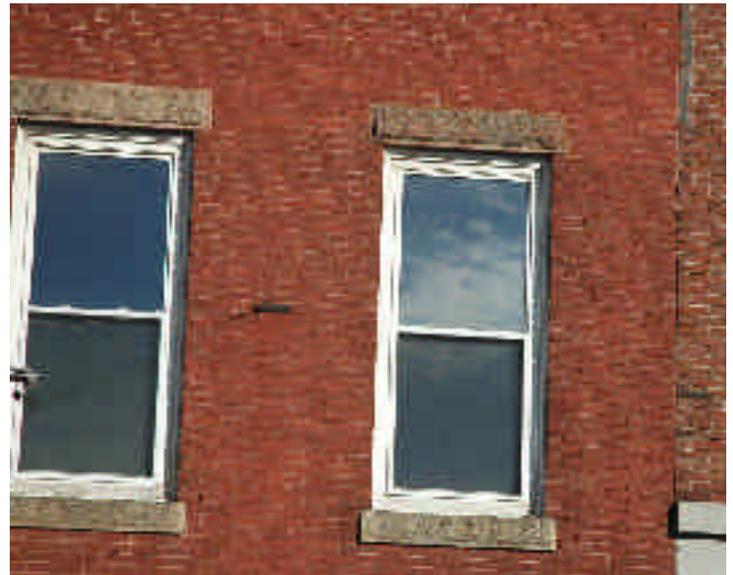
Most aspects of this property are in good or excellent condition with exception of excessive signage, poor paint condition at street level as well as poor brick facade condition. The net amount of signage (facade, windows, and awning) should be reduced if possible. Wood trim should be repainted and brick facade should be repointed.

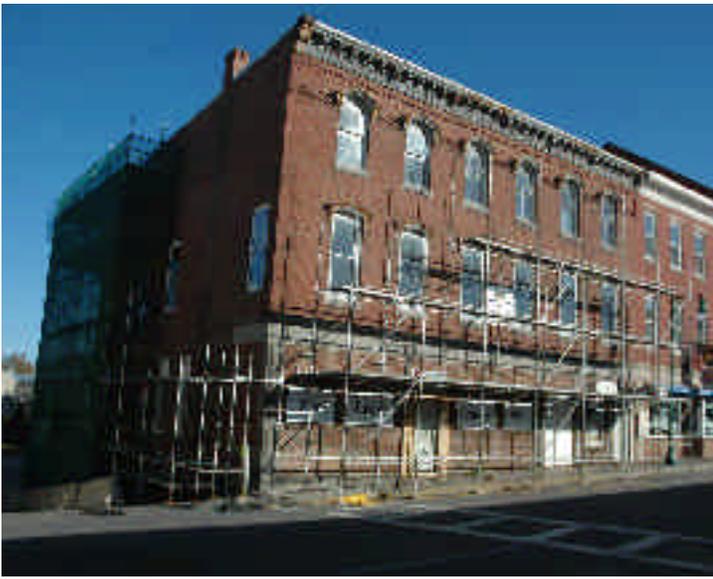
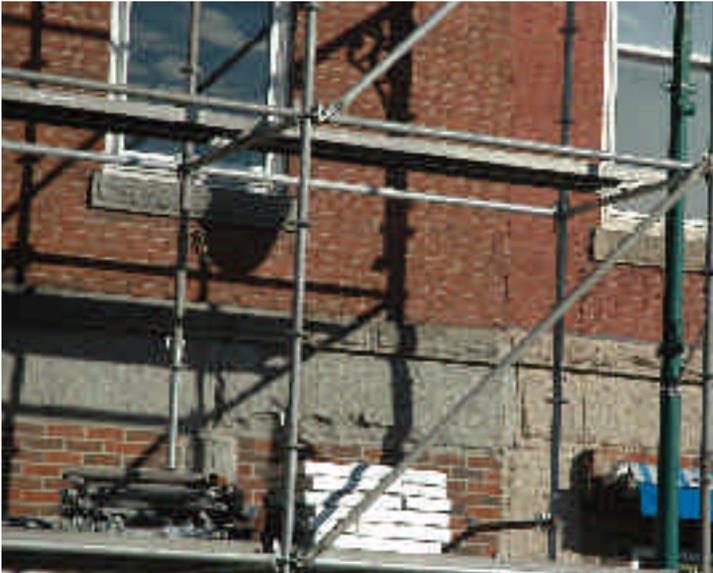
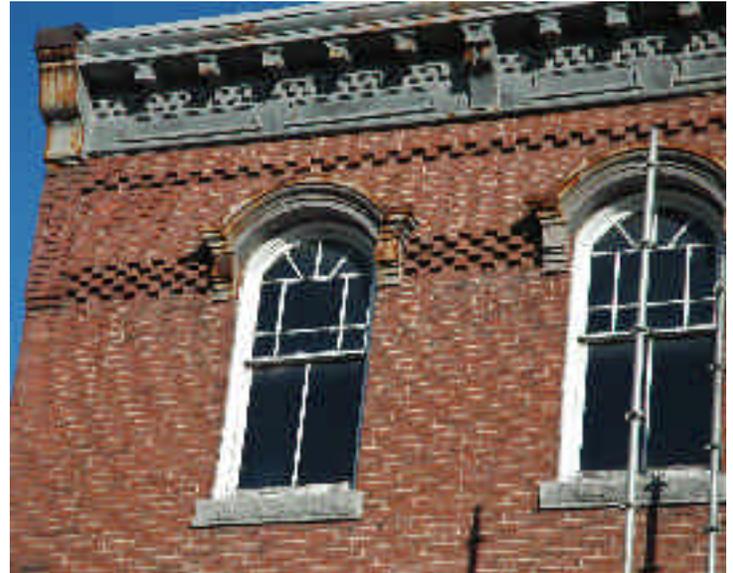
This property is currently under construction. Conditions relating to evaluative criteria are to be determined. Harbor side facade requires significant upgrades in fenestration to transform it to a primary commercial storefront facade.

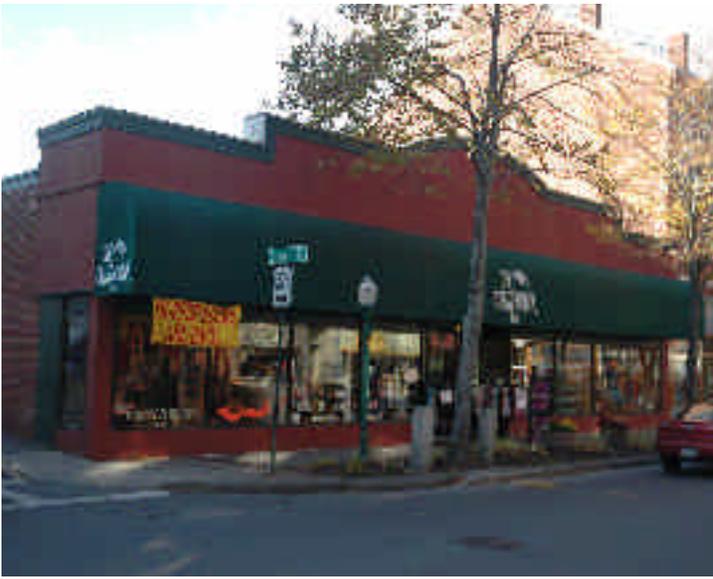
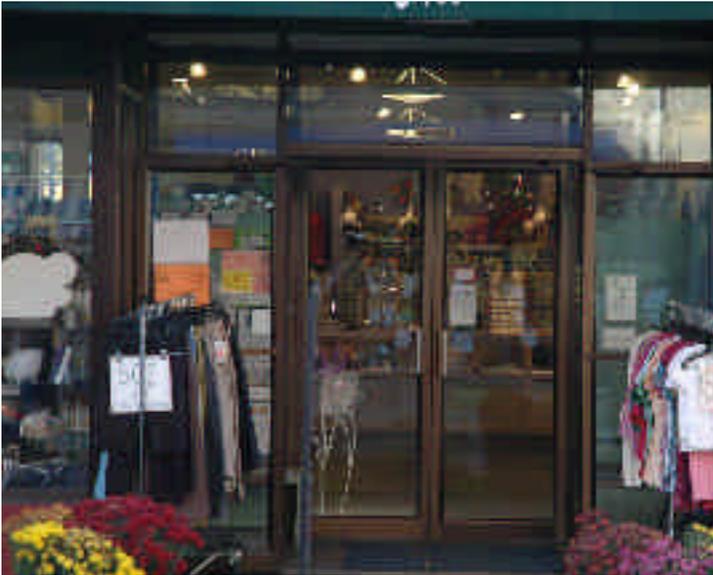
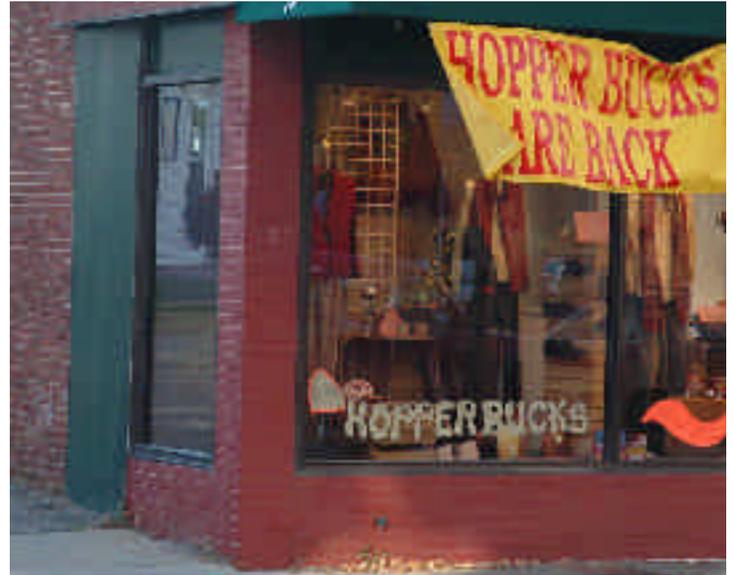
Most aspects of this property are in good condition with exception of excessive signage in the form of banners added to the large quantity of permanent awning signs.

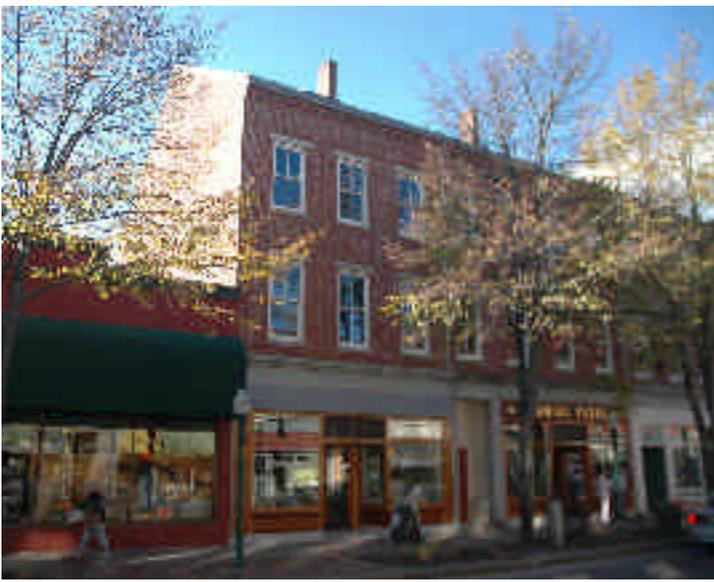
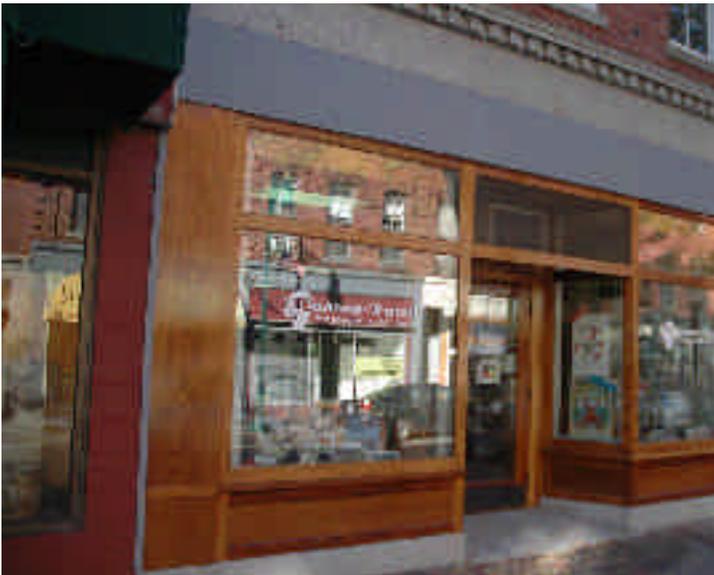
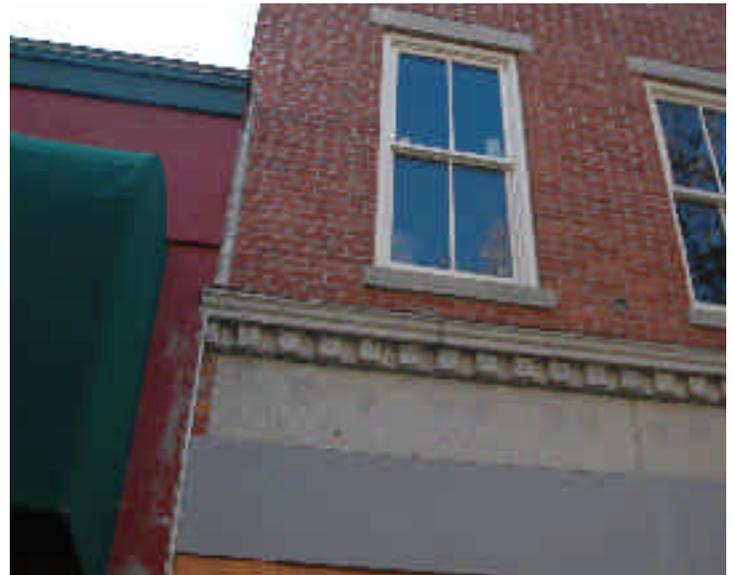
All aspects of this building are in good condition with the exception of small signage applied to the storefront windows. Aside from a recommendation to add a historically correct hanging sign off the facade, no repair recommendations were identified.

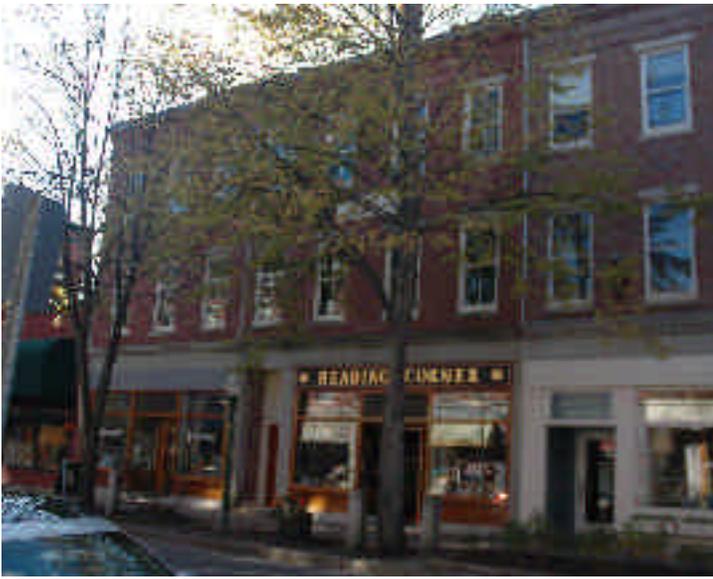
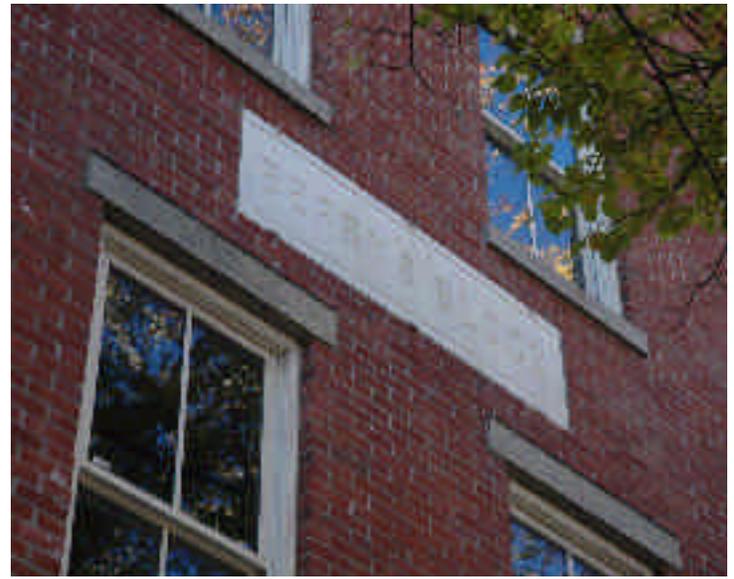
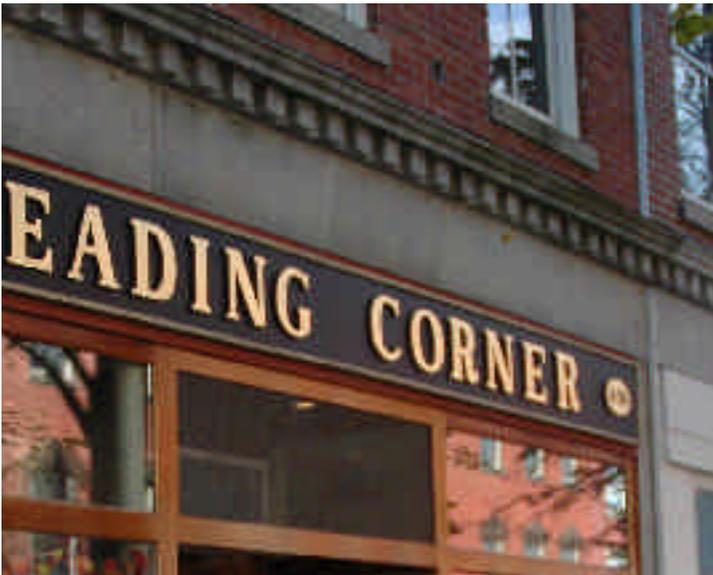
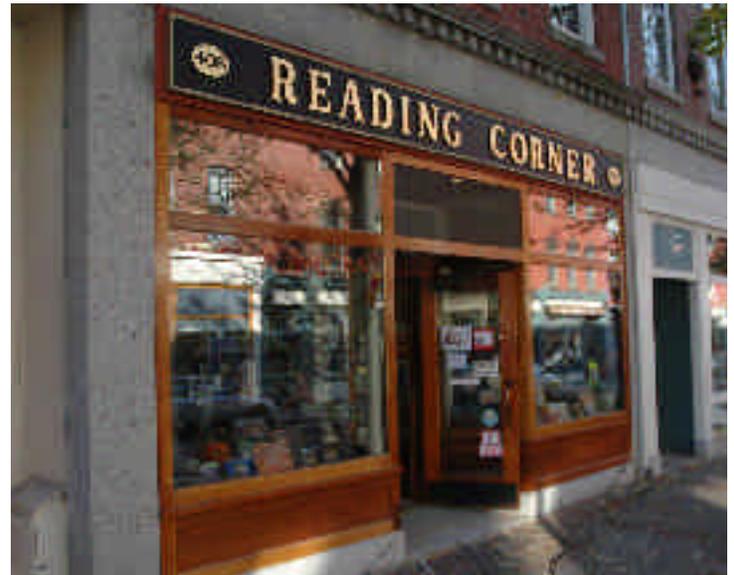
All aspects of this building are in good condition. No repair recommendations were identified.

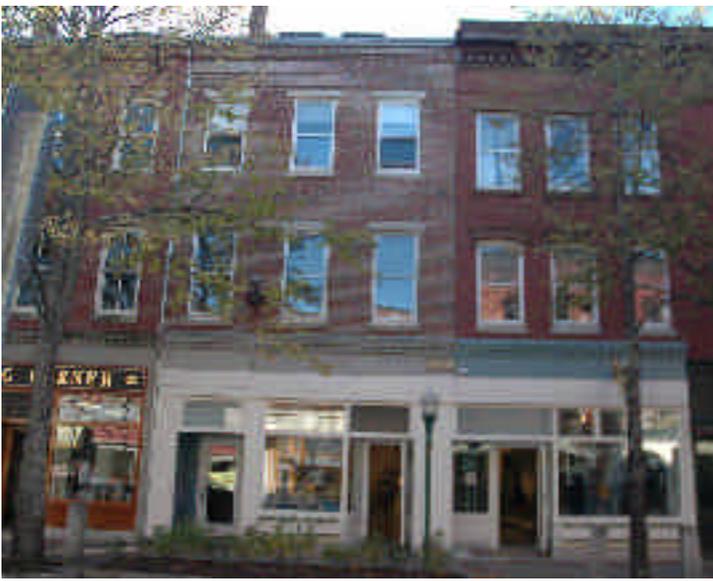
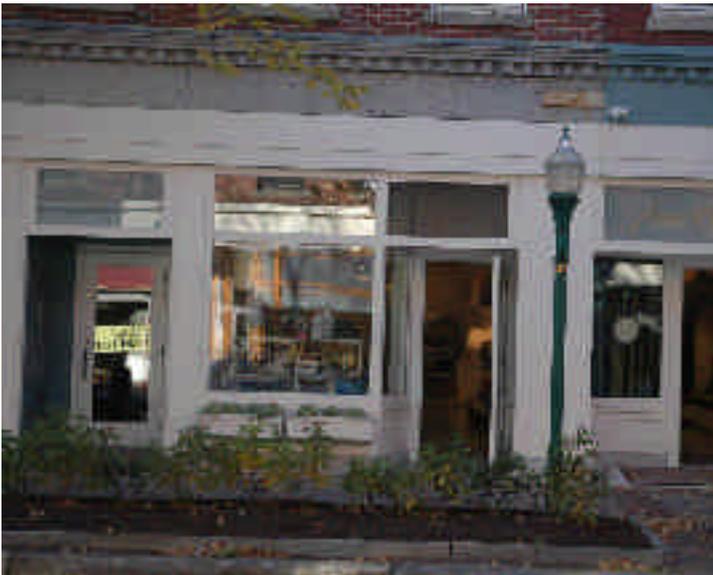
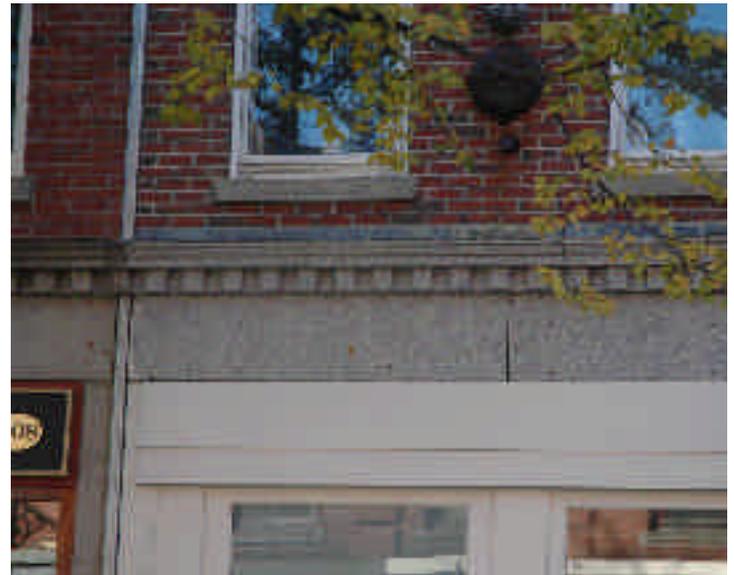
Most aspects of this property are in good condition with exception of inadequate signage applied directly to the storefront windows, poor paint condition on upper window trim, and potential wood cornice trim. It is unclear whether the wood cornice trim belongs to property 420 or 410. If it belongs to 410, the recommendation is that they should be replaced with historically appropriate restoration. Signage should be improved. Window trim should be repainted.

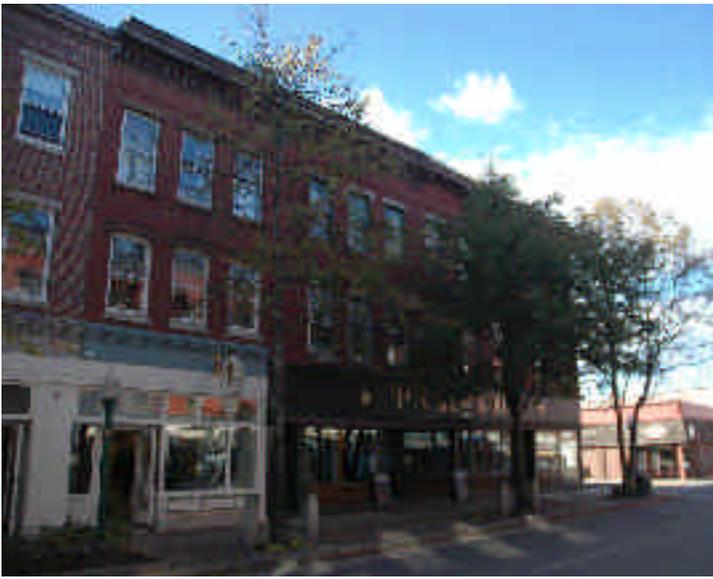
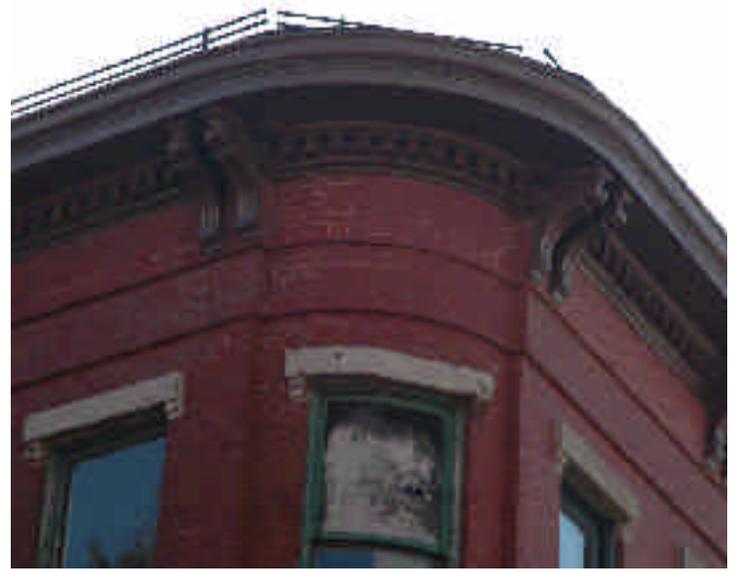
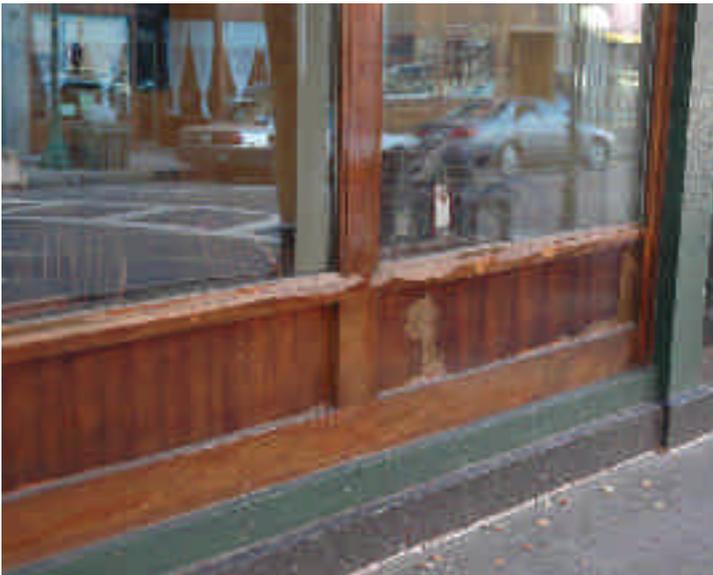
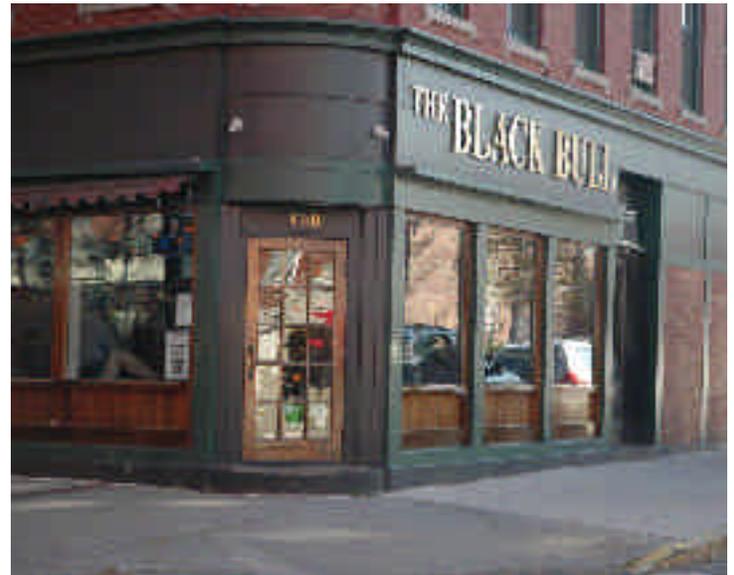
Many aspects of this property are in poor condition including: poor paint and brick condition throughout the facades and poor awning condition. Street level woodwork requires scraping and new clear finish. Paint on upper window trim and cast concrete sills / lintels require extensive scraping, prep, and new paint. Portions of cornice on the south end are in terrible condition. If that portion is owned by property 420, they should be replaced with historically appropriate restoration. Brick on upper floors require pointing in several areas. The awning facing Main Street was rolled up at the time of inspection but appears to be in poor condition. If this is the case, the recommendation is to replace it.

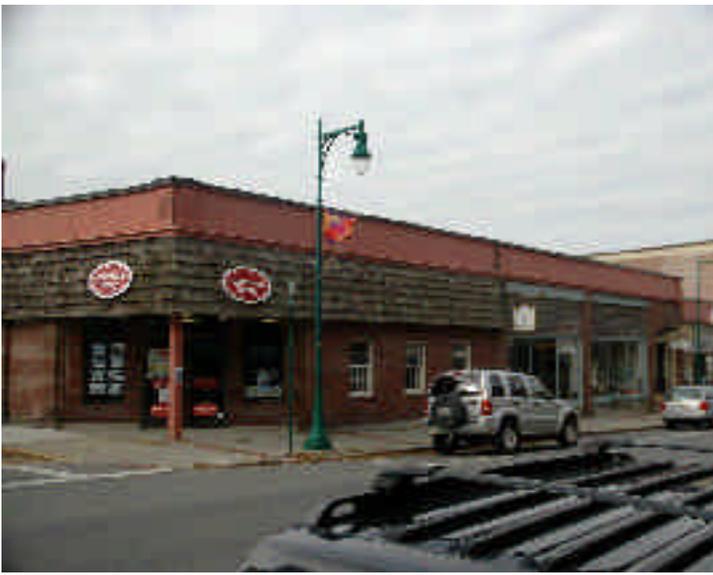
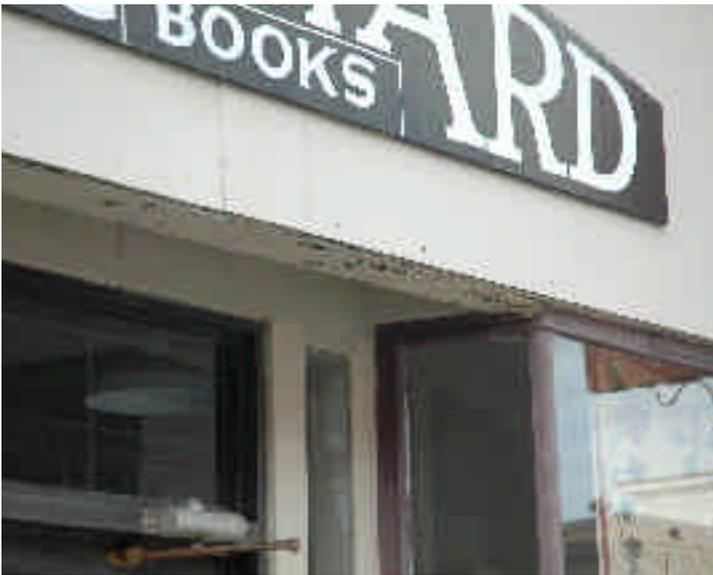
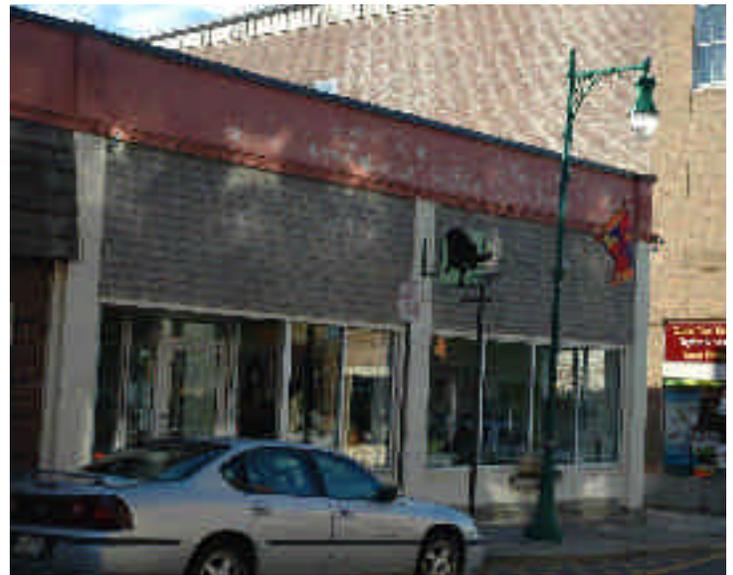
Many aspects of this property are in poor condition including: inconsistent signage across multiple storefronts, unsightly awning bump outs, poor paint condition, poor awning condition, and poor upper facade / cornice conditions. Shingled bump outs should be removed to provide a consistent facade surface. Signage should be reconfigured to fit into each facade bay over doorways in a consistent way. Paint on facade, at enties, and cornice areas should be scraped and painted.

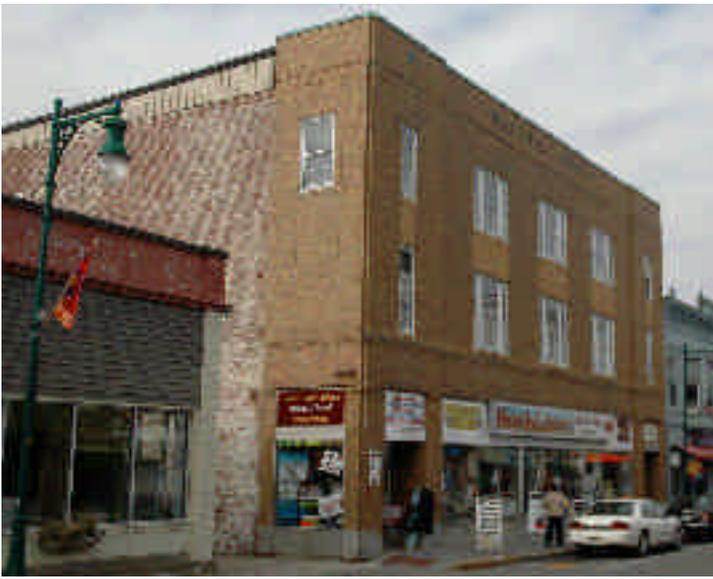
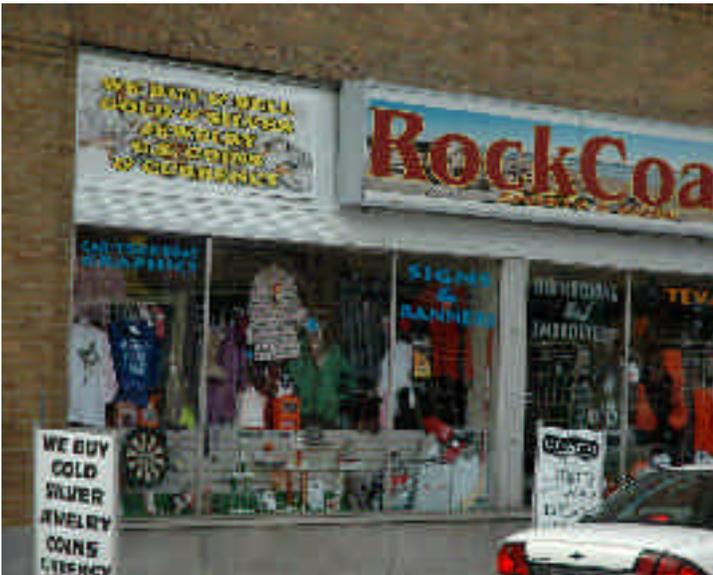
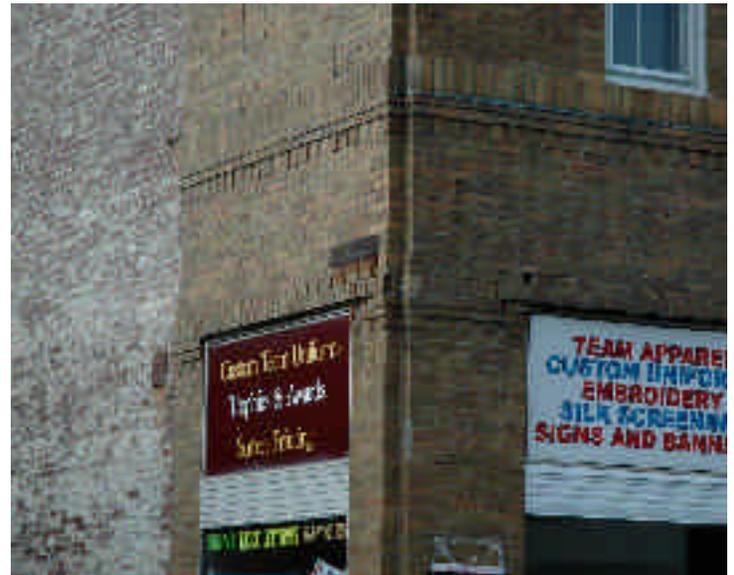
Several aspects of this property are in poor or unsatisfactory condition including: excessive signage, poor condition of storefront window frames and metal panels as well as poor condition of upper window frames and bricks. Facade signage is not in keeping with the historic character of both the building and the street and should be modified in the near future. Storefront system includes aluminum frames that require replacement or improvement and metal panels that interrupt the original portions of the facade. The metal panels should be removed and replaced with insulated glazing or spandrel glass. Upper floor window trim paint is in poor condition and new paint should be applied. Upper floor brick requires pointing in some locations.
