2009 Downtown Revitalization Plan UPDATE

City of Rockland, Maine

2009 DOWNTOWN REVITALIZATION PLAN UPDATE

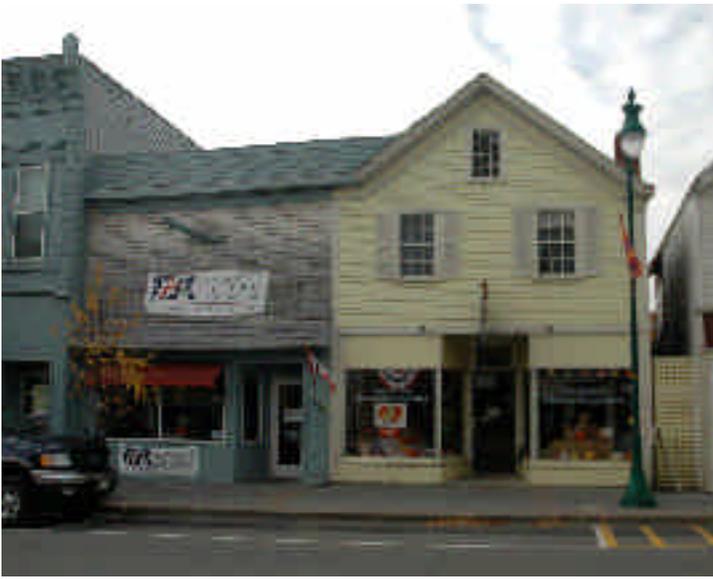
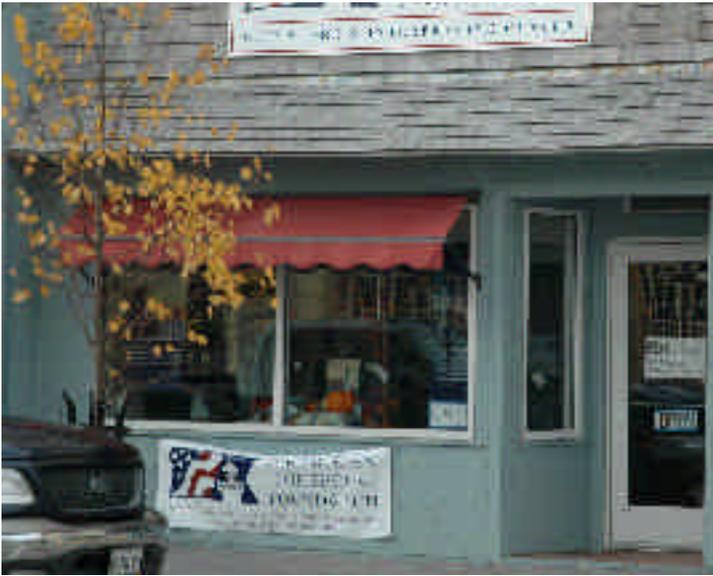
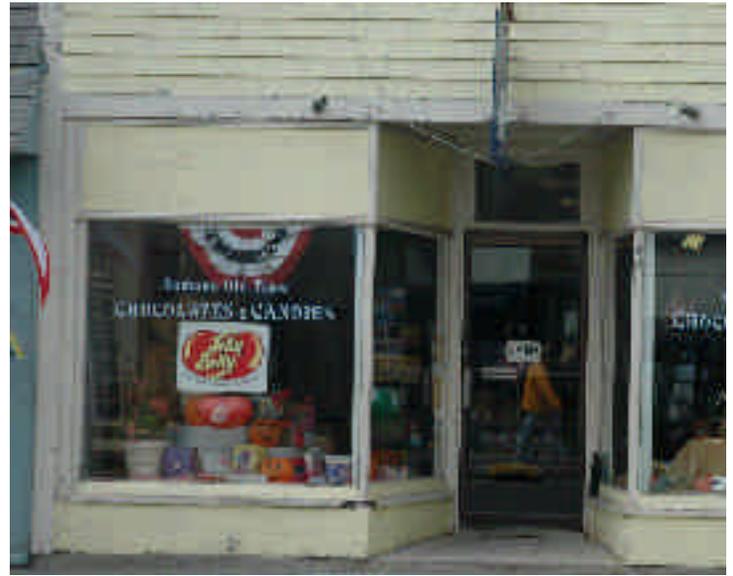
Most aspects of this property are in good condition with exception of excessive signage, poor trim condition at street level, and poor paint condition on upper window trim. Signage is very large yet difficult to read. Relocating a new sign off the facade may be more successful. Trim should be replaced and it is recommended that wood paneling at street level be removed to restore facade to original condition. Wood trim at upper window areas should be scraped and painted.

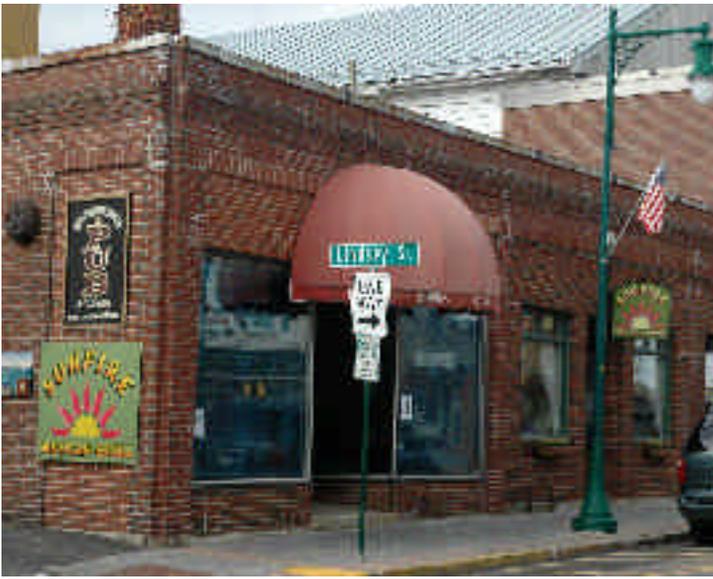
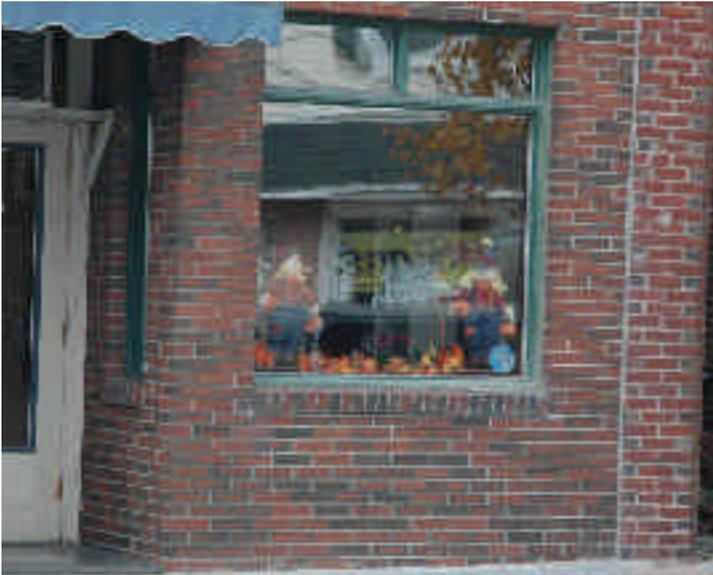
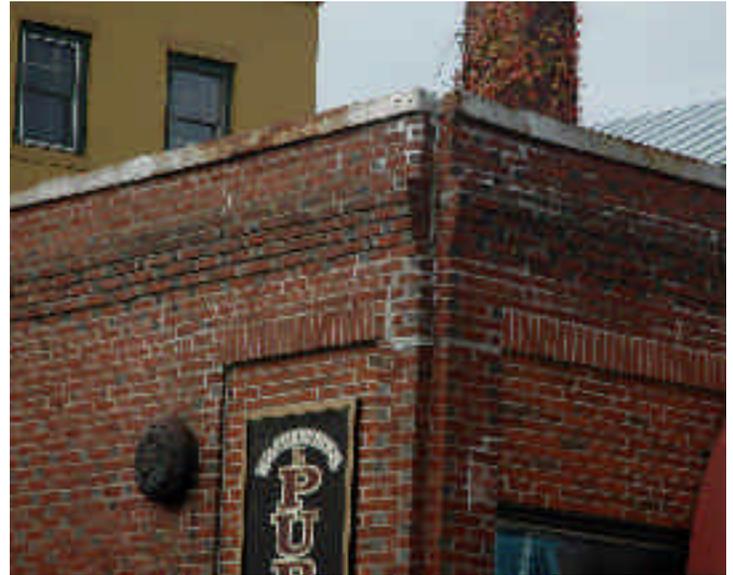
Most aspects of this property are in good condition with exception of poor trim condition at street level, odd infill at upper windows, and poor paint condition at facia. Paint at street level should be touched up. Upper windows appear to have replacement windows that are significantly smaller than the original opening. Existing windows should be replaced with properly sized units to fit the existing window opening. Facia trim is rotten and should be replaced.

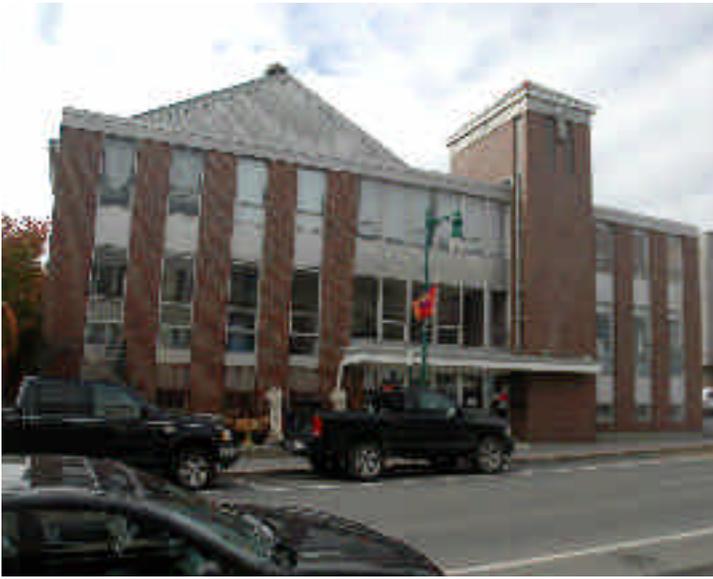
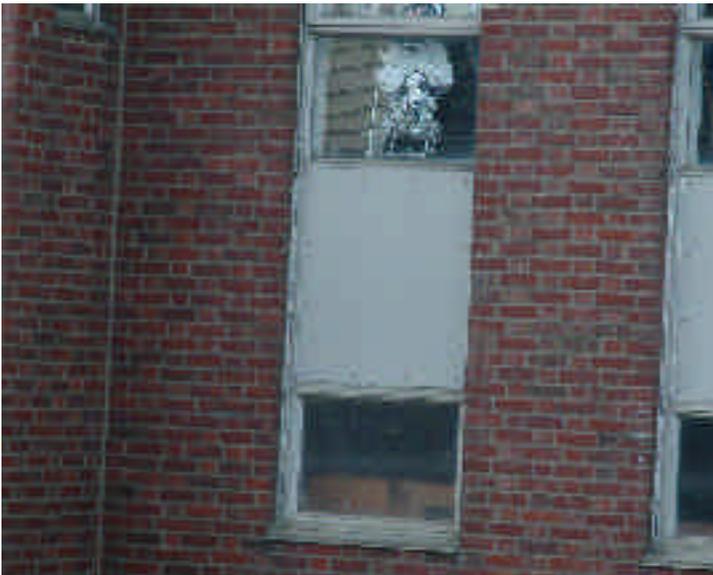
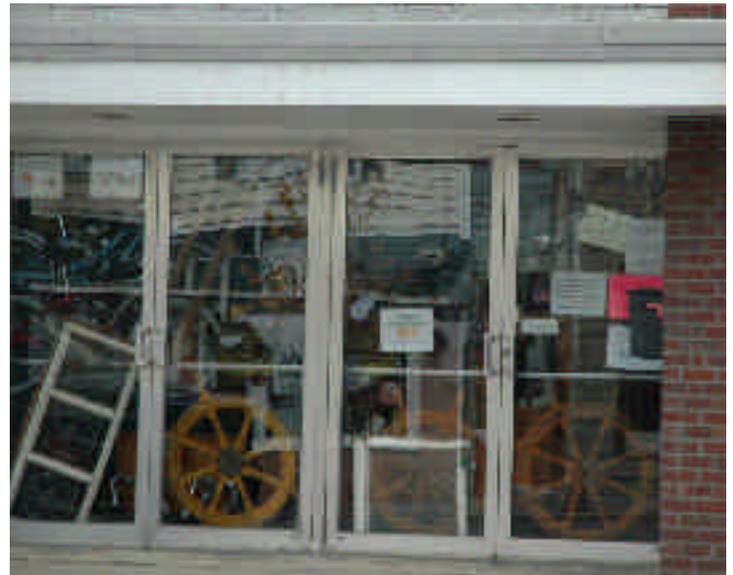
Most aspects of this property are in good condition with exception of poor trim condition at street level, odd infill at upper windows, and poor paint condition at facia. Paint at street level should be touched up. Upper windows appear to have replacement windows that are significantly smaller than the original opening. Existing windows should be replaced with properly sized units to fit the existing window opening. Facia trim is rotten and should be replaced.

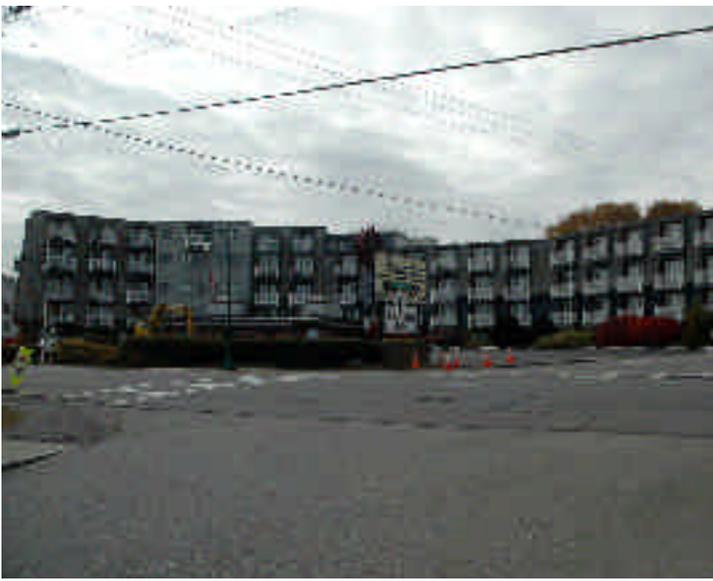
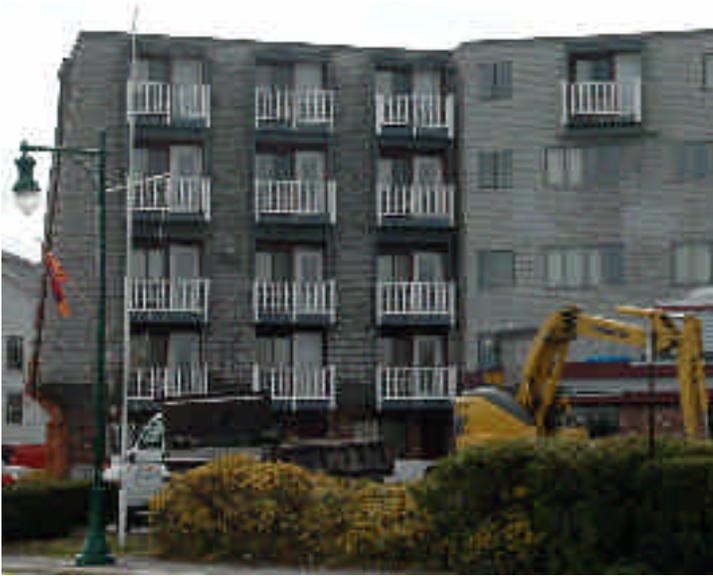
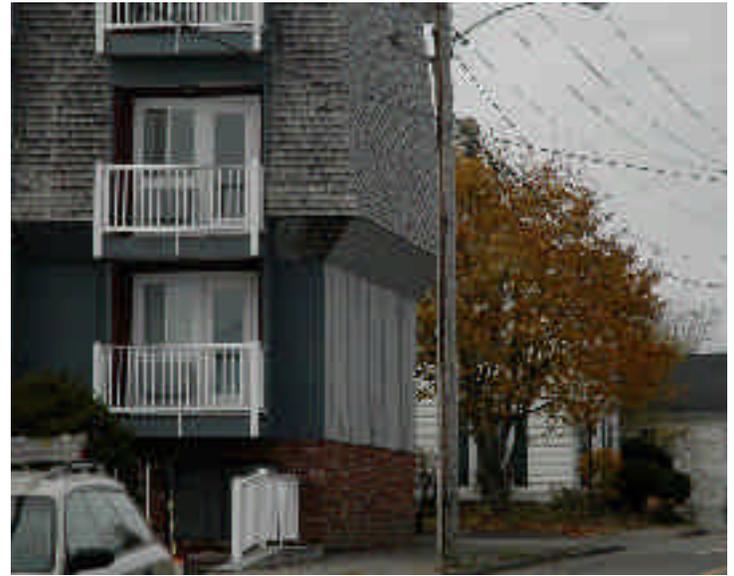
Several aspects of this property are in poor or unsatisfactory condition including: poor canopy condition, poor condition of storefront doors, window frames and metal panels as well as poor condition of upper window frames and panels. Given the style of this building, it is recommended that the canopy, window, and door systems be restored and/or updated rather than removing them.

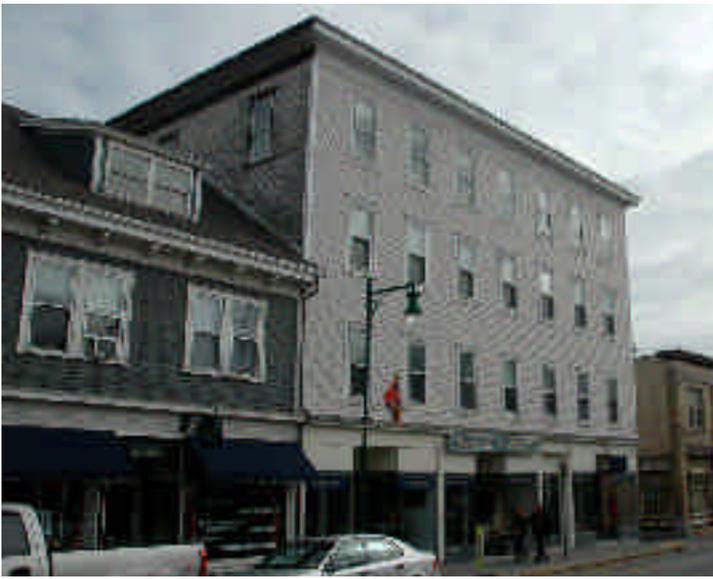
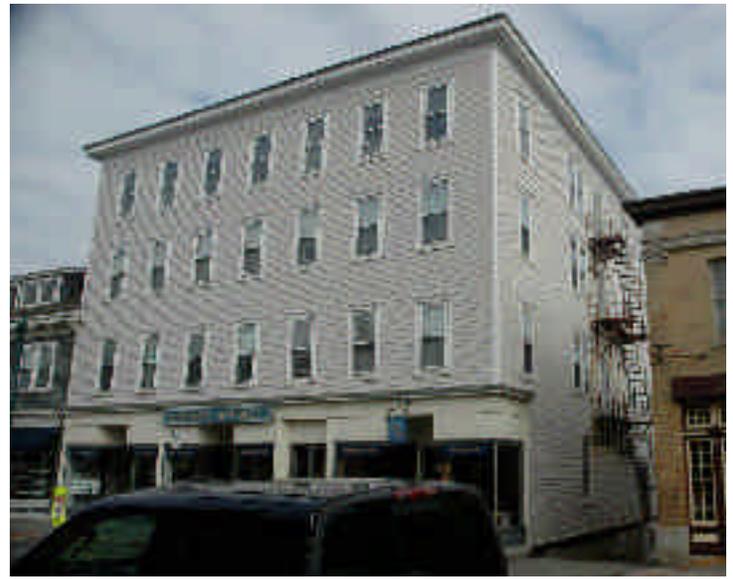
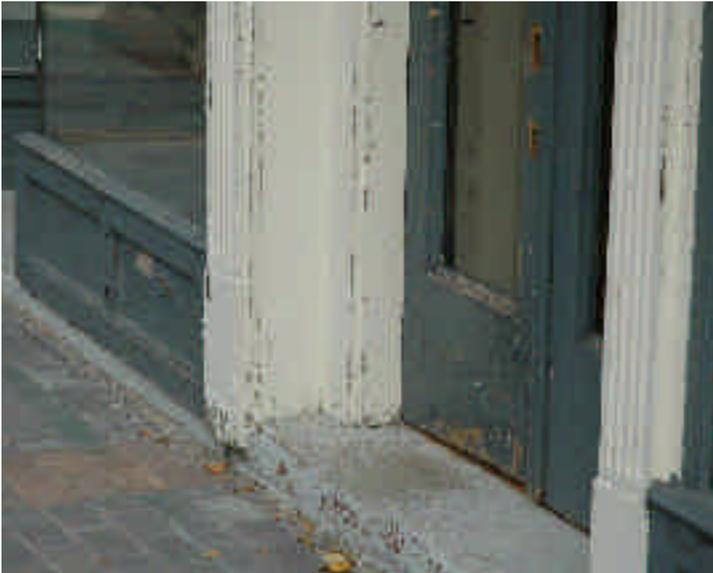
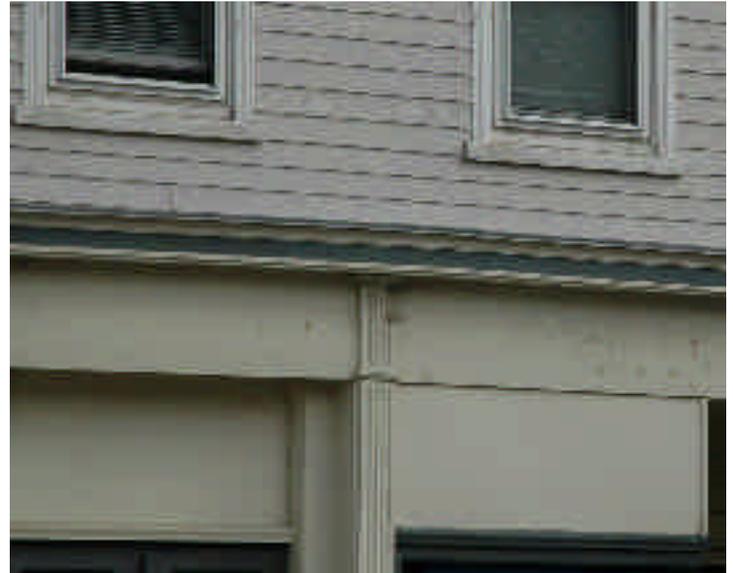
Most aspects of this property are in fair or good condition with exception of poor sign condition and poor condition of upper level windows. The storefront is vacant and it is recommended that the new tenant provide a new sign in place of the existing. One existing sign has historical significance, it should be repainted and restored. Upper level windows require repair and restoration and perhaps reglazing.

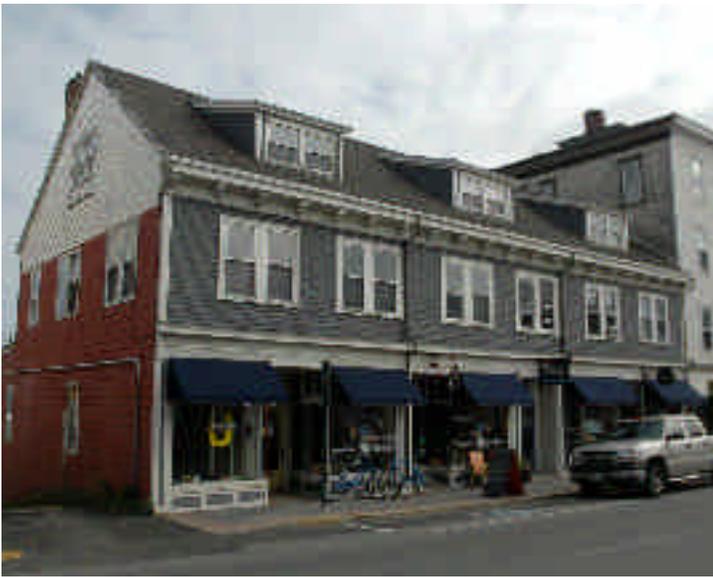
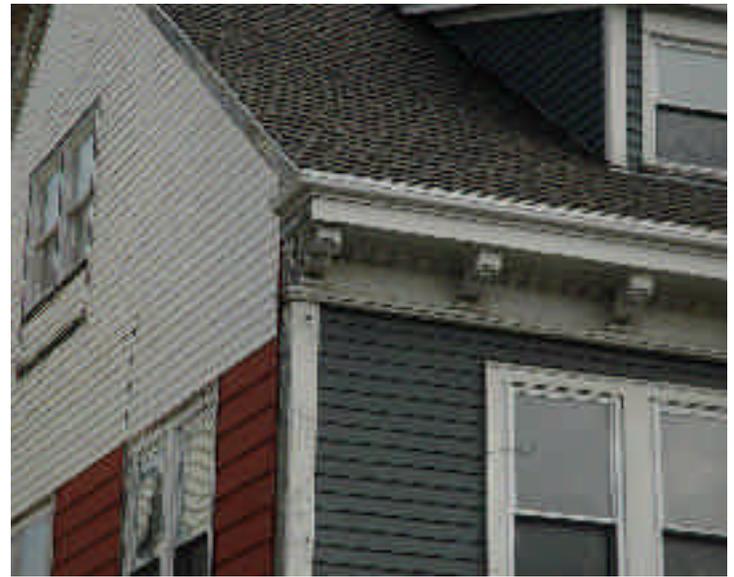
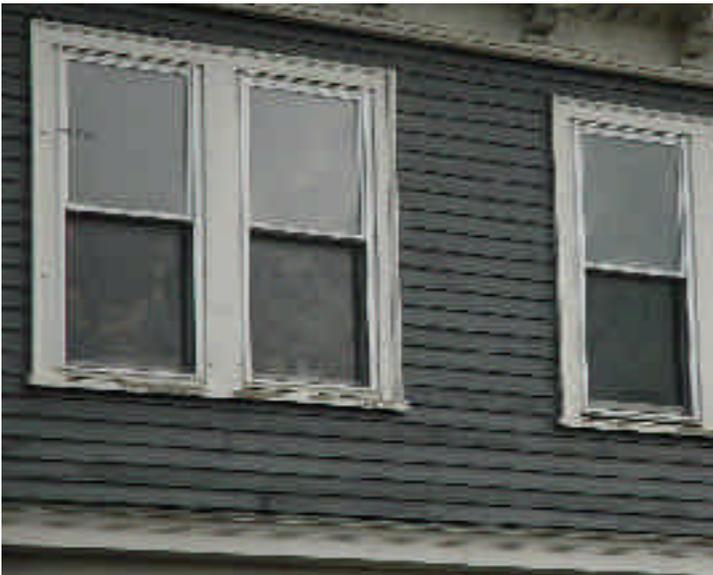
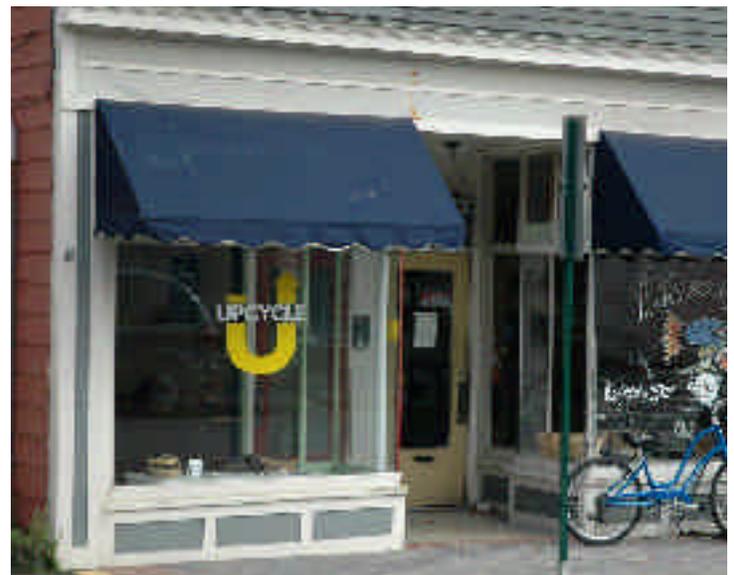
Several aspects of this property are in poor condition including: street level trim, doors, metal window frames, and wood panels as well as upper level window trim. New cement board siding and cornice detailing has been added to the entire building recently. It is recommended that doors and storefront window systems are updated and that wood paneling and trim are repainted.

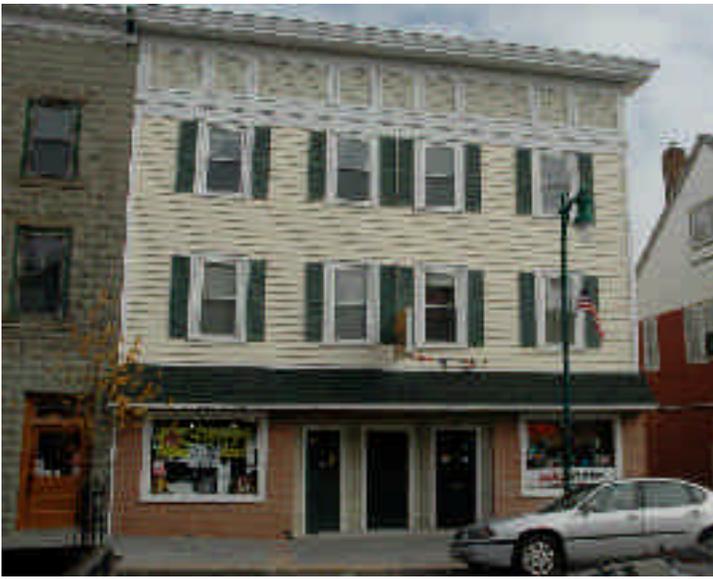
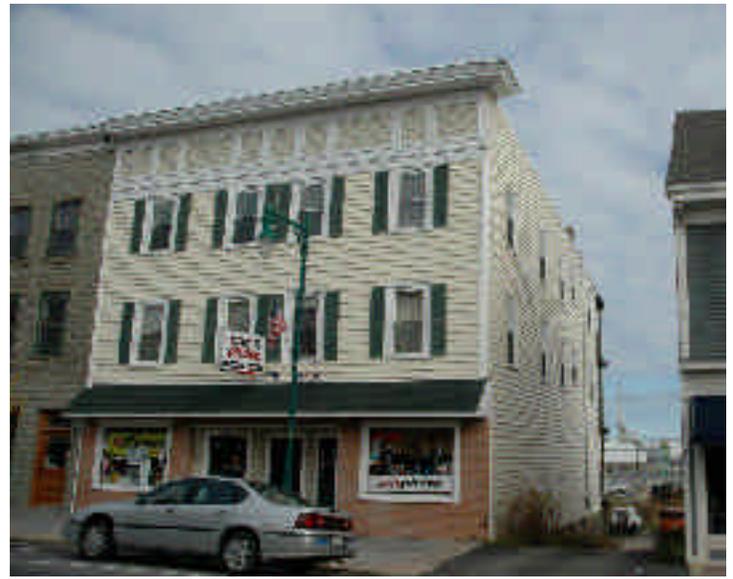
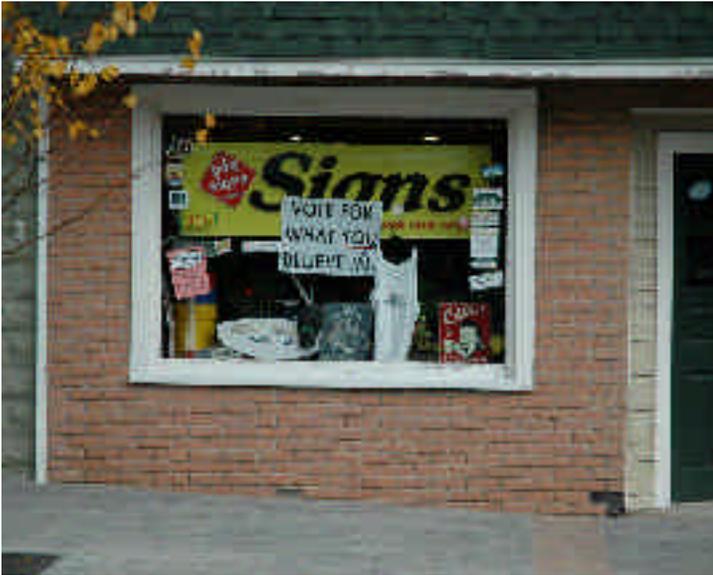
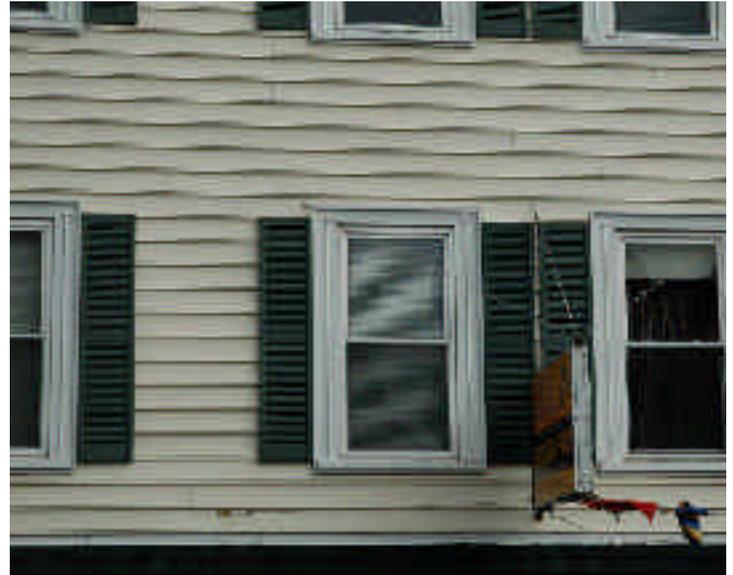
Several aspects of this property are in poor condition including: street level trim, doors, and metal window frames as well as upper level window and eave trim. It is recommended that doors and storefront window systems are updated and that wood paneling and trim are repaired / painted.

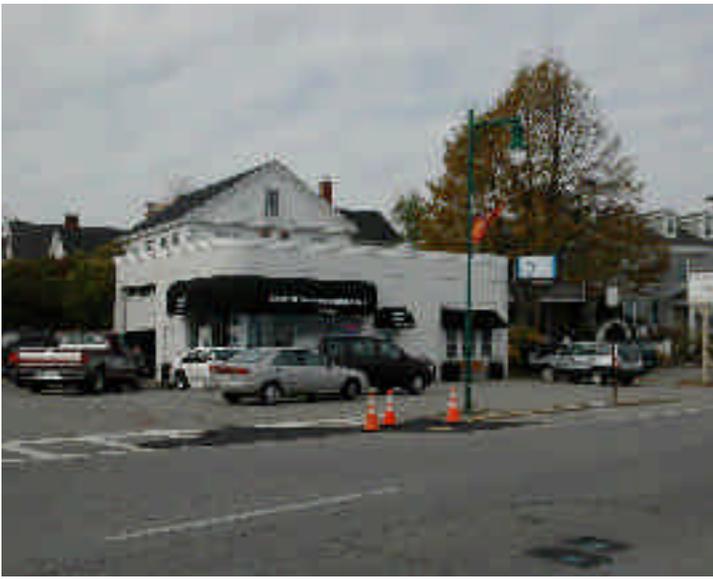
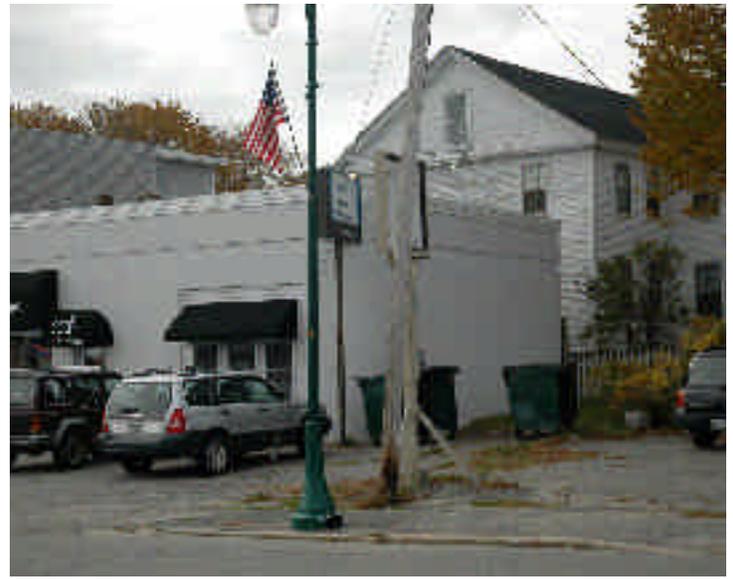
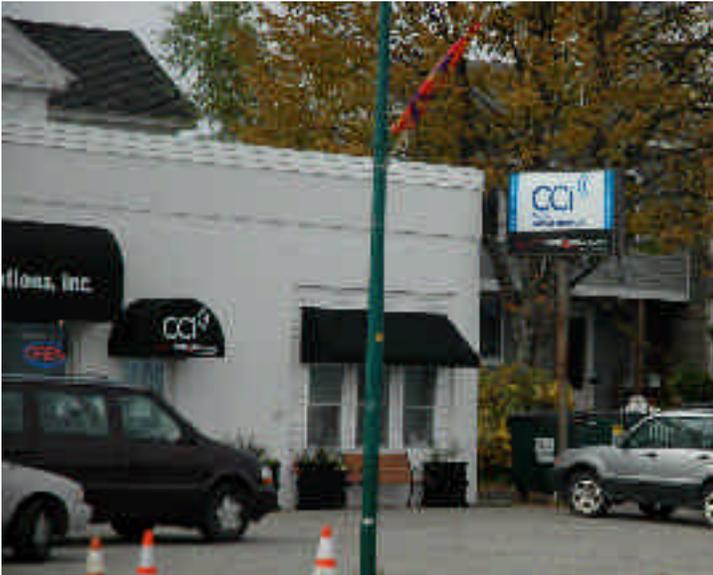
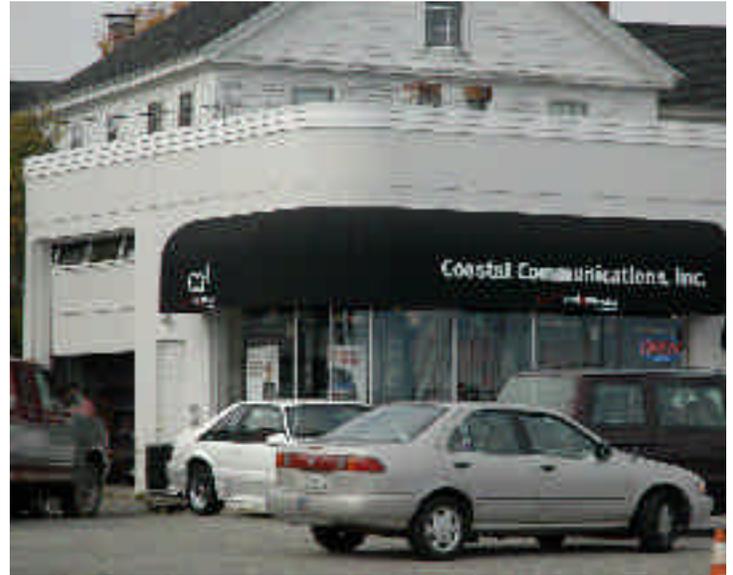
Several aspects of this property are in poor condition including: concrete lintels and lintels, upper window trim, and wood eave / cornices. Damaged sills and lintels should be replaced both for aesthetics and safety from falling debris on the sidewalk. Window trim appears to be in very poor shape and should be replaced with trim matching the existing detail. Eaves should be scraped, assessed, and restored if needed. Noted on the street level were newly painted CMU and new wood entry doors. The Facade CMU appears to be in very good condition but should be assessed due to the poor condition of the sills and lintels.

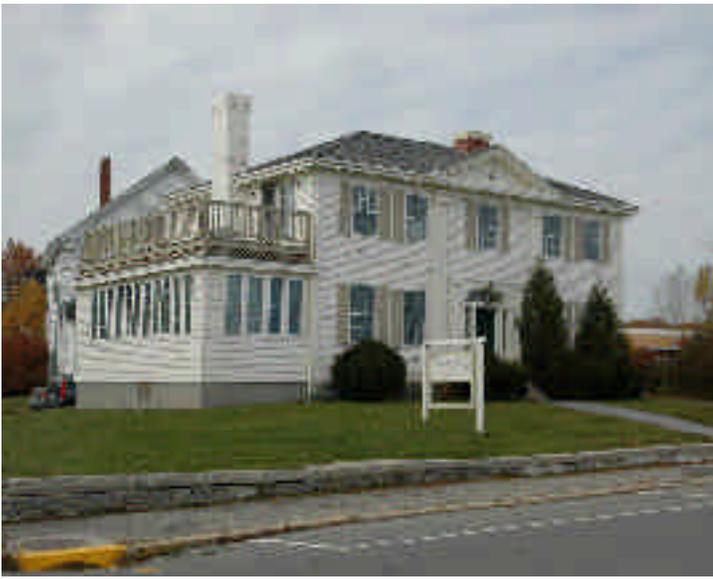
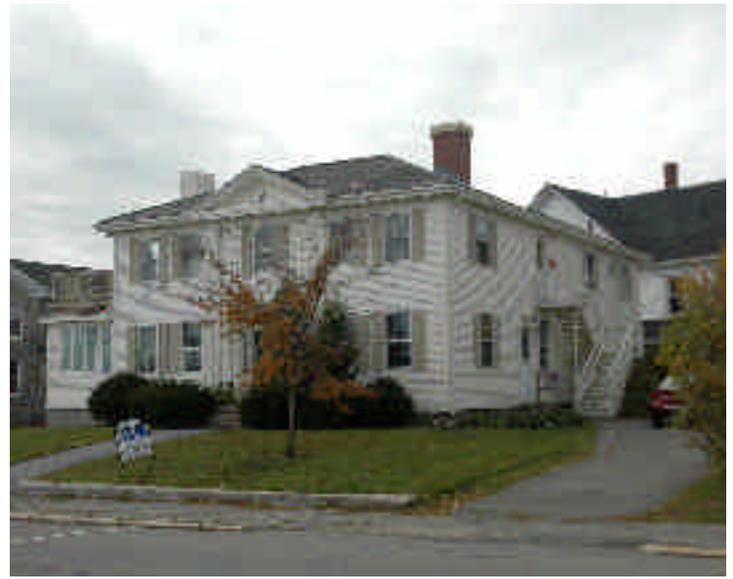
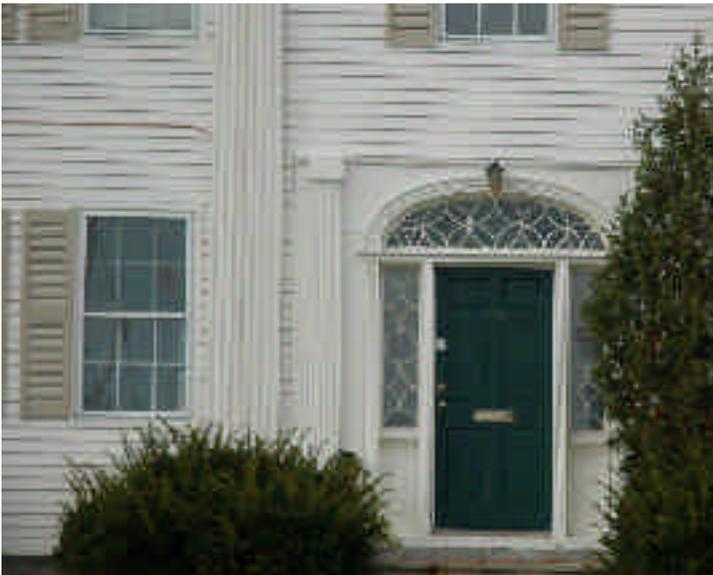
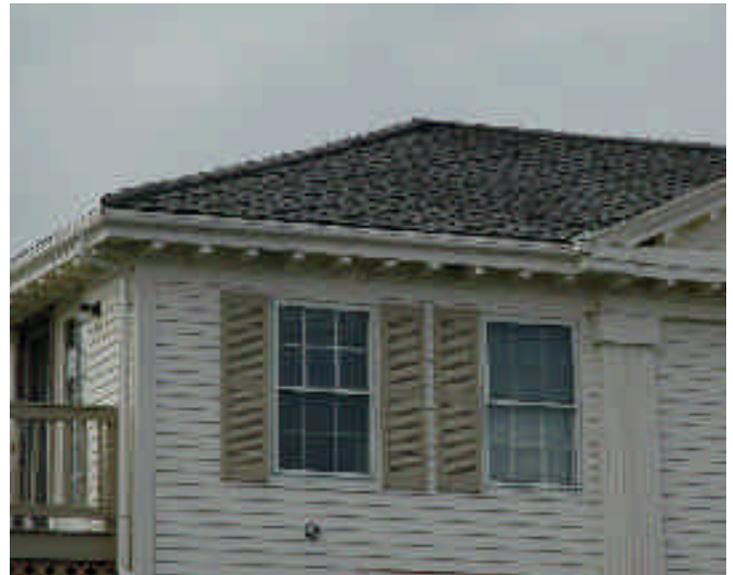
Most aspects of this property are in good condition. No repair recommendations were identified.

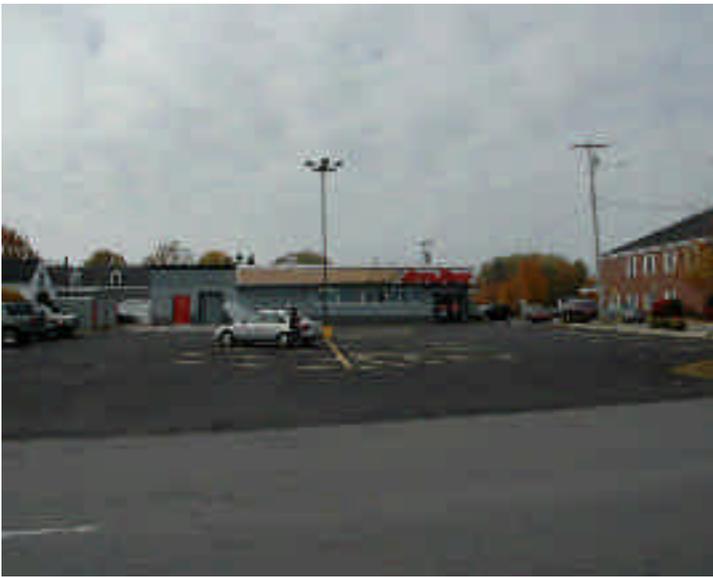
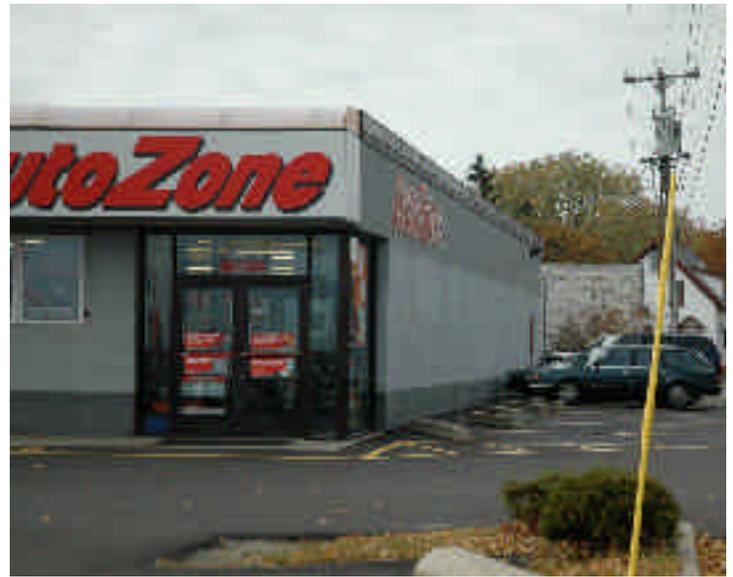
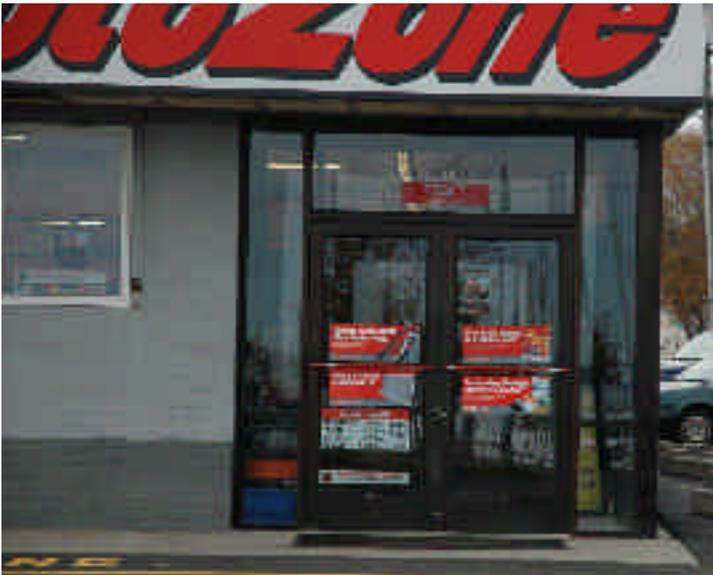
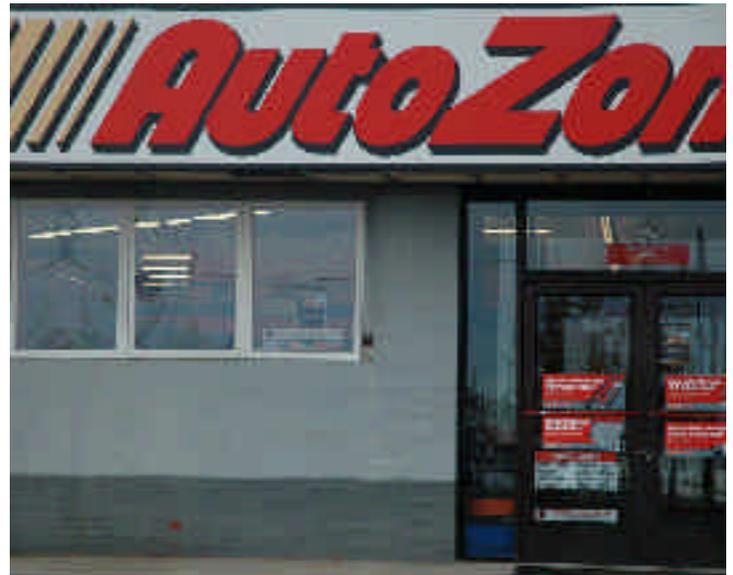
Most aspects of this property are in good condition. No repair recommendations were identified.

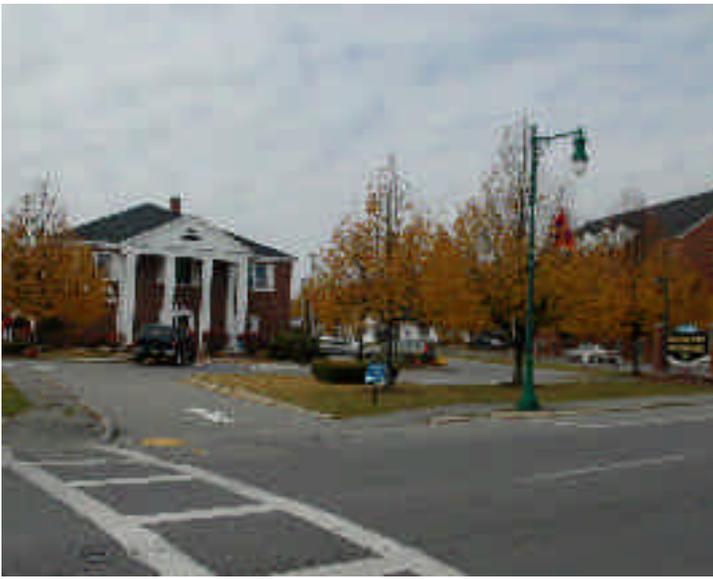
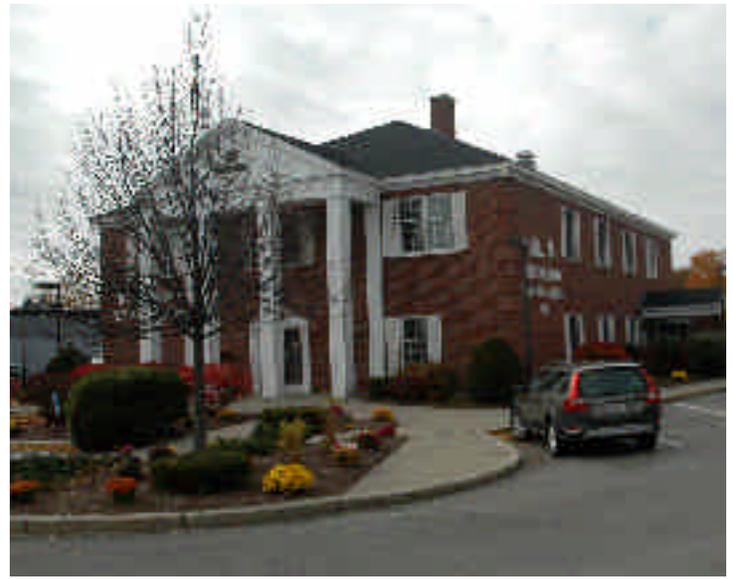
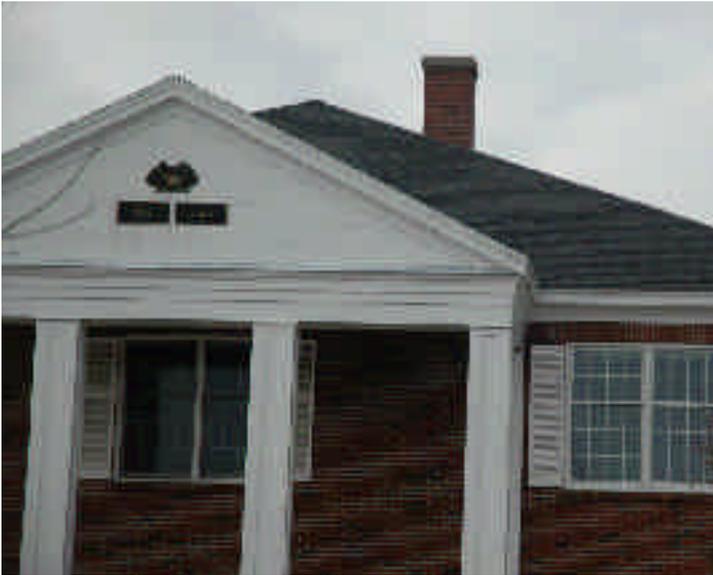
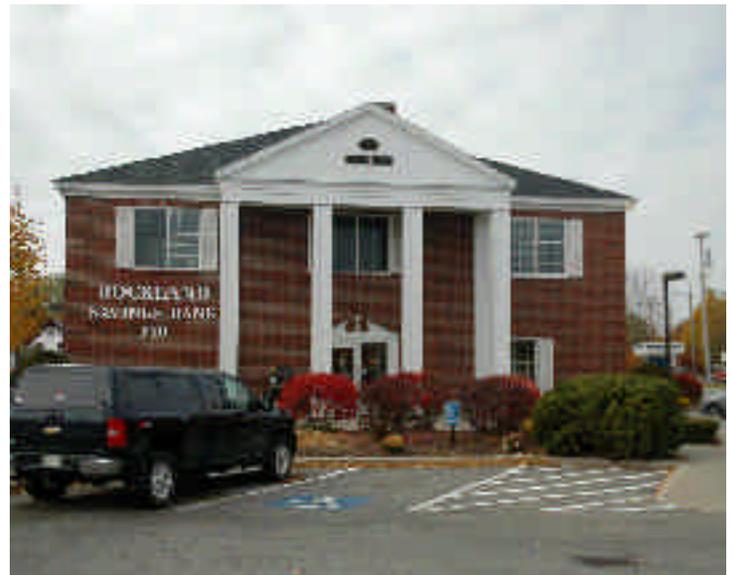
Most aspects of this property are in good condition with exception of excessive signage. Signage is typical of this type of business use but is not in keeping with the historic character of Main Street.

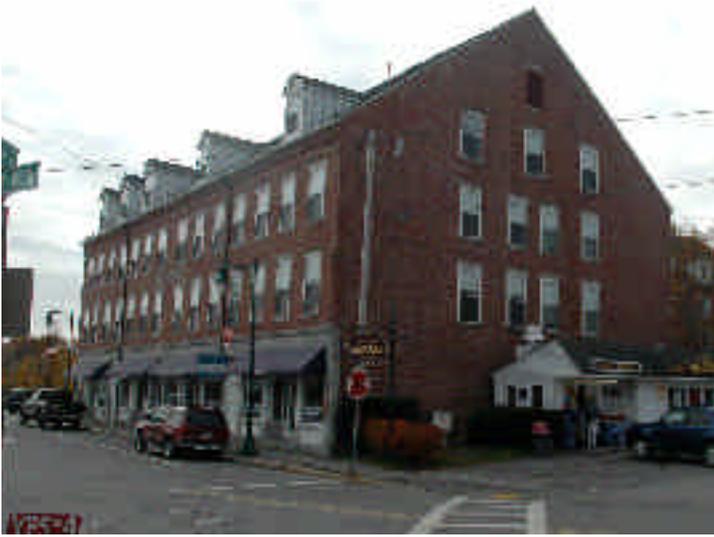
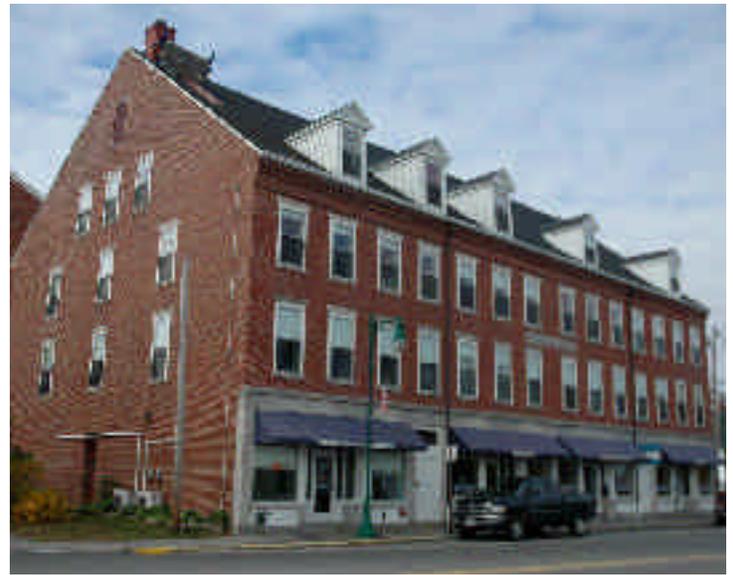
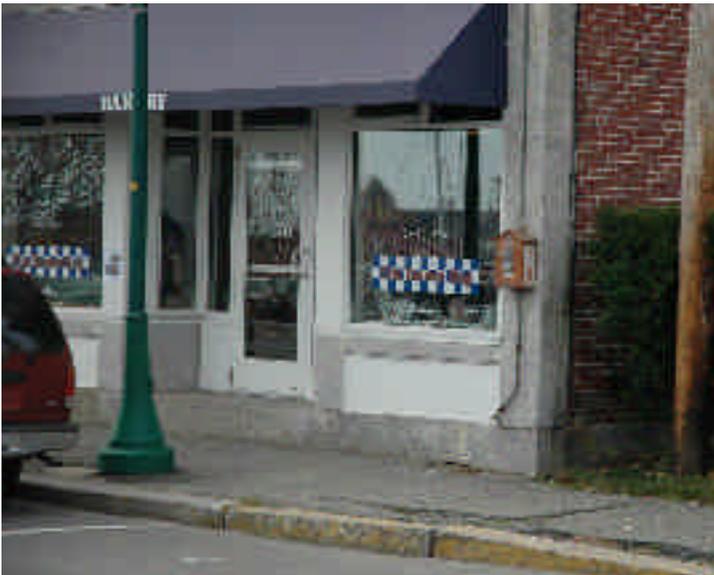
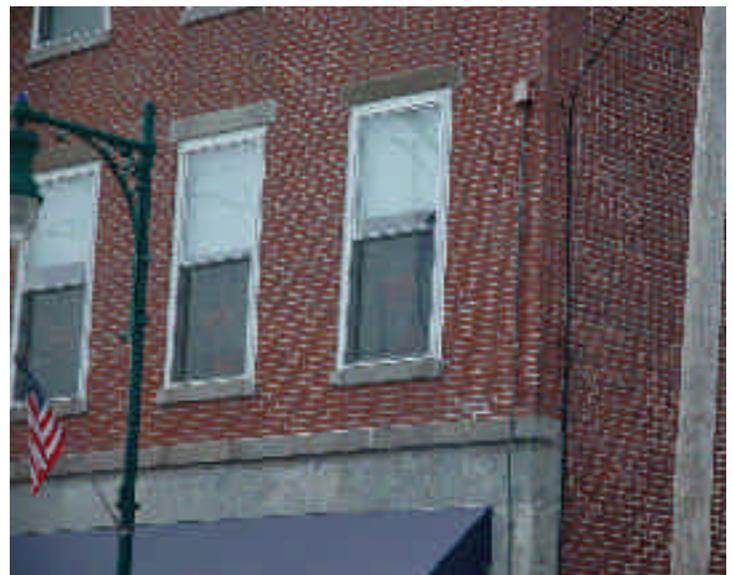
Most aspects of this property are in good condition with exception of excessive signage. Signage is typical of this type of business use but is not in keeping with the historic character of Main Street.

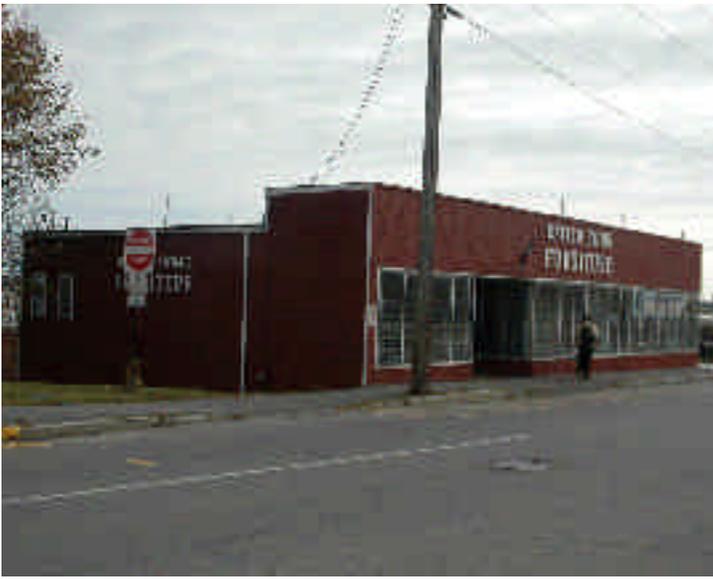
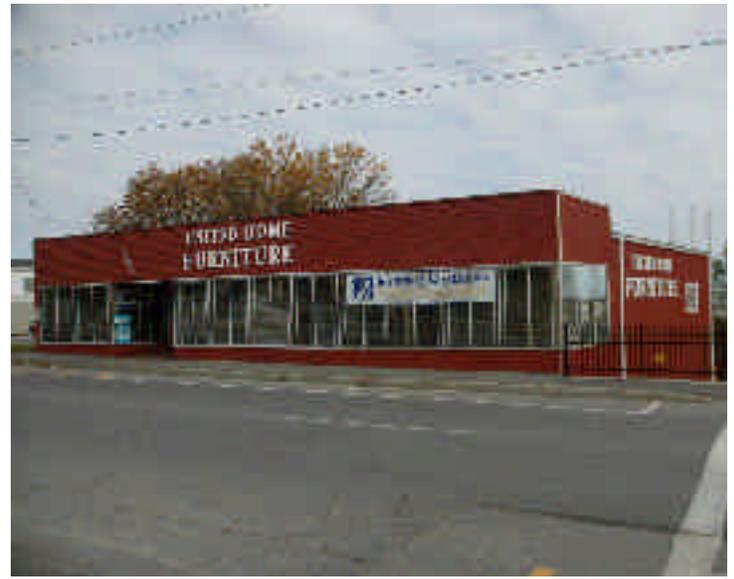
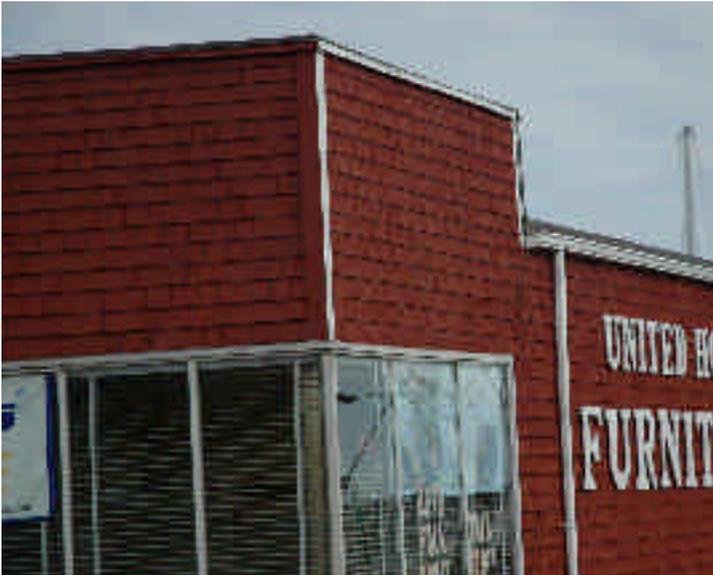
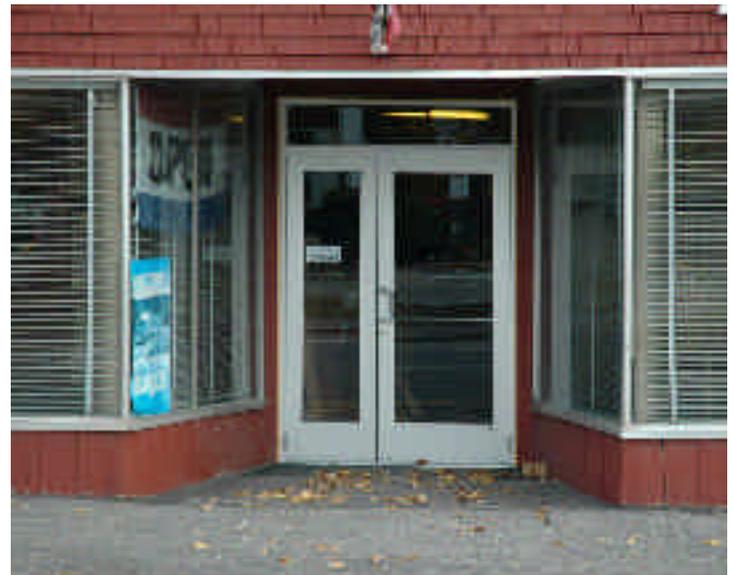
Most aspects of this property are in good condition. No repair recommendations were identified.

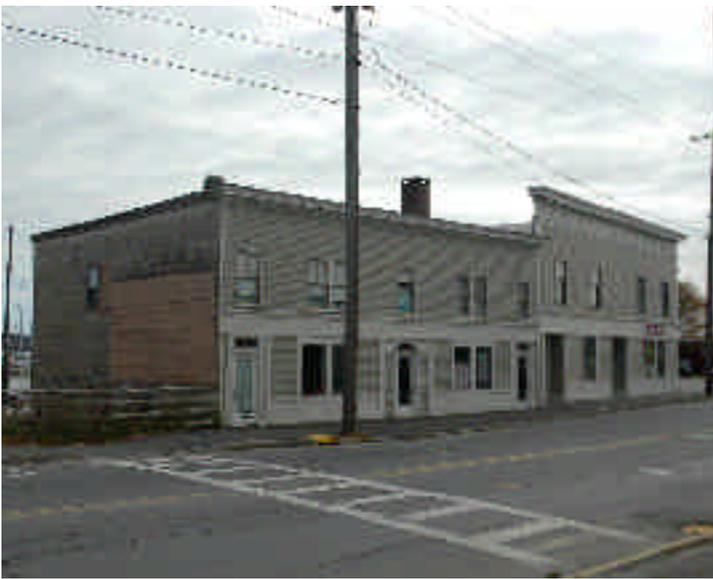
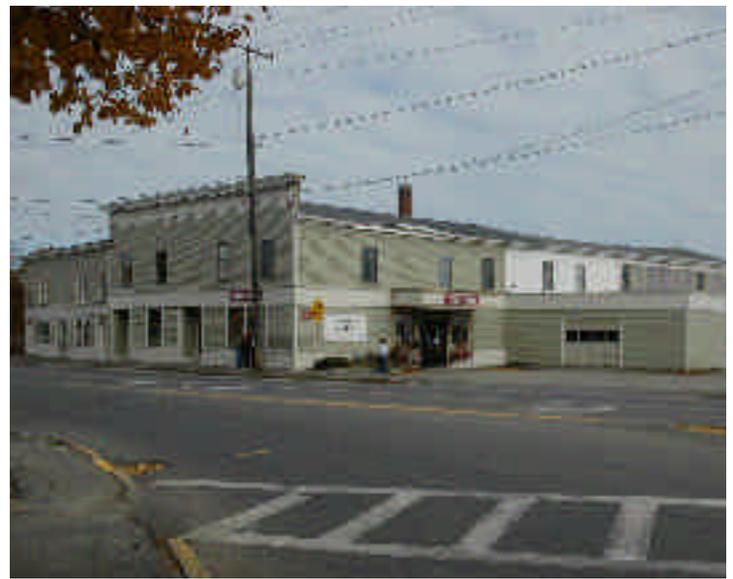
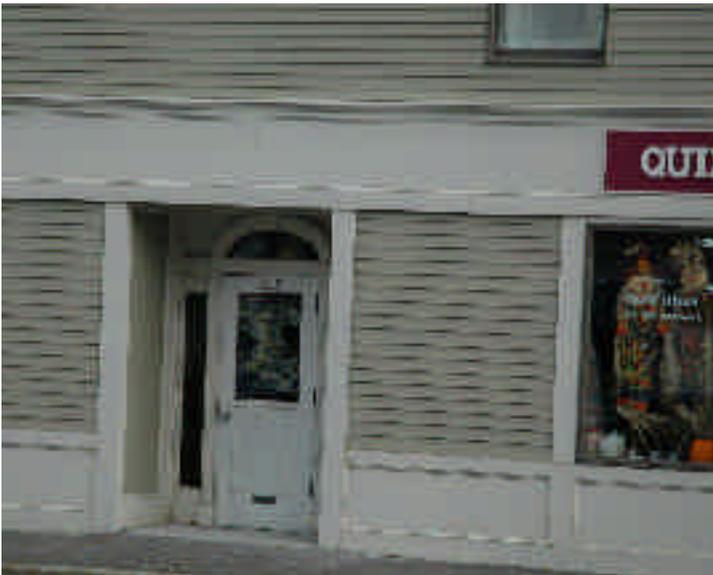
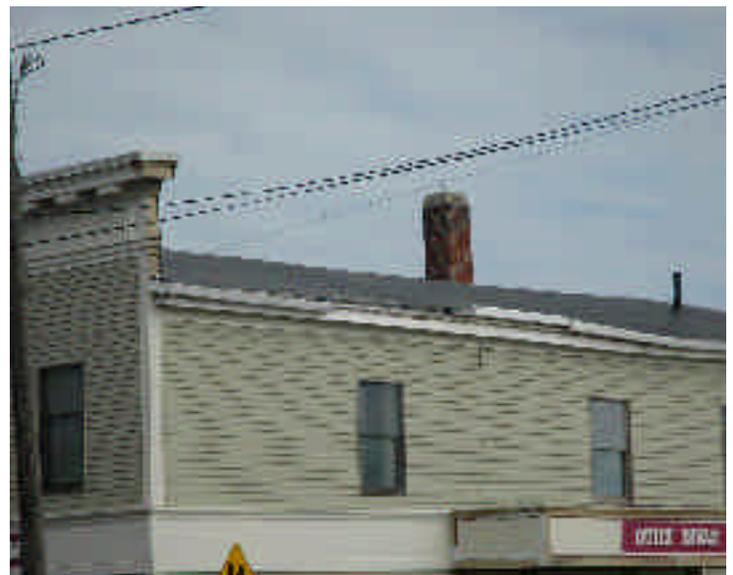
Most aspects of this property are in fair condition with exception of excessive signage. Signage is typical of this type of business use but is not in keeping with the historic character of Main Street.
