2009 Downtown Revitalization Plan UPDATE

City of Rockland, Maine

2009 DOWNTOWN REVITALIZATION PLAN UPDATE

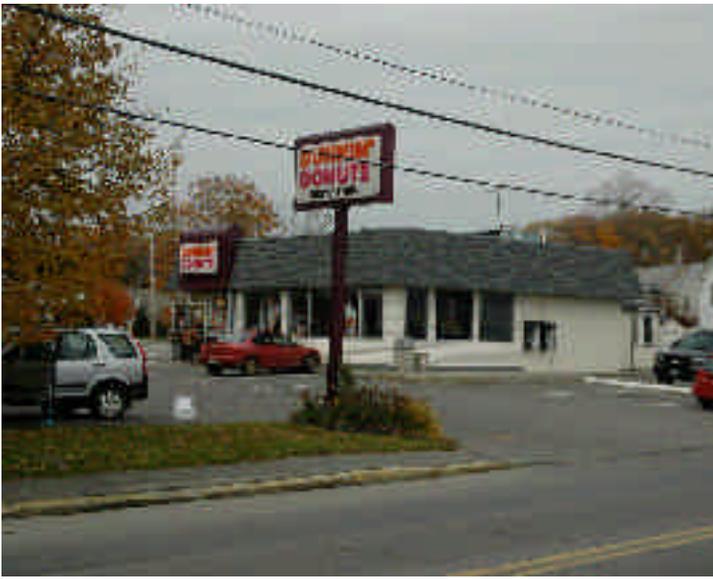
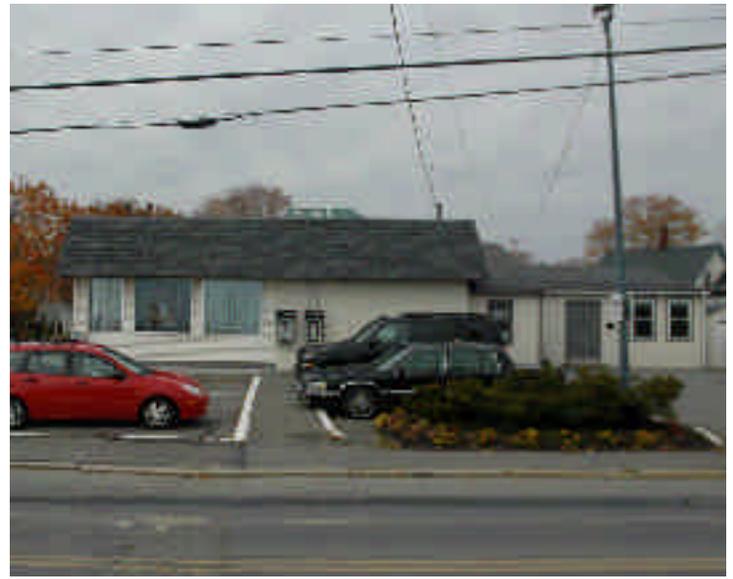
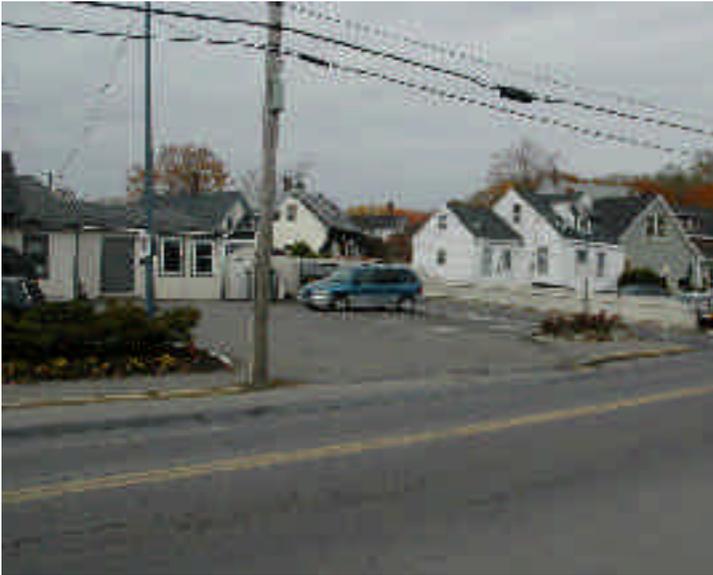
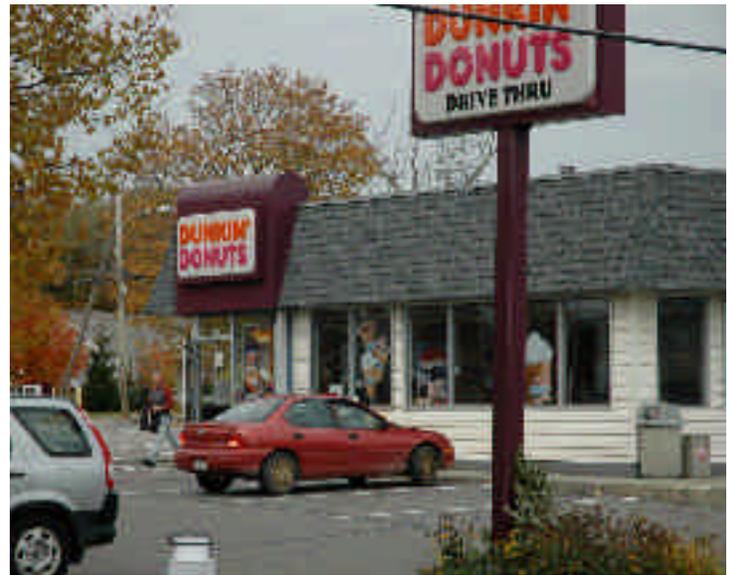
Most aspects of this property are in good condition with exception of poor trim and cornice/roofline conditions. Paint and repair of these areas is recommended.

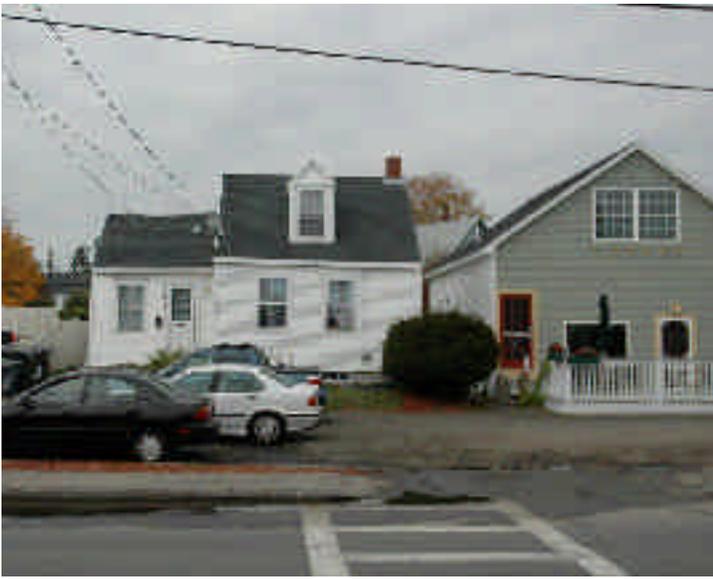
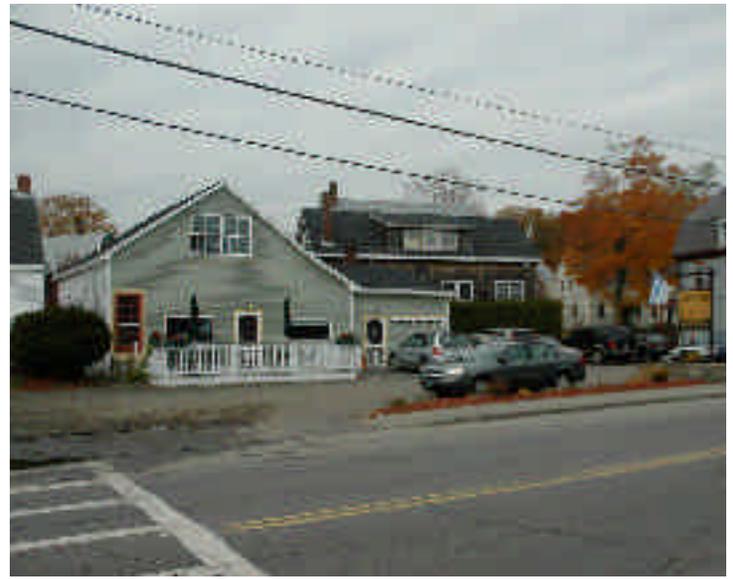
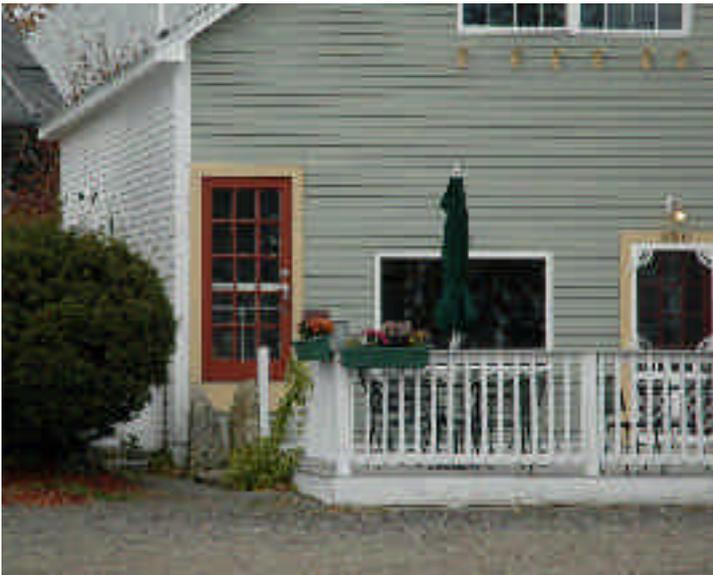
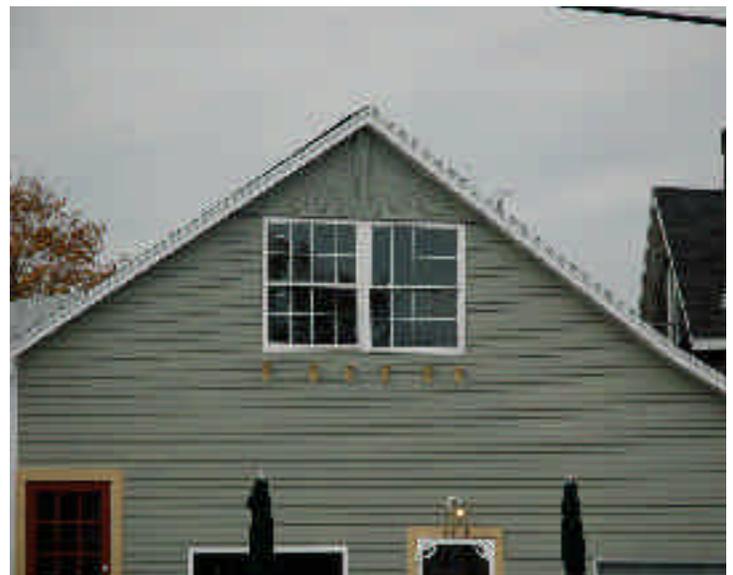
Most aspects of this property are in good condition with exception of excessive signage. Signage is typical of this type of business use but is not in keeping with the historic character of Main Street.

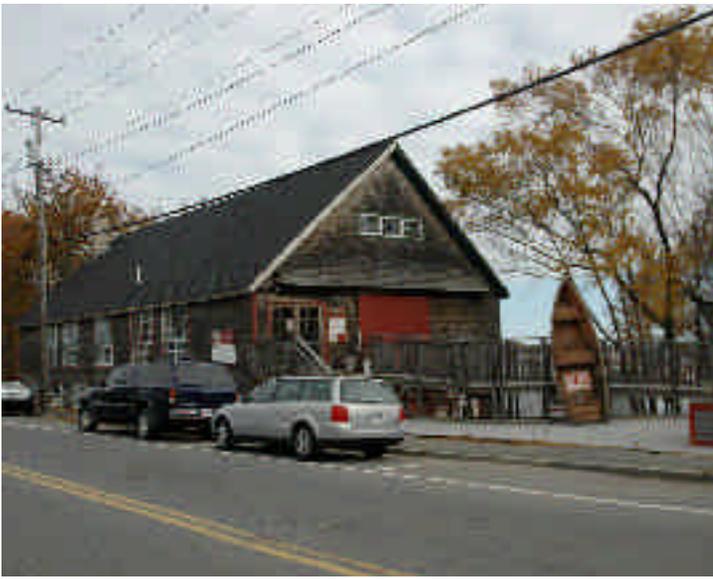
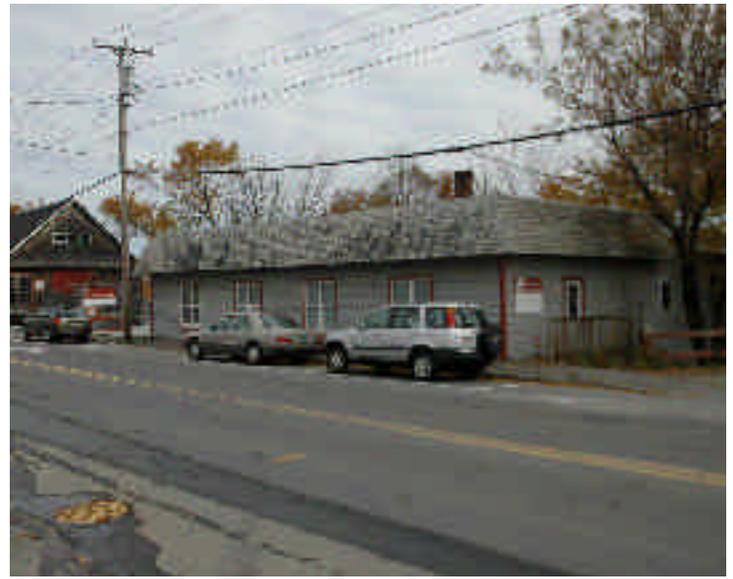
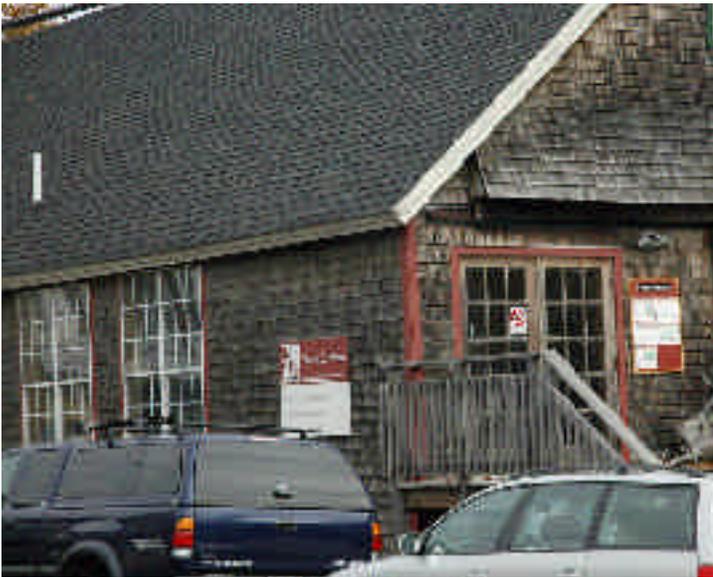
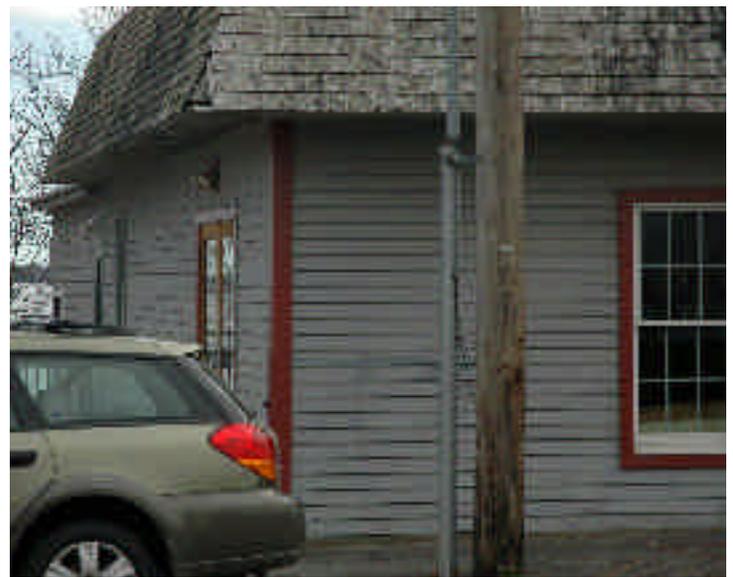
Most aspects of this property are in good condition. No repair recommendations were identified.

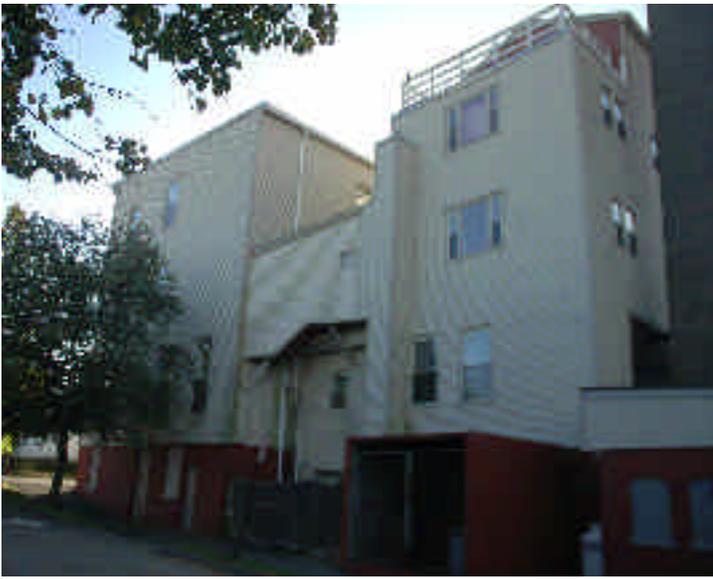
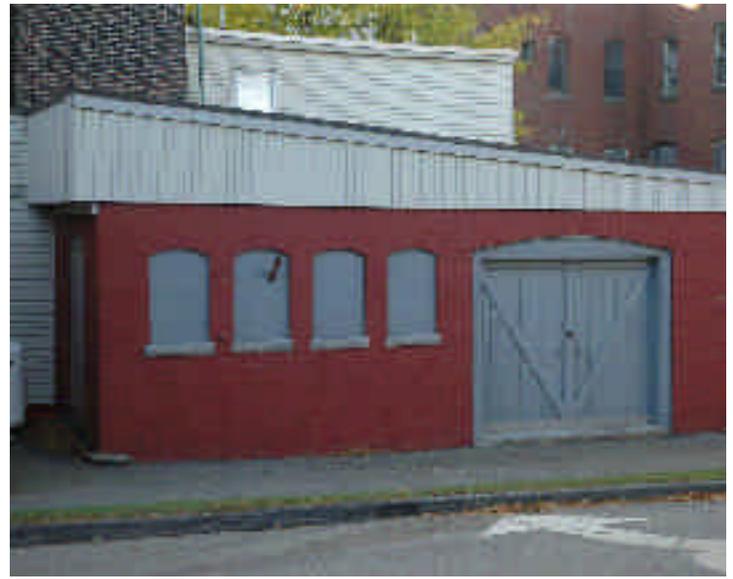
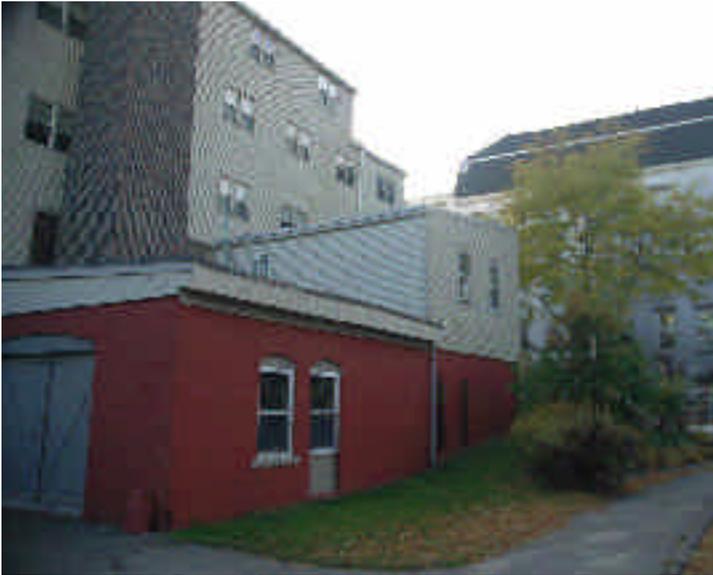
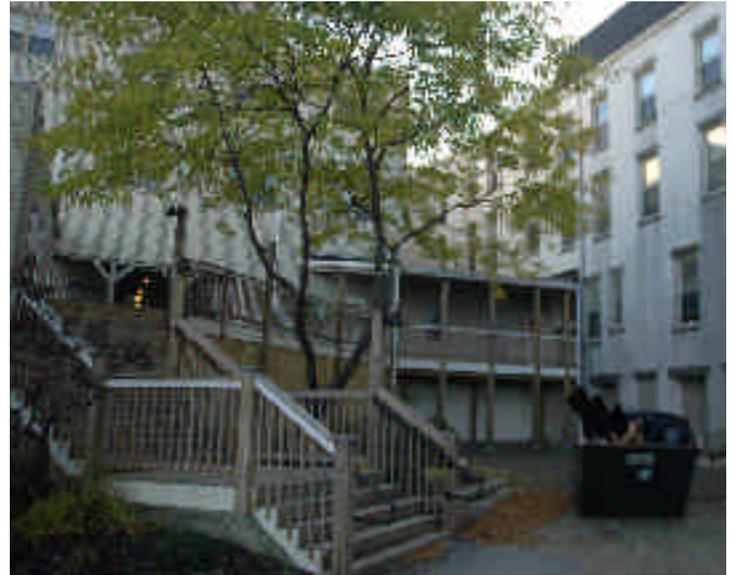
Most aspects of this property are in good condition with exception of inadequate signage and issues at the roof eaves.

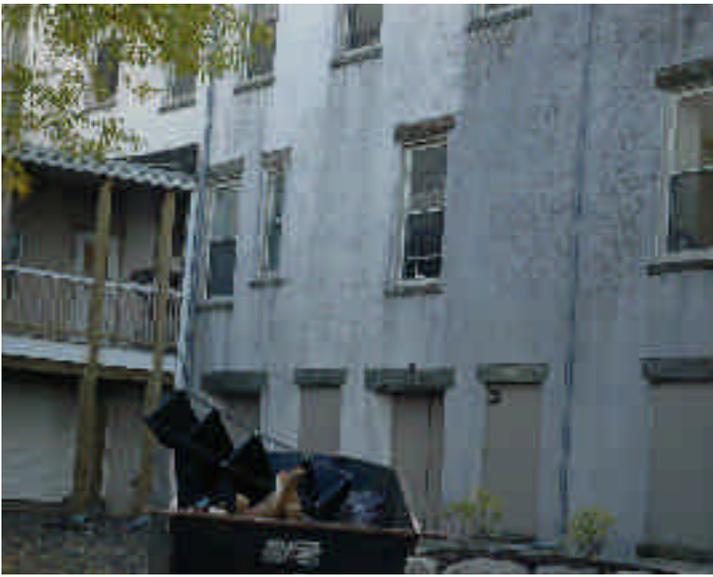
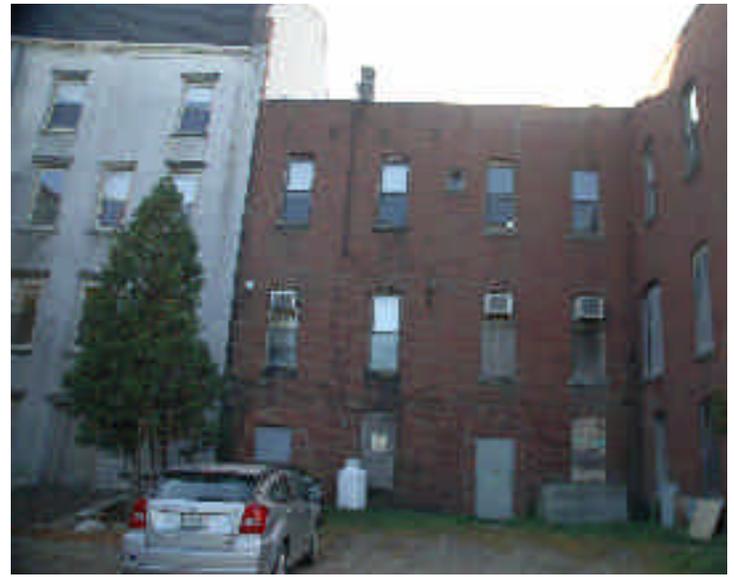
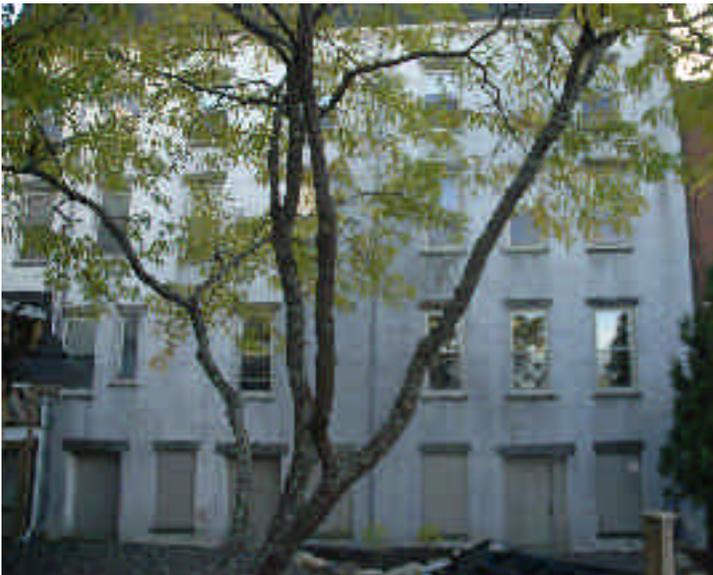
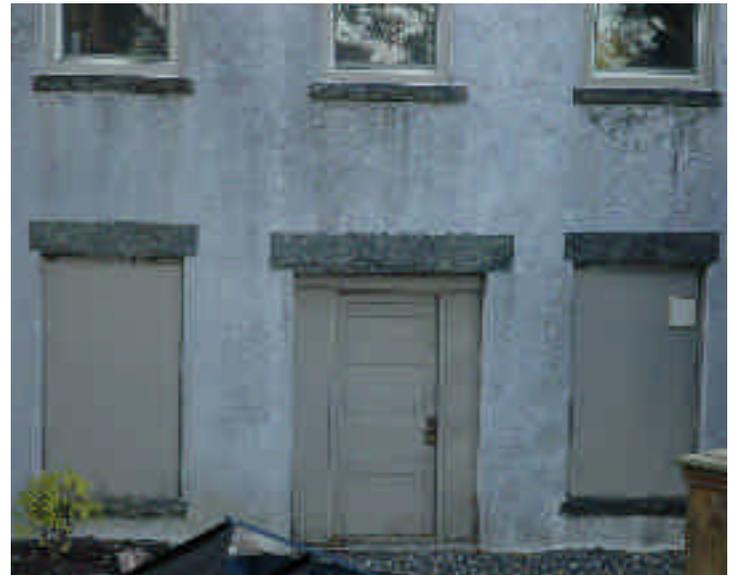
Several aspects of this property are in poor condition including: lack of entry door, boarded windows on street level, and poor paint condition. Harbor side facade is currently unsightly and requires significant upgrades to transform it to a primary commercial storefront facade.

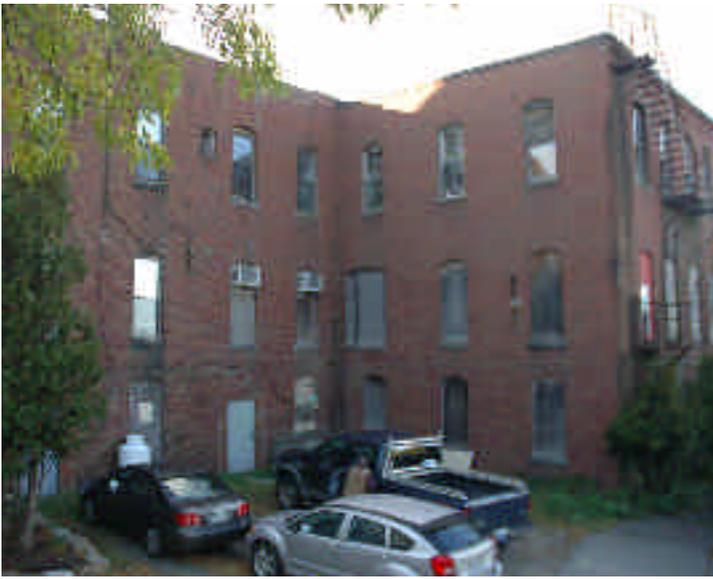
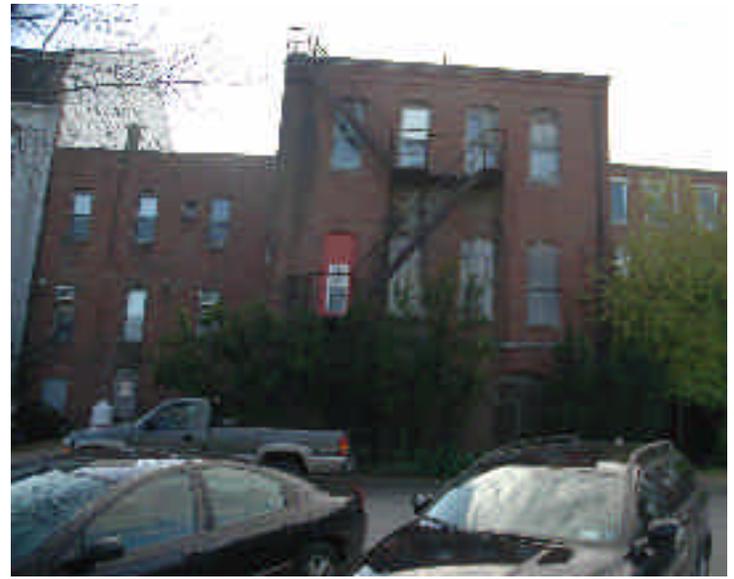
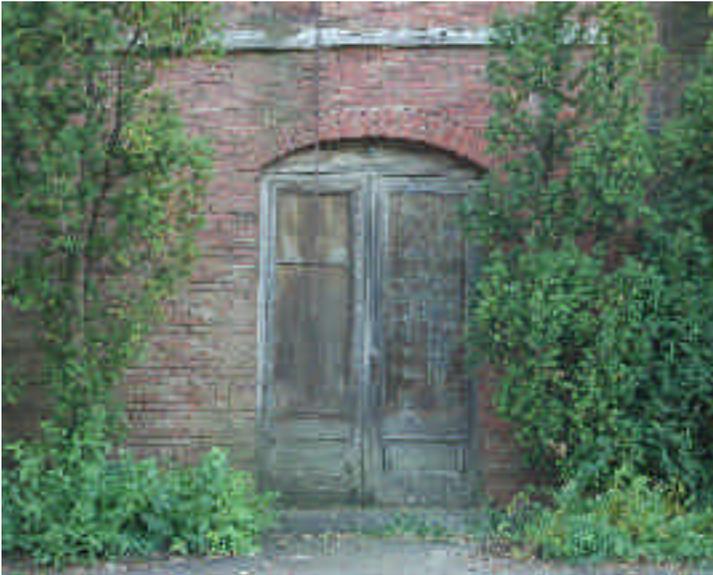
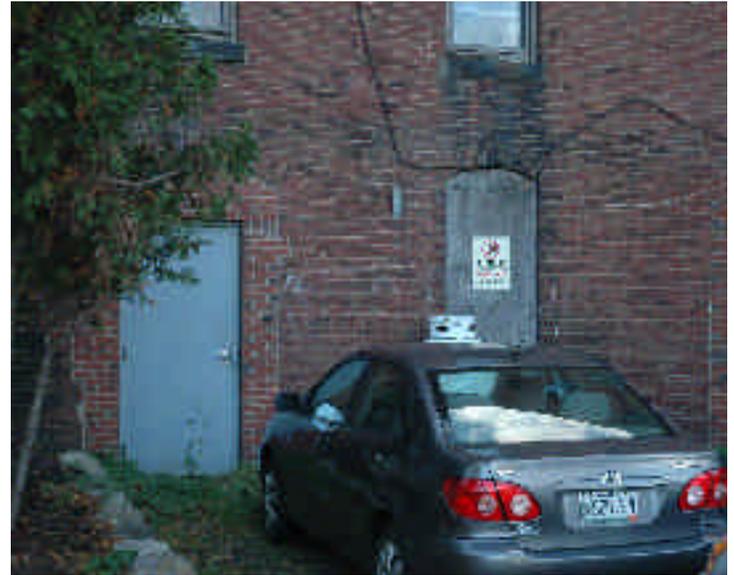
Several aspects of this property are in poor condition including: lack of entry door, boarded windows on street level, and poor paint condition. Harbor side facade is currently unsightly and requires significant upgrades to transform it to a primary commercial storefront facade.

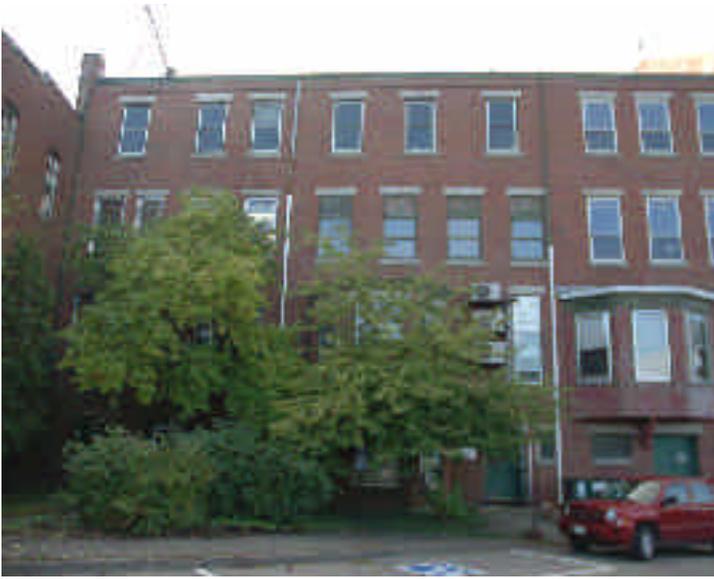
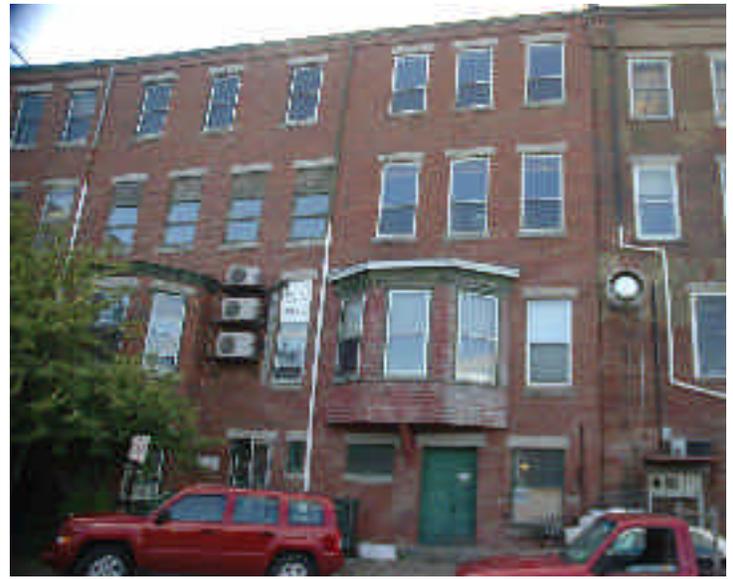
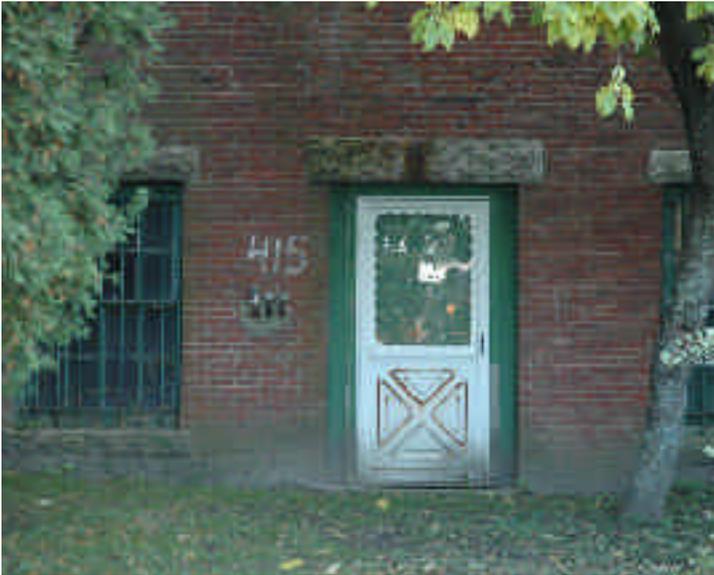
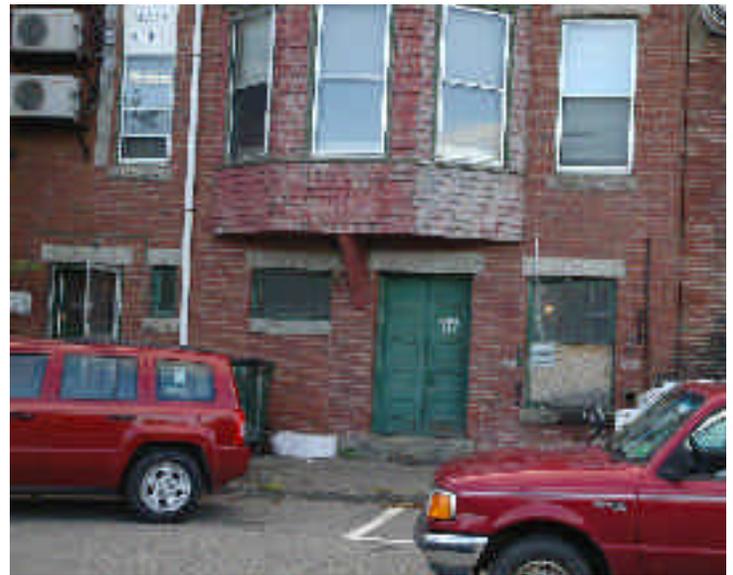
Several aspects of this property are in poor condition including: potential entry doors, boarded windows on all levels, paint and brick facade condition, and overgrown vegetation. Harbor side facade requires significant upgrades to transform it to a primary commercial storefront facade.

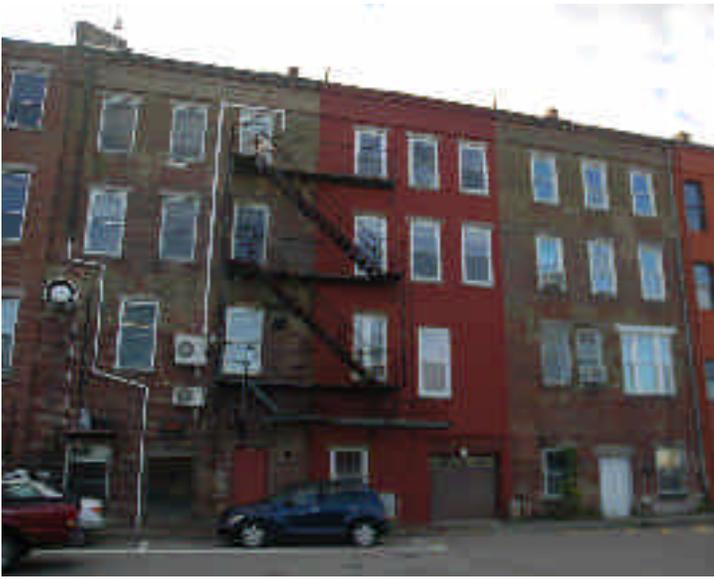
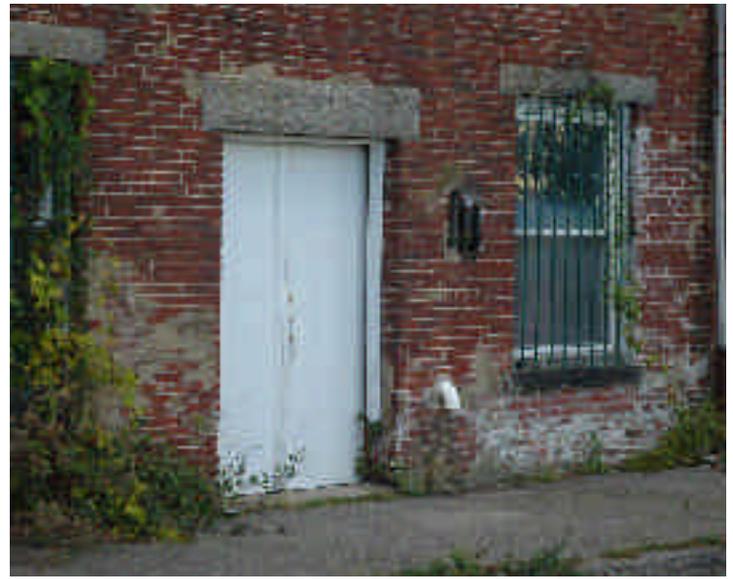
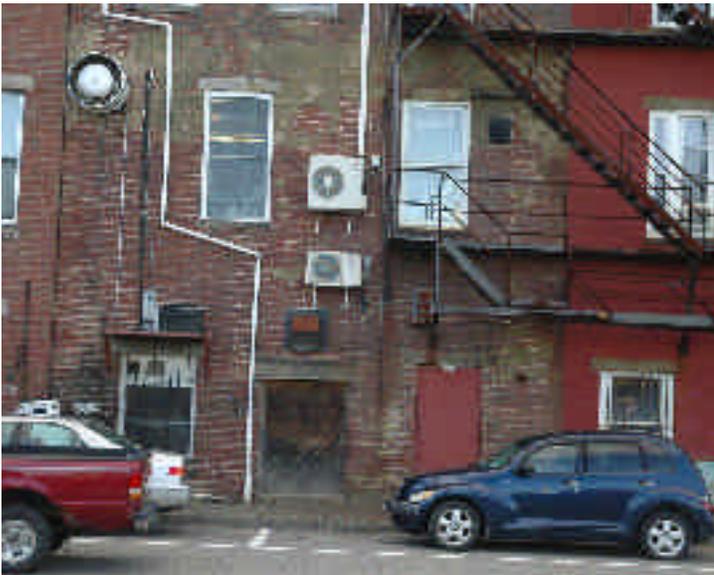
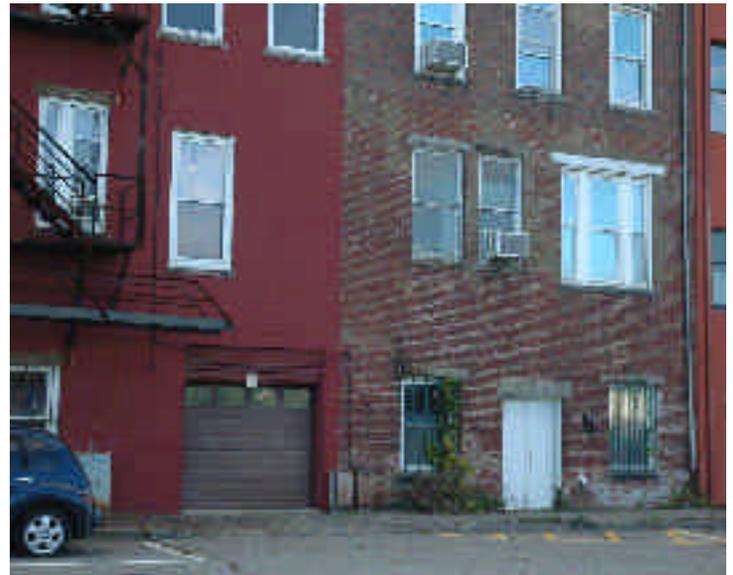
Several aspects of this property are in poor condition including: potential entry doors, boarded windows on all levels, paint and brick facade condition, and overgrown vegetation. Harbor side facade requires significant upgrades to transform it to a primary commercial storefront facade.

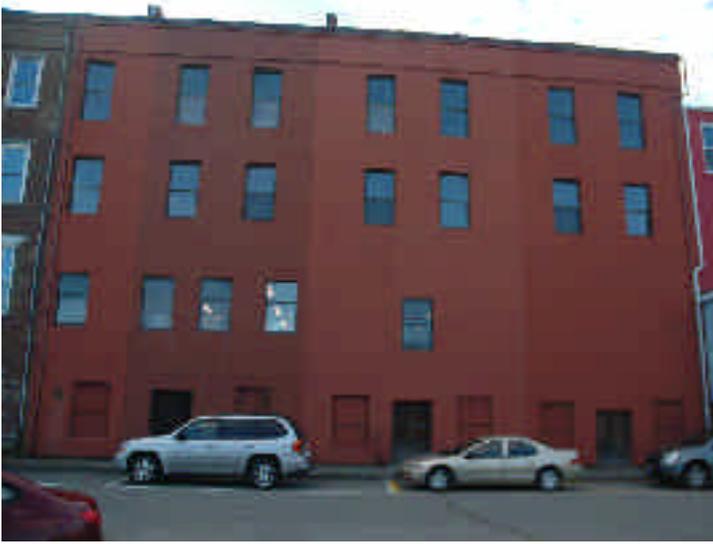
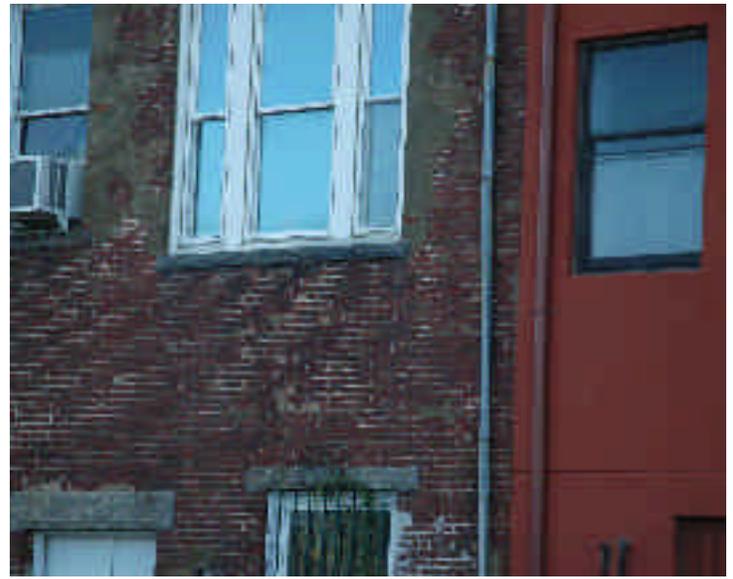
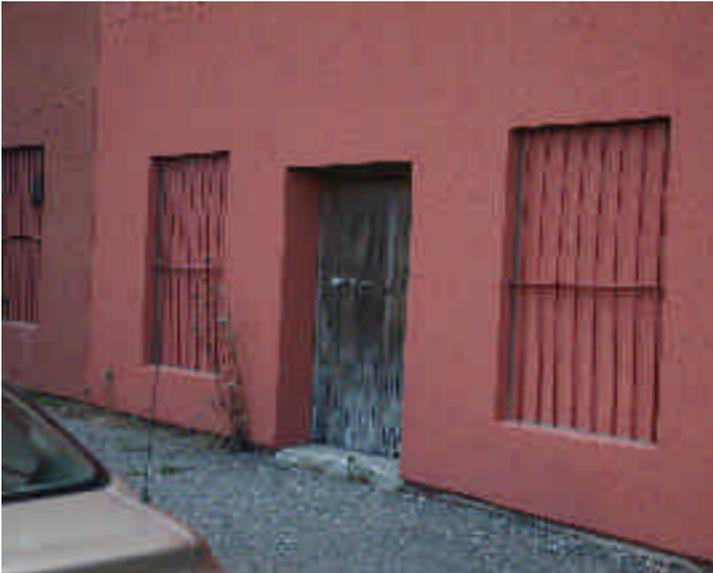
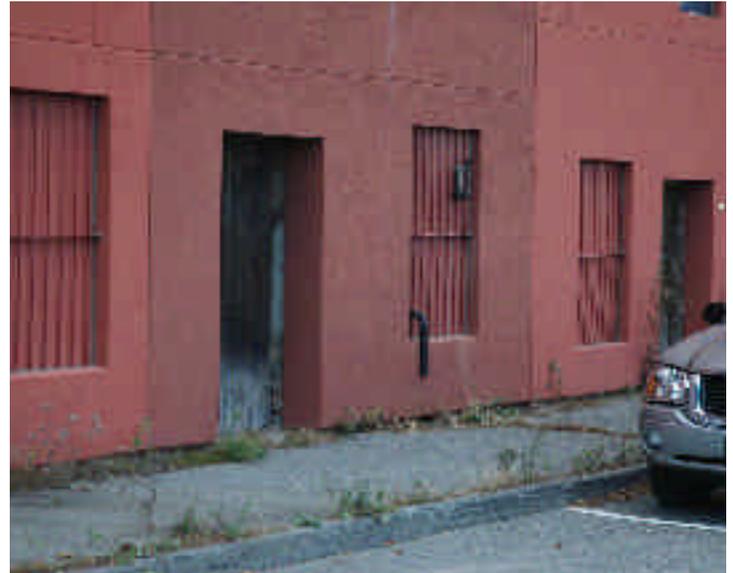
Several aspects of this property are in poor condition including: potential entry doors, boarded windows on all levels, paint and brick facade condition, and vestigial plaster applied to brick. Harbor side facade requires significant upgrades to transform it to a primary commercial storefront facade.

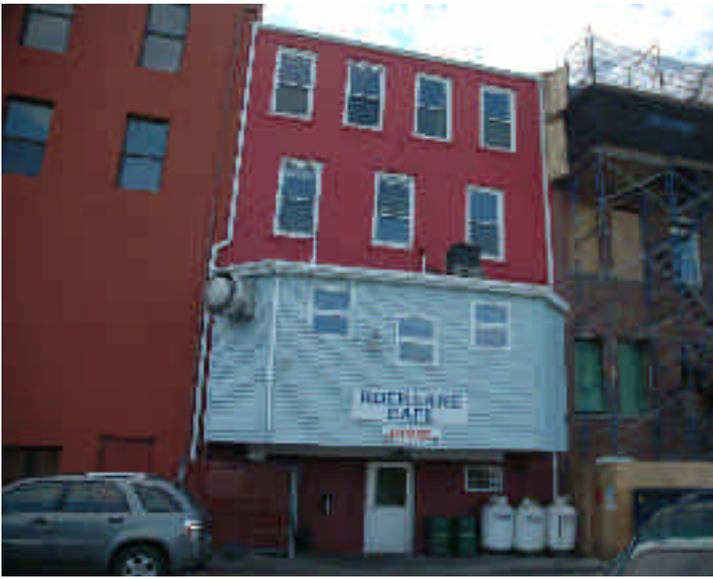
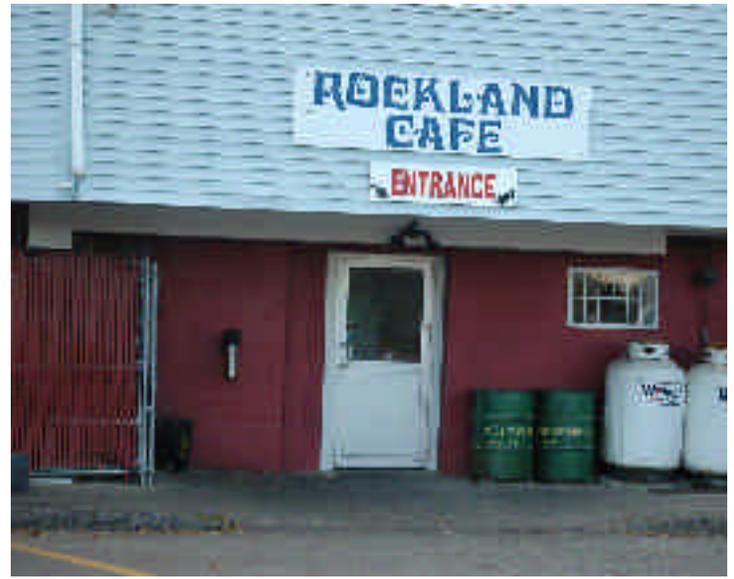
Most aspects of this property are in good or excellent condition with exception of the lack of an entry door and boarded windows at street level. Harbor side facade requires significant upgrades in fenestration to transform it to a primary commercial storefront facade.

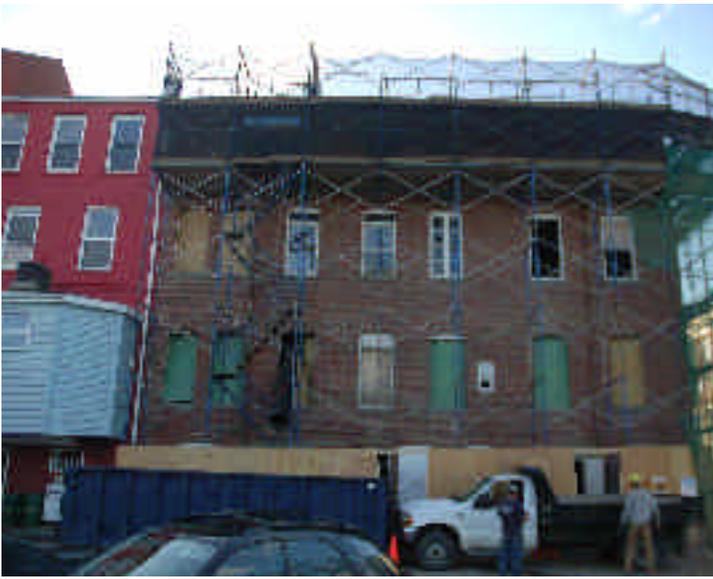
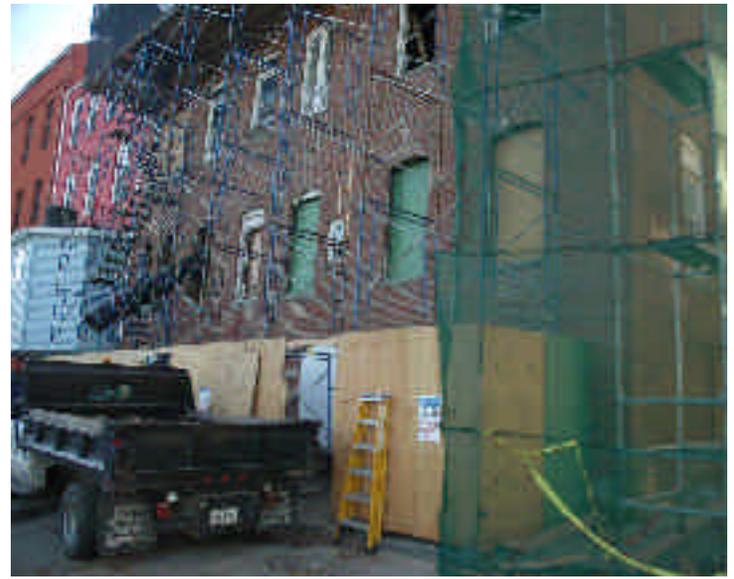
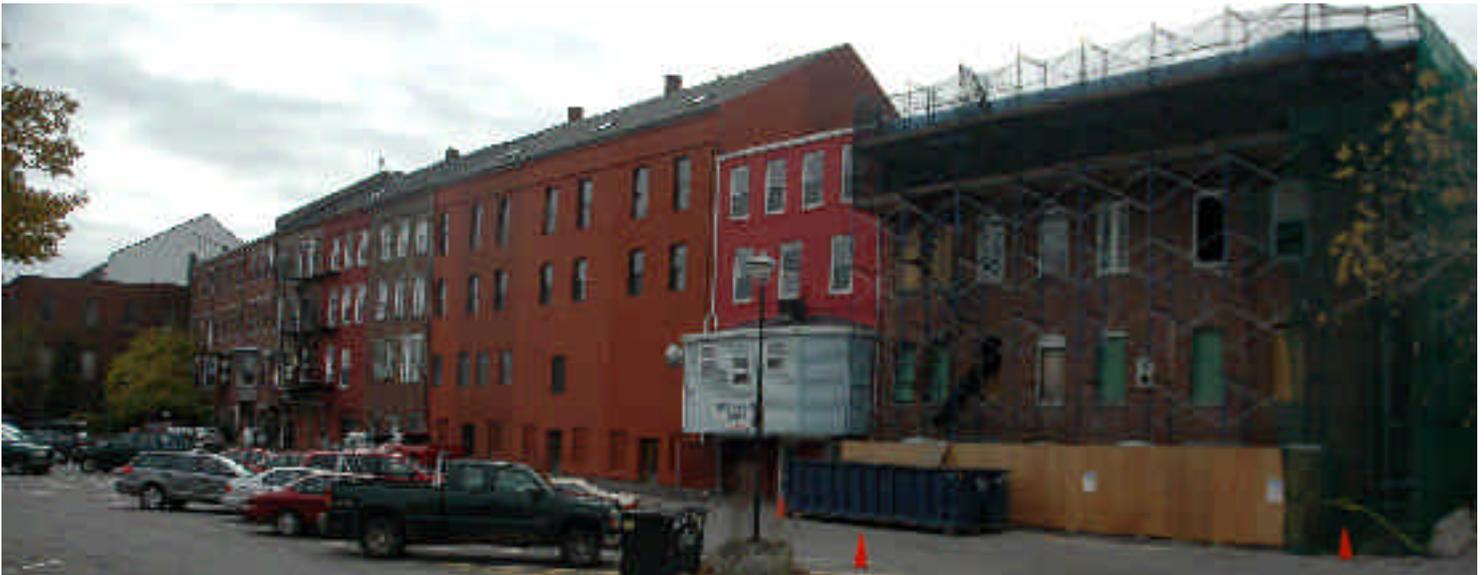
Most aspects of this property are in fair or good condition with exception of poor entry door and poor structural facade conditions across entire facade. Harbor side facade requires several upgrades to transform it to a primary commercial storefront facade.

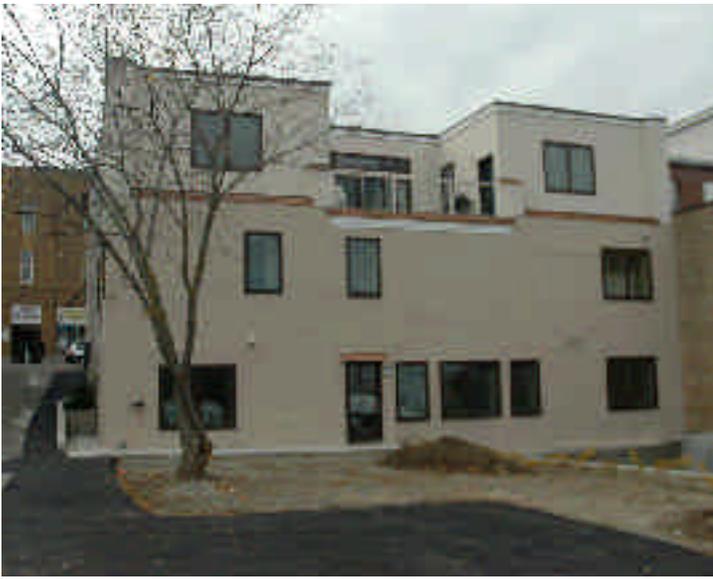
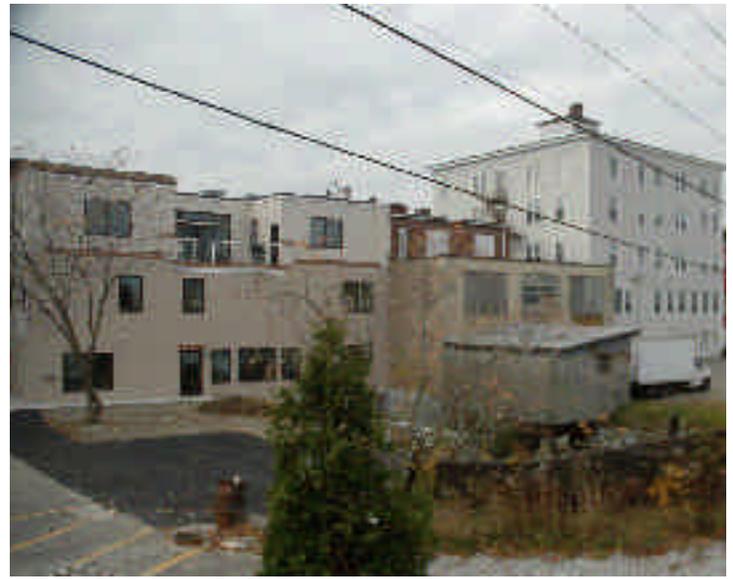
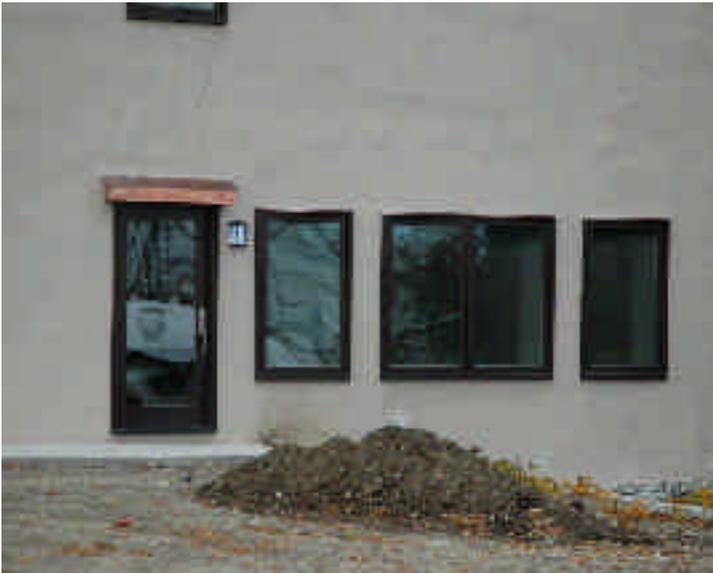
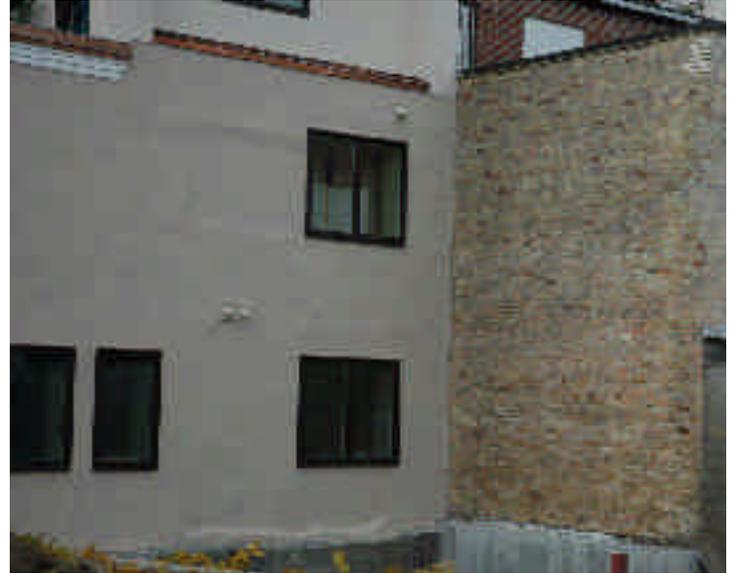
All aspects of this building are in good or excellent condition. No repair recommendations were identified. Harborside access appears to be residential. Potential or appropriate commercial use for this property is unknown.

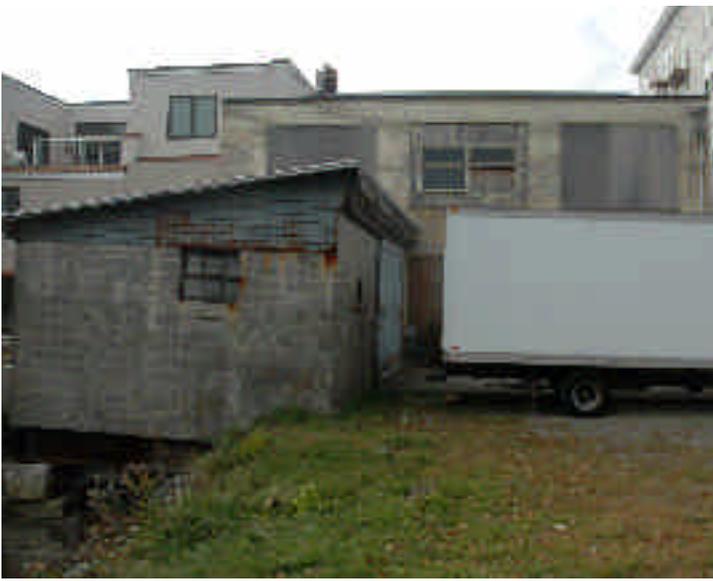
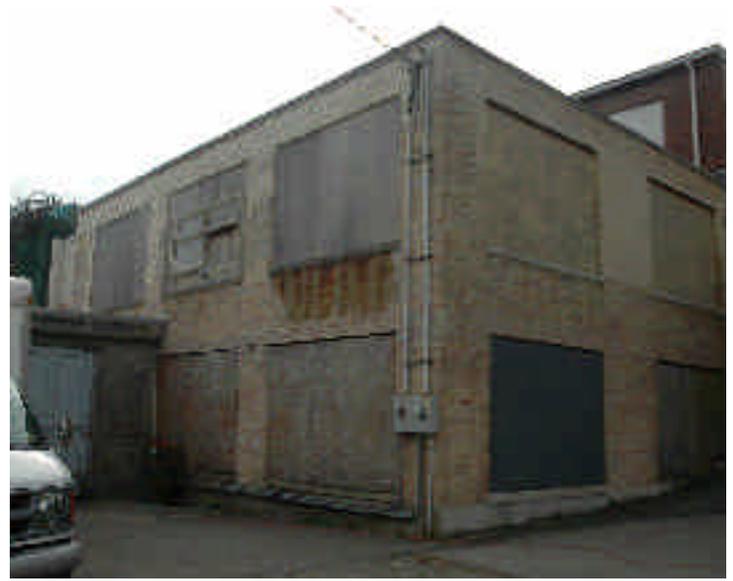
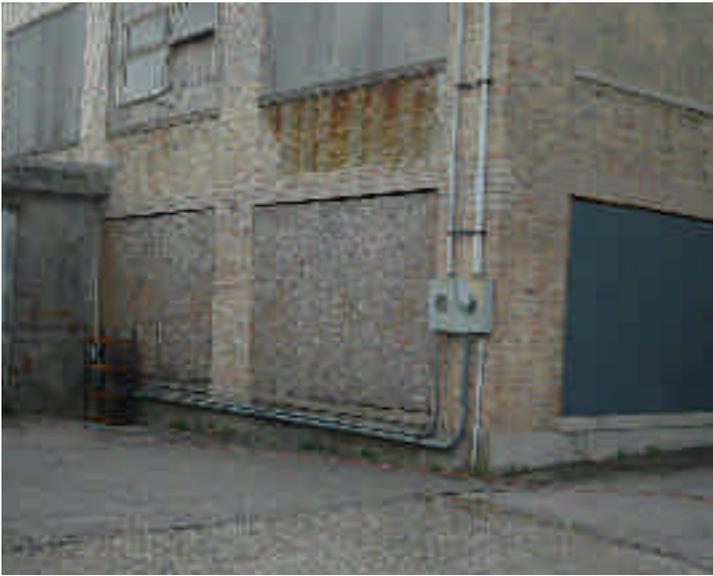
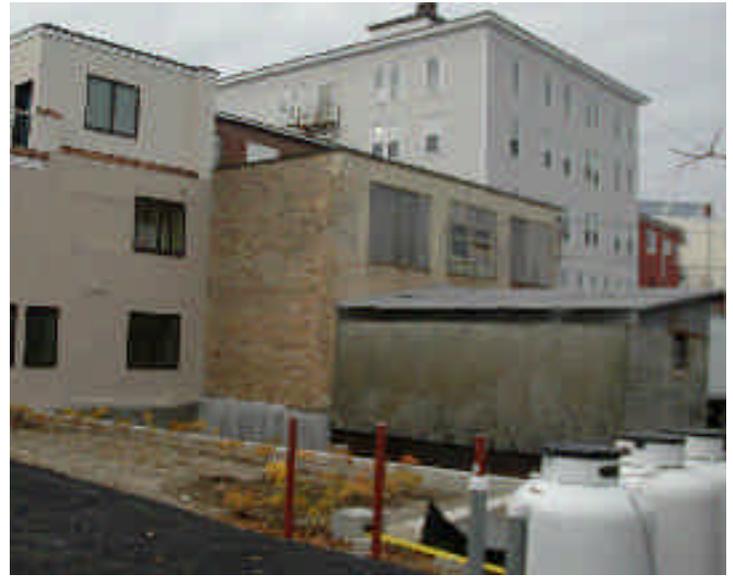
Several aspects of this property are in poor condition including: potential entry doors, boarded windows on all levels and brick facade condition. Harbor side facade requires significant upgrades to transform it to a primary commercial storefront facade.
