2009 Downtown Revitalization Plan UPDATE

City of Rockland, Maine

2009 DOWNTOWN REVITALIZATION PLAN UPDATE

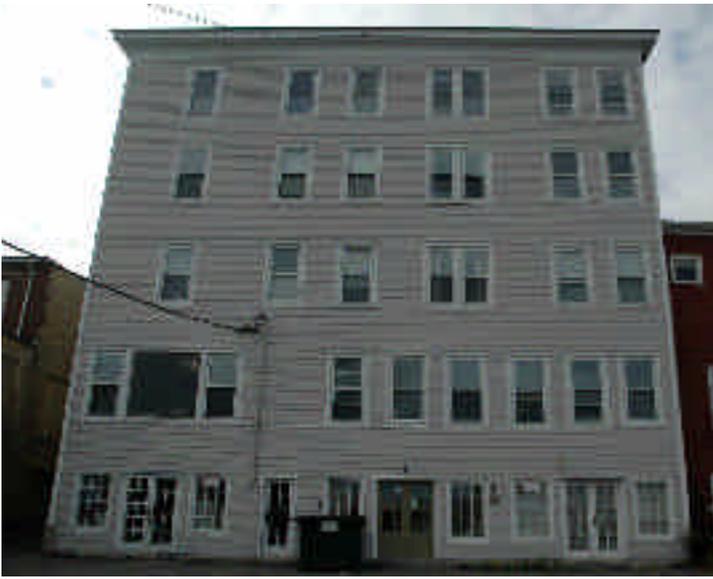
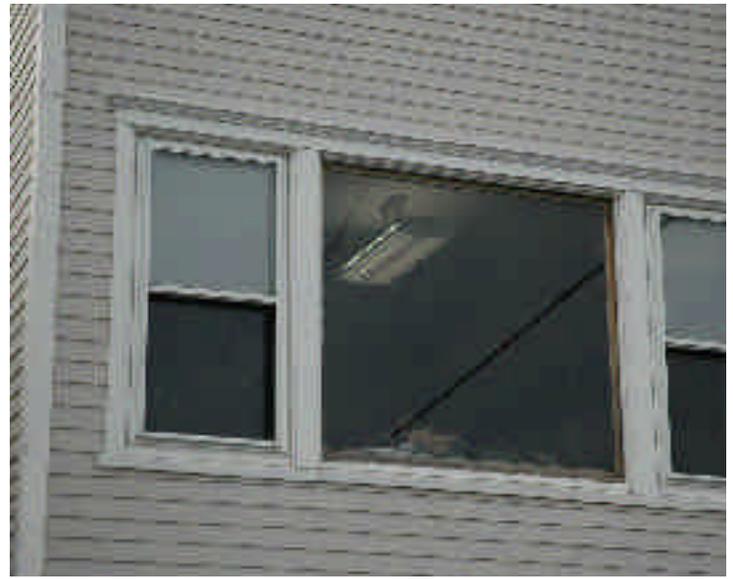
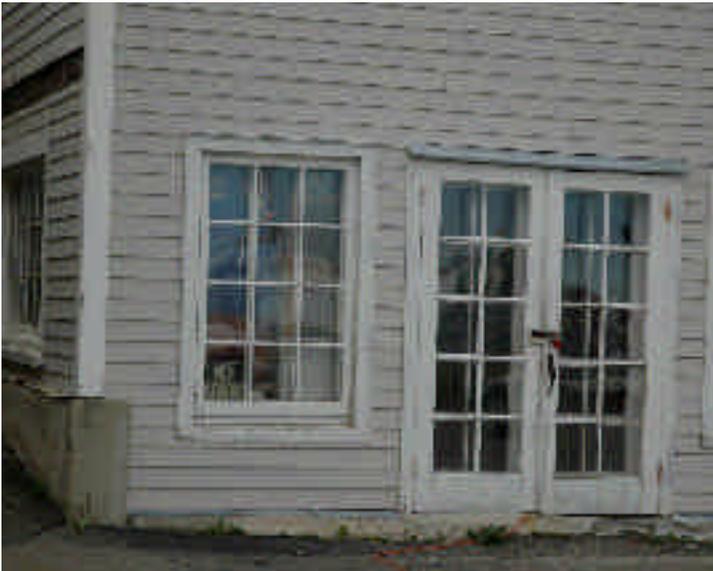
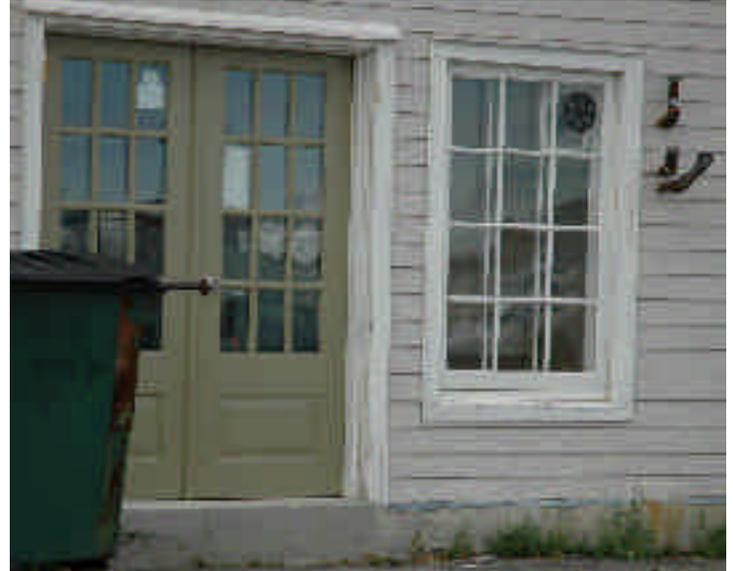
Most aspects of this property are in good or excellent condition with exception of the 2 entry door locations in poor condition, poor paint condition, and poor window condition at second level. Harbor side facade requires relatively few upgrades in fenestration and paint to transform it to a primary commercial storefront facade.

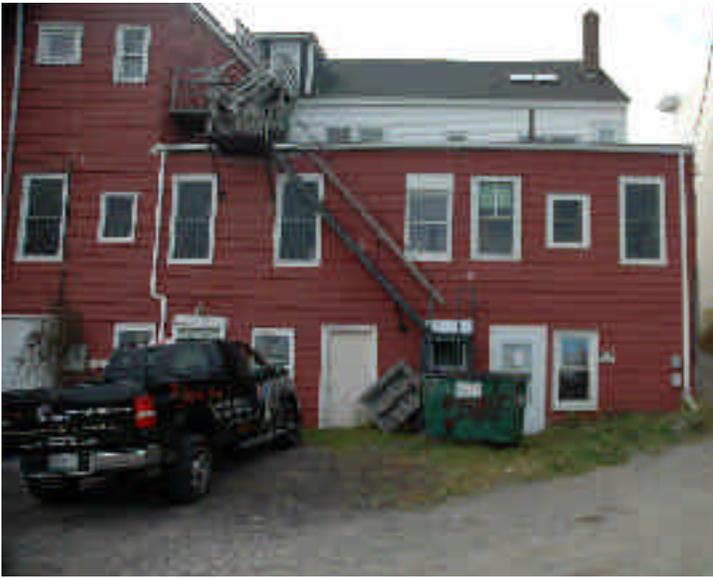
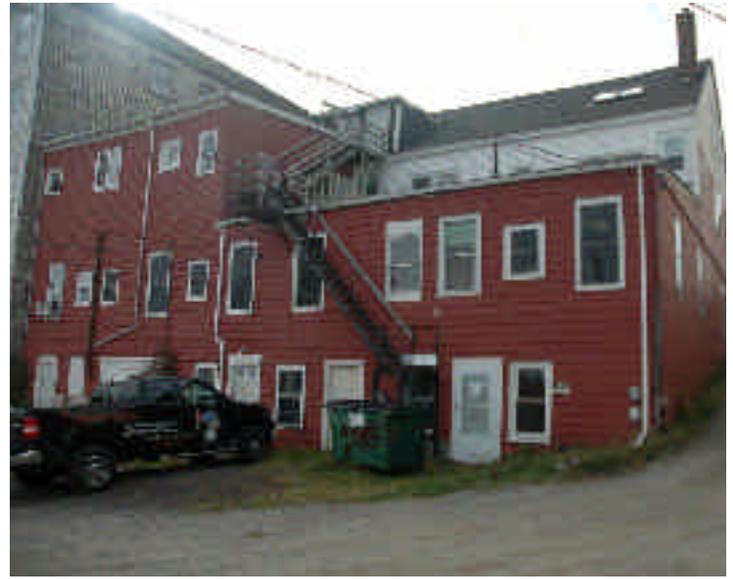
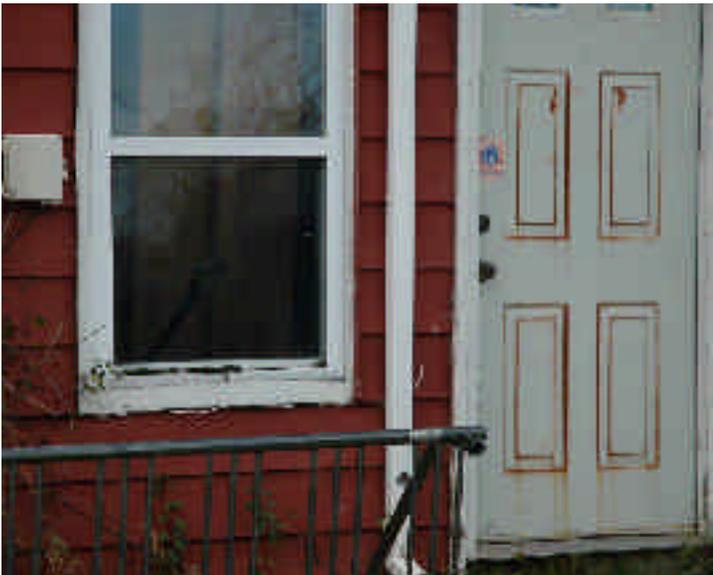
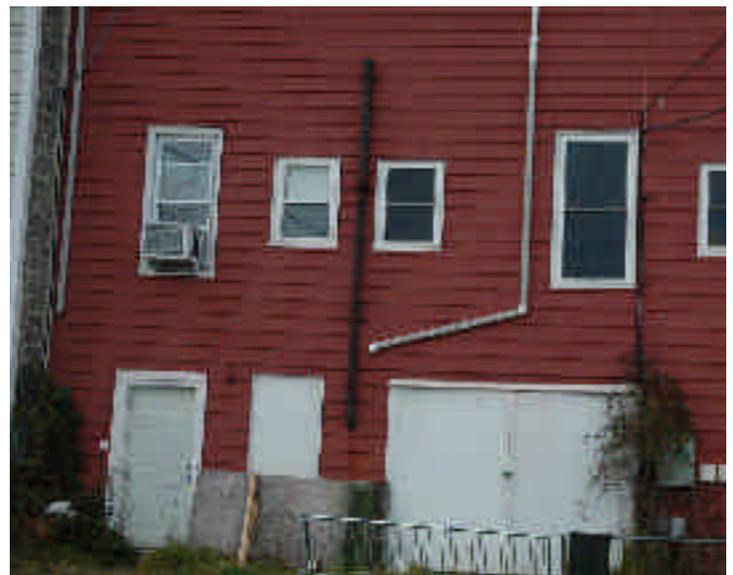
Several aspects of this property are in poor condition including: potential entry doors and structural facade on all levels. Harbor side facade requires significant upgrades to transform it to a primary commercial storefront facade.

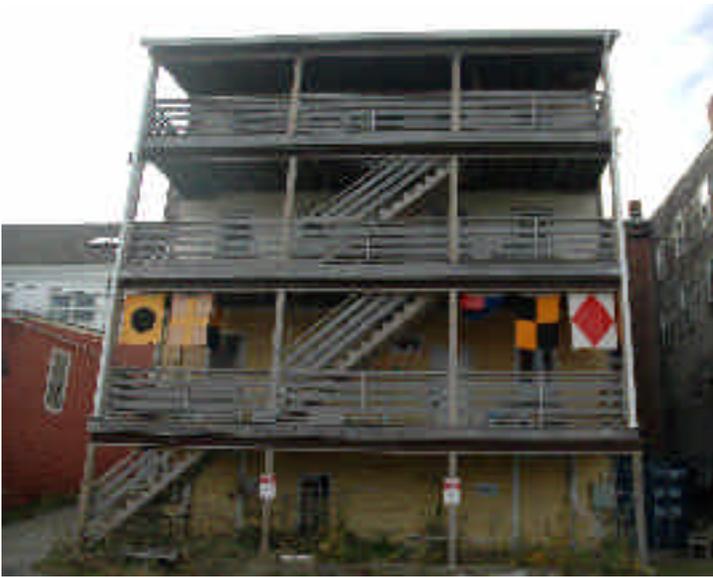
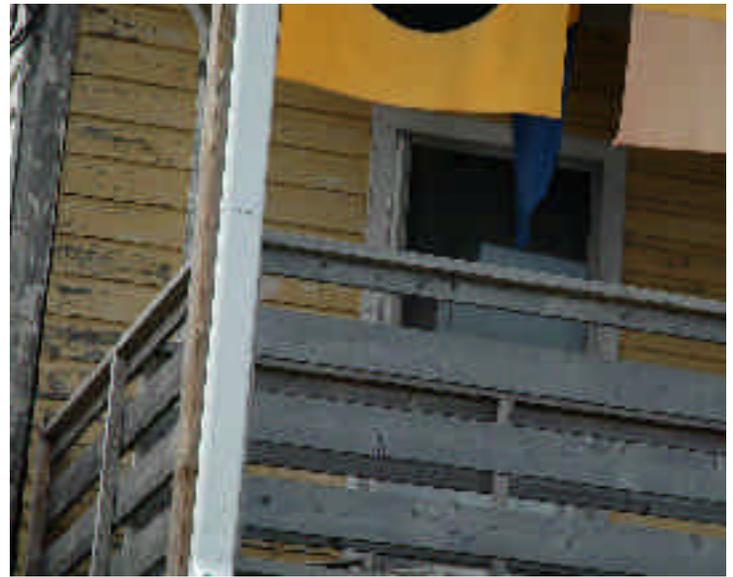
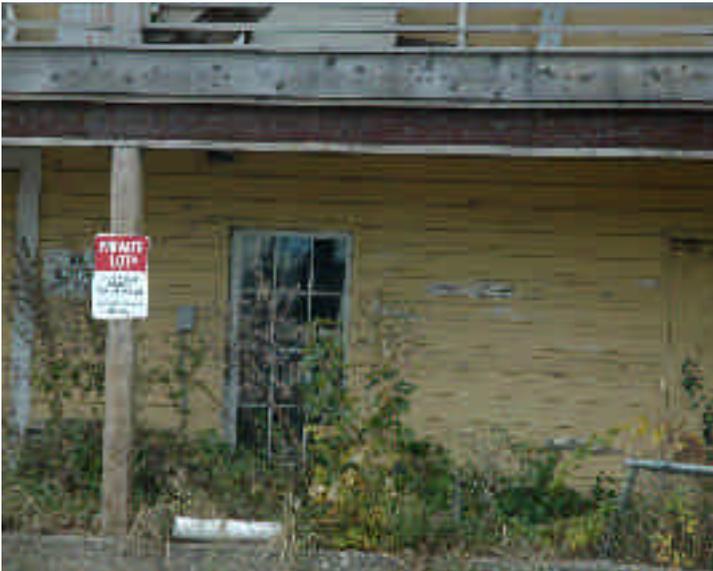
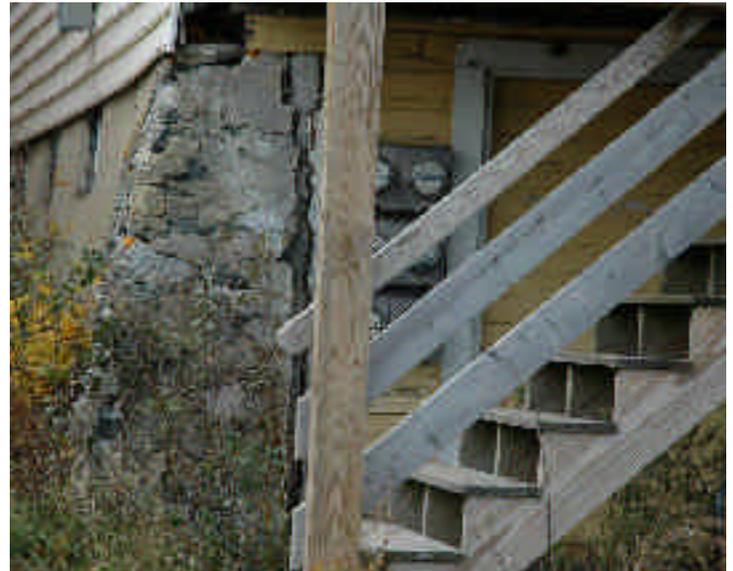
Several aspects of this property are in poor condition including: potential entry doors, structural facade, windows, and paint on all levels. Residential tenement character of this property creates a difficult condition to transform Harbor side facade to a primary commercial storefront facade. Significant work will need to be done.

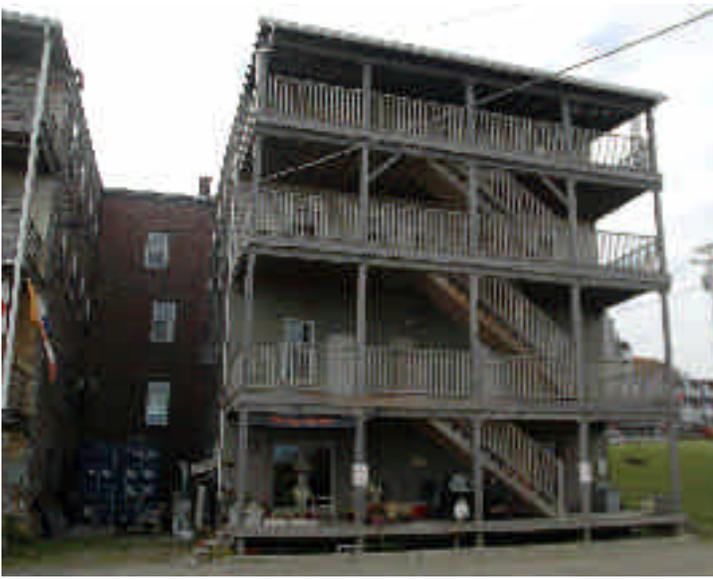
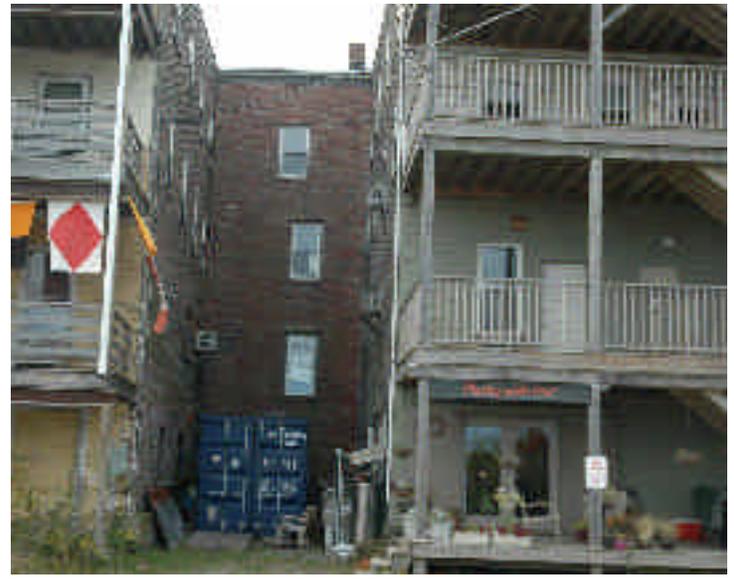
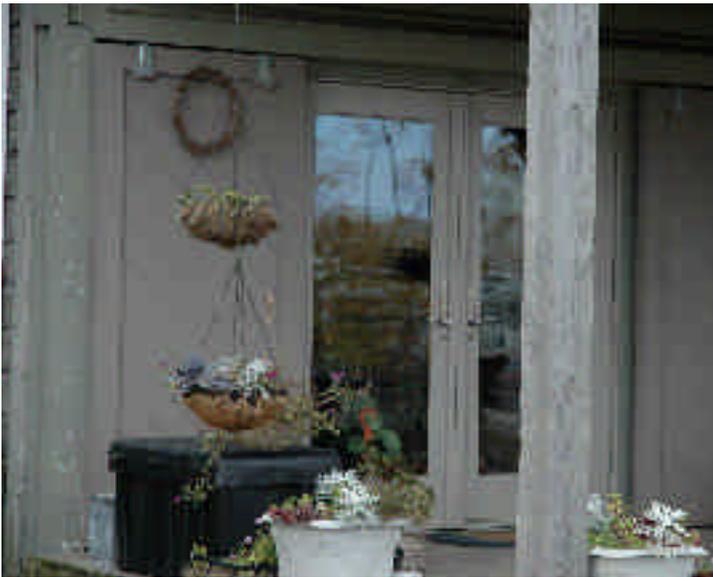
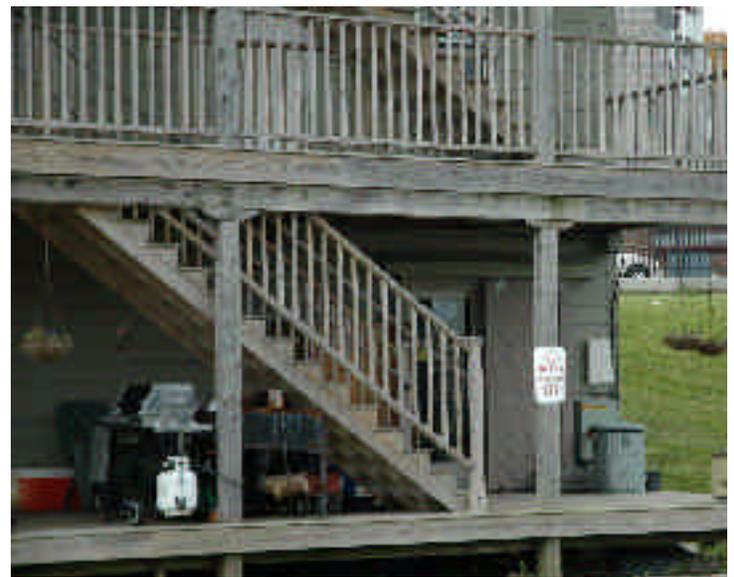
Several aspects of this property are in poor condition including: entry door access. Residential tenement character of this property creates a difficult condition to transform Harbor side facade to a primary commercial storefront facade. Significant work will need to be done.
